# SEYMOUR ROAD SAFETY AUDIT

Route 67 (Bank Street) & Klarides Village Drive

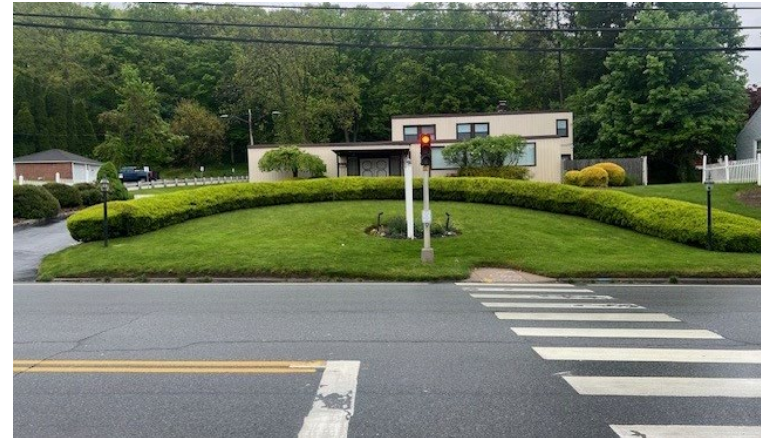
- Pedestrian fatalities in 2021 at this signalized intersection
- Sidewalks currently only exist on the south side of Route 67
- Town participants expressed the need for a safer pedestrian experience crossing from the funeral home to the plaza driveway
- NVCOG discusses this intersection in their 2023 Spot Improvement Study and plans to improve the condition of the

*Exhibit 15: Crosswalk and landing area on the north end of the Route 67 and Klarides Village Drive intersection*

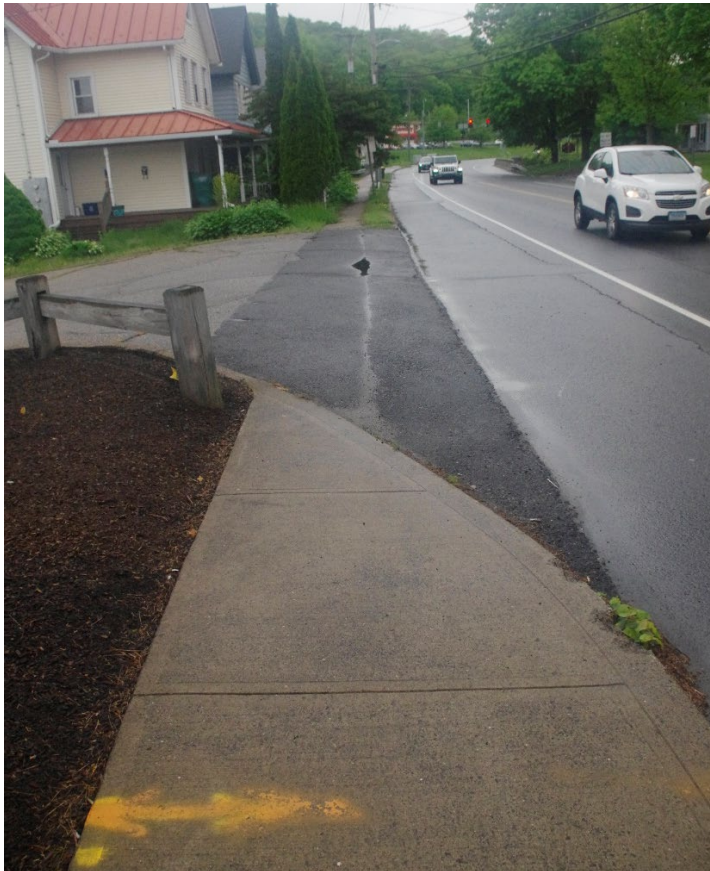
- Participants discussed the difficult pedestrian experience heading west bound on Route 67 due to the sidewalk conditions
- Shoulder widths are narrow along Route 67
- Exhibit 16 displays the long-unmarked crosswalk at the west side entry/exit of Klarides Village Plaza
- Participants discussed the overgrown landscaping along the sidewalk covering the speed limit sign, as displayed in Exhibit 17
- Sidewalks need repair in some areas, cracks on the sidewalk make it difficult for pedestrians who use wheelchairs, walkers, or strollers

Exhibit 16: Crosswalk at 285 Bank Street (Route 67) exiting Klarides Village Plaza

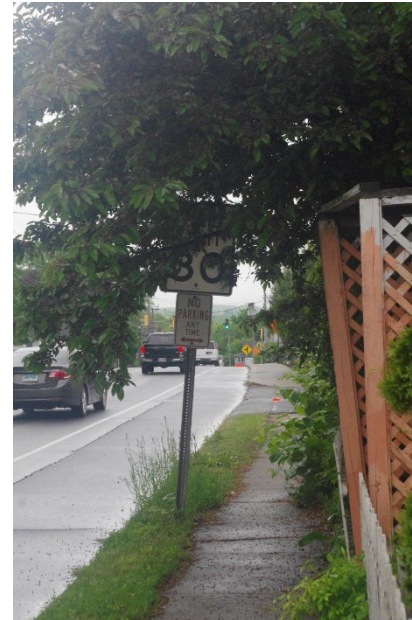
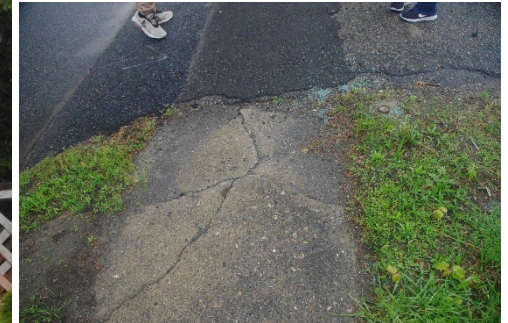
Exhibit 17: Covered speed limit sign and cracked sidewalk along Route 67 near West Street

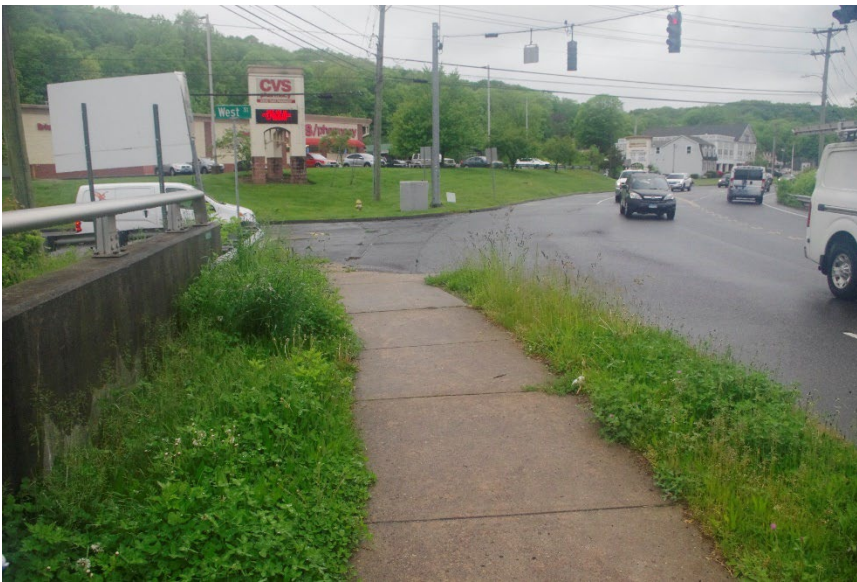
- Town participants said they would like to continue the pedestrian experience beyond West Street and link the Klarides Village Plaza to the Oxmour Plaza Shopping Center
- There is currently a no pedestrian crossing sign at this intersection, as shown in Exhibit 19

*Exhibit 18: Route 67 and West Street Intersection*

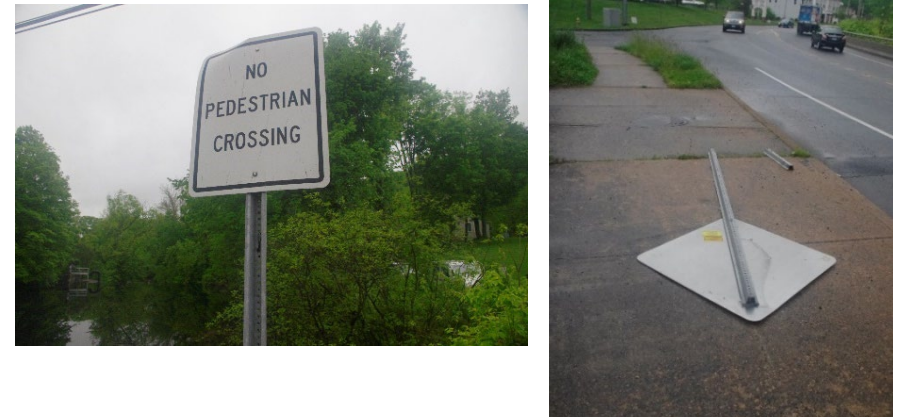
*Exhibit 19: No pedestrian crossing sign at West Street intersection and break-away sign damaged near the intersection*

- 3) Replace knocked down sign.

- **Next Step:** CTDOT to replace sign near the intersection of Route 67 and West Street. Email [jim.zaharevich@ct.gov](mailto:jim.zaharevich@ct.gov).

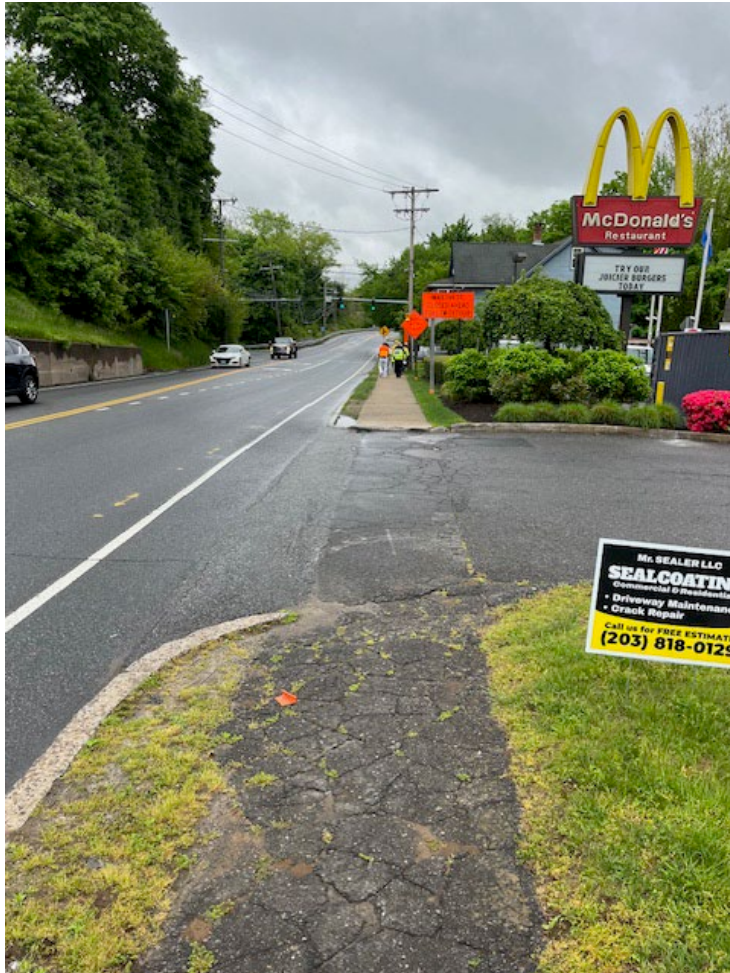
- The sidewalk needs repair, as displayed in Exhibit 20
- High volume of vehicles on Route 67 making left turns into the plaza from multiple points along Bank Street. Left turns are being addressed in the Route 67 construction project
- Swan Avenue has a sidewalk up to Route 67 but there is no marked crosswalk for pedestrians to cross displayed in Exhibit 21. There is also no sidewalk on the north side of Route 67 causing pedestrians to walk on the grass or road near this intersection

Exhibit 20: Damaged Sidewalk Near McDonald's Entrance

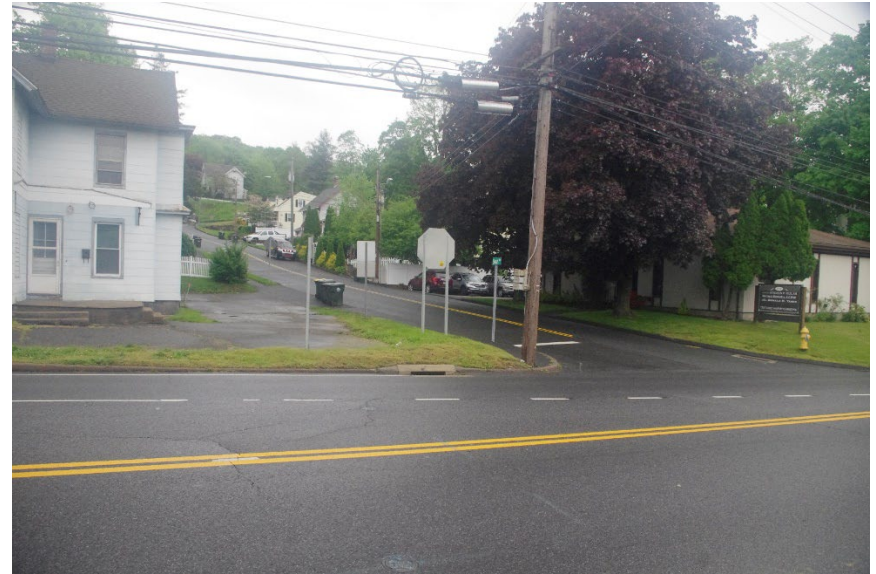
Exhibit 21: Existing Sidewalk on Swan Avenue at Route 67 Intersection

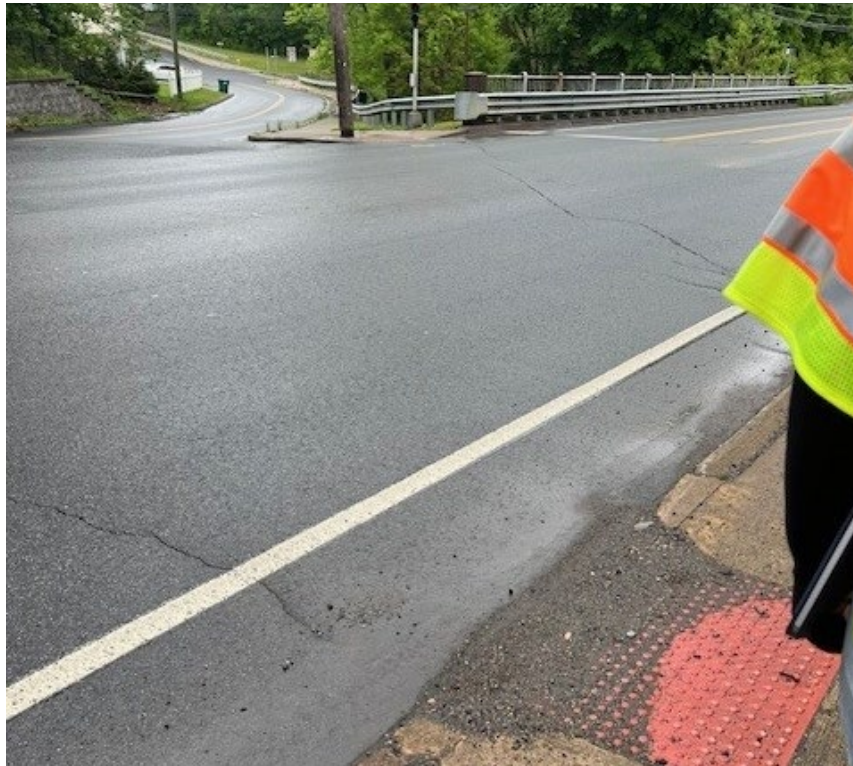
- No crosswalks at this intersection, as shown in Exhibit 22
- Awkward geometry at this signalized intersection
- Sidewalks need repair near the intersection, which will be addressed in the Route 67 construction project
- Obstructions for pedestrians at the intersection, as displayed in Exhibit 23

*Exhibit 22: No Marked Crosswalks at Route 67 and Old Drive Intersection*

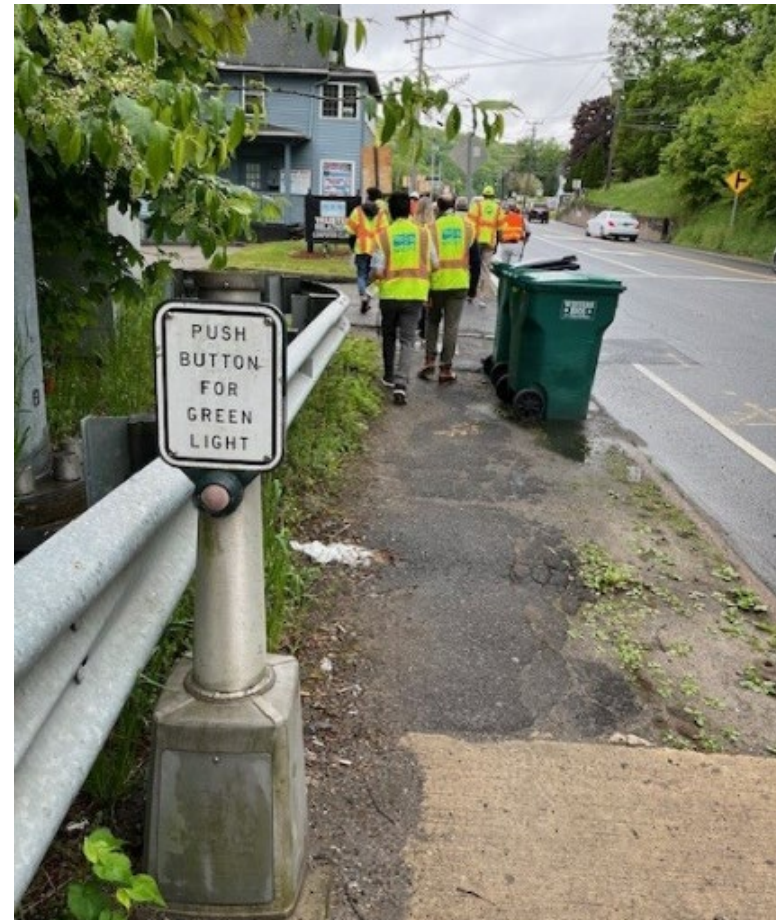
*Exhibit 23: Trash Receptacles on Sidewalk near Old Drive Intersection*
