# ANSONIA / DERBY ROAD SAFETY AUDIT

Route 853 (Division Street): Route 727 (Pershing Drive)  
to Route 115 (Derby Avenue / Main Street)

**FEBRUARY 2025**

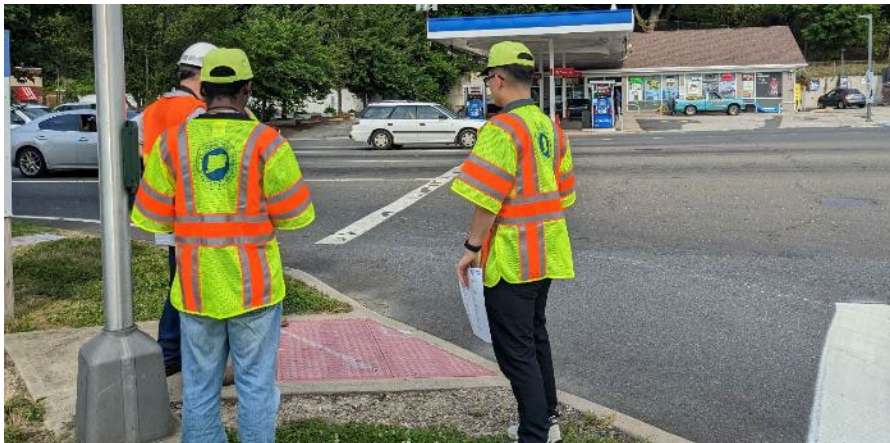
*Exhibit 18: RSA Participants Observing Pedestrian Signal Head*

A summary of the team's findings from documenting conditions observed in the field, along with comments from municipal stakeholders, is presented below. Exhibit 18 shows RSA participants observing the pedestrian crossing at the intersection of Route 853 (Division Street) and Route 727 (Pershing Drive).

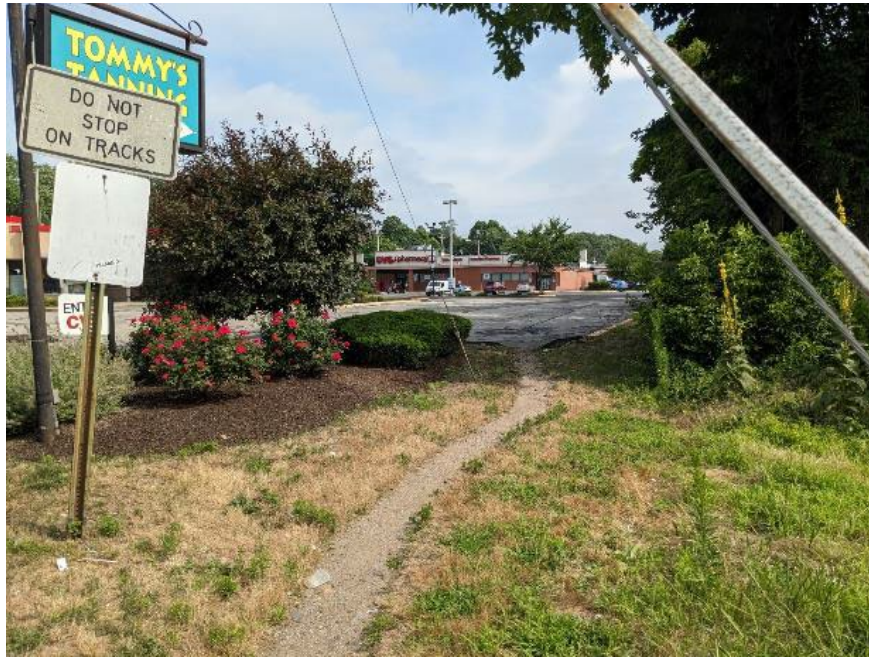
Exhibit 19: Visible "Goat Path" Leading to CVS Parking Lot

- Sidewalks are only present on the north side of Division Street and abruptly end at the CVS driveway. Sidewalks are in poor condition.
- A pedestrian “goat path” exists heading into CVS parking lot, as displayed in Exhibit 19.

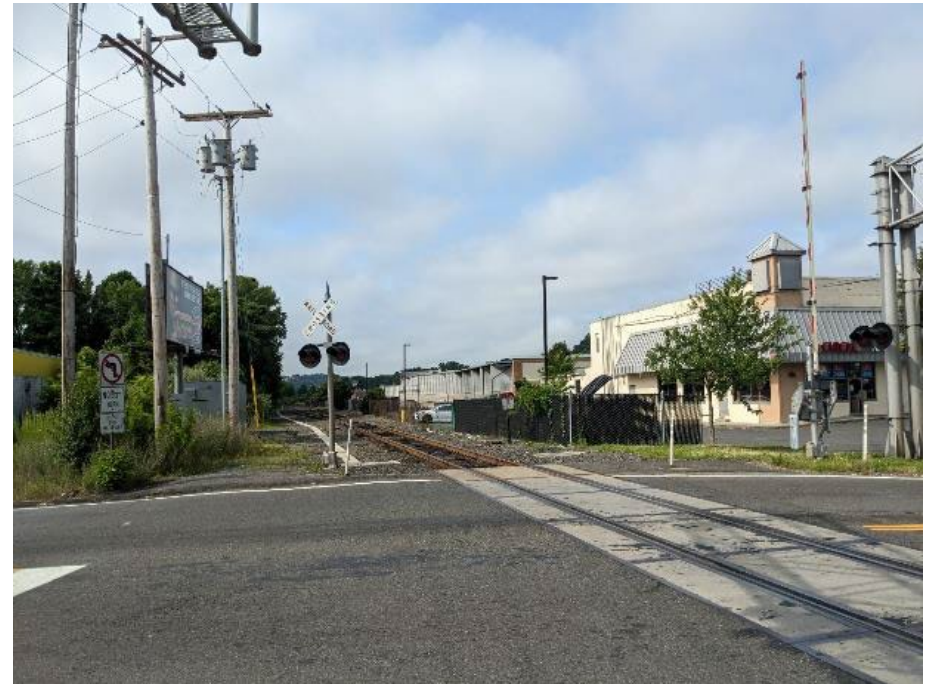
Exhibit 20: Rail Crossing on Division Street

- The detectable warning surface does not extend the entire ramp opening width.
- The 4'x4' clear area is not located outside the vehicle travel way.
- There is no detectable warning surface at the rail crossing, which sees 22 bi-directional trains a day at this location. Exhibit 20 displays the rail crossing.
- The great number of curb cuts and driveways encourage many left turns on Division Street.

The proposed changes at this location aim to improve safety and accessibility along Division Street, especially at the challenging rail crossing. Currently, the detectable warning surface DWS doesn't extend across the full ramp width, making pedestrian accommodations inadequate. Installing ADA-compliant crosswalks, sidewalks, and curb ramps will address these issues. A midblock crossing with a pedestrian island and flashing beacons will improve safety near the former Stop & Shop. Buffered bike lanes and a turning lane will enhance safety for cyclists. Long-term, pursuing grade separation at the rail crossing will further reduce risks and improve navigation for both pedestrians and cyclists.

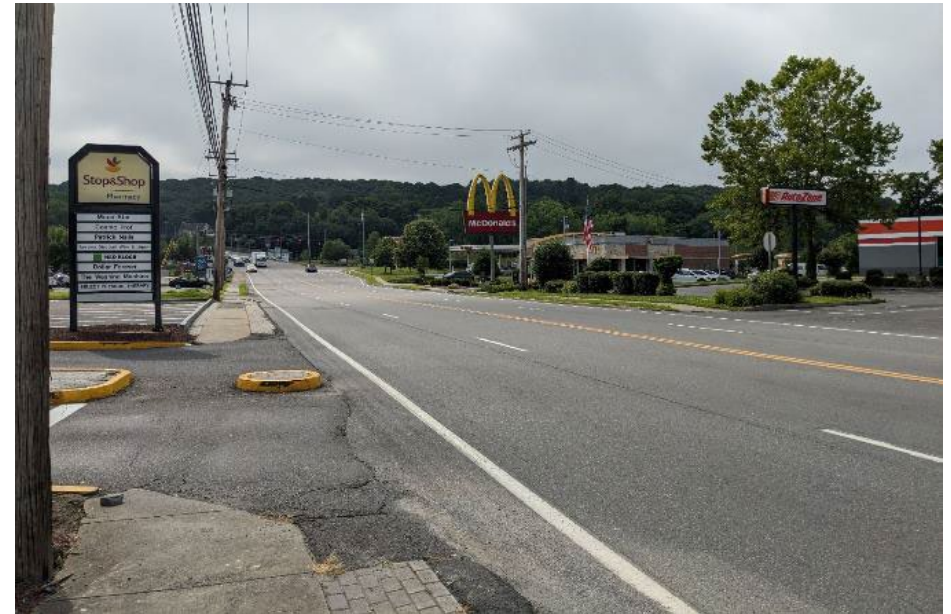
Exhibit 22: Pavers and Sidewalks in Poor Condition on Division Street

- There is a lot of debris in the shoulders of the roadway and in the catch basins.
- There is evidence of damage to brick pavers in this area, as displayed in Exhibit 22.
- Sidewalks are in poor condition in this area.
- Driveways lack ADA amenities such as tactile warning strips and ramps.
- Pedestrian scale lighting does not exist.

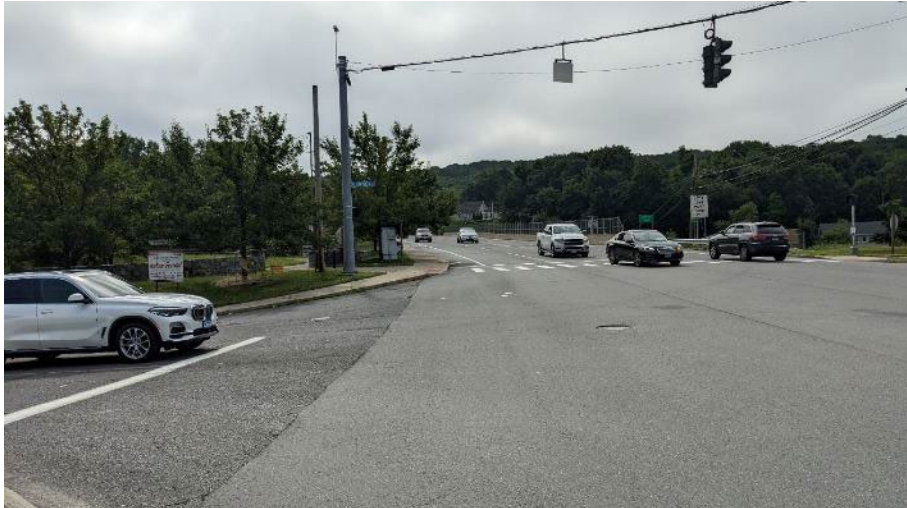
*Exhibit 23: Missing Crosswalks on North and South Approaches at Intersection of Division Street and North Division Street*

- High speeds were observed in this location.
- There are limited ADA accommodations.
- While there is an exclusive pedestrian phase at intersection, no crosswalks exist across the north or south leg of the intersection. This is displayed in Exhibit 23.
- A participant stated that the Naugatuck Greenway Trail has high ridership in this area. Exhibit 24 displays the Ansonia Riverwalk Park Connection to the Naugatuck River Greenway Trail. Additional

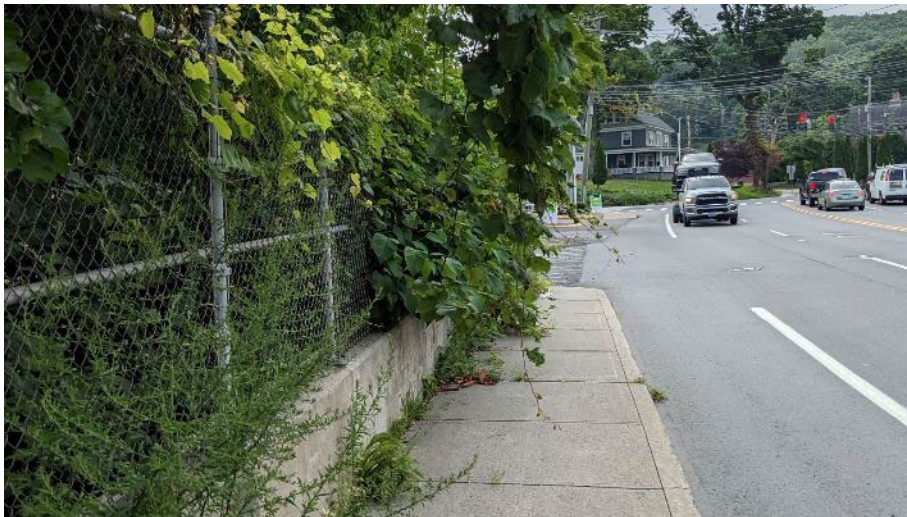
*Exhibit 25: Overgrown Vegetation Along Bridge on Division Street Near South Division Street Underpass*

- The South Division Street and Division Street intersection has poor sightlines. Motorists cannot easily see pedestrians.
- There is overgrown vegetation along bridge as shown in Exhibit 25.
- The sidewalks are in poor condition in this area.
- The pedestrian signals at all corners of intersection are not functioning properly. Exhibit 26 shows a pedestrian crossing at this location without the signal.
- Road grades and angles cause sightline issues at this intersection.

Improvements in this location aim to improve pedestrian accommodation through the inclusion of pedestrian scale lighting, crosswalks, and curb ramps. Long term, it is recommended that the ROW and intersection are realigned to improve sightlines.

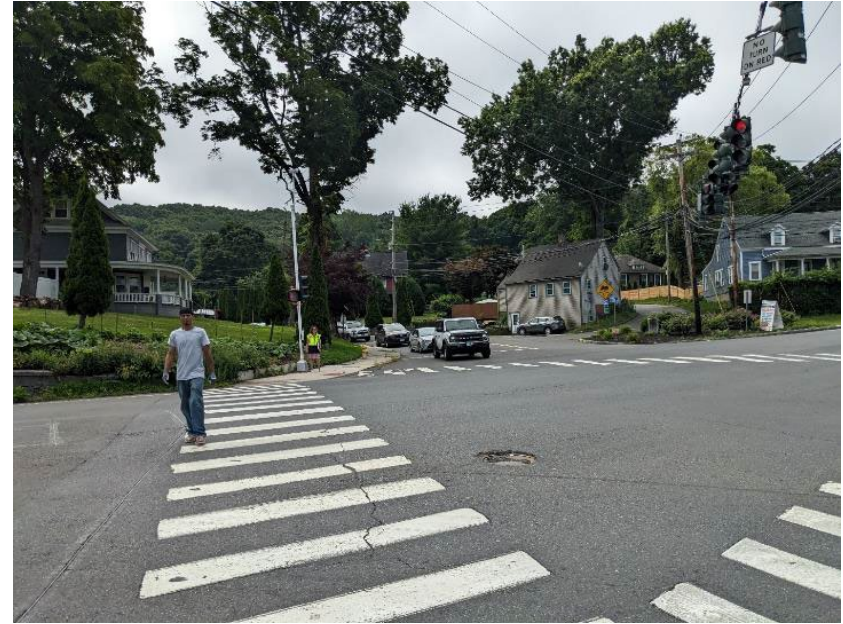
*Exhibit 26: Pedestrian Crossings at Division Street/Elm Street and Main Street/Derby Avenue*

- The participants observed motorists ignoring the No Turn on Red sign onto Division Street.
- A catch basin located in the walk area at the gas station driveway.
- All legs of the intersection are not ADA-compliant.
