# Bridgeport Road Safety Audit

Route 127 (East Main Street): Nichols Street to Boston Avenue

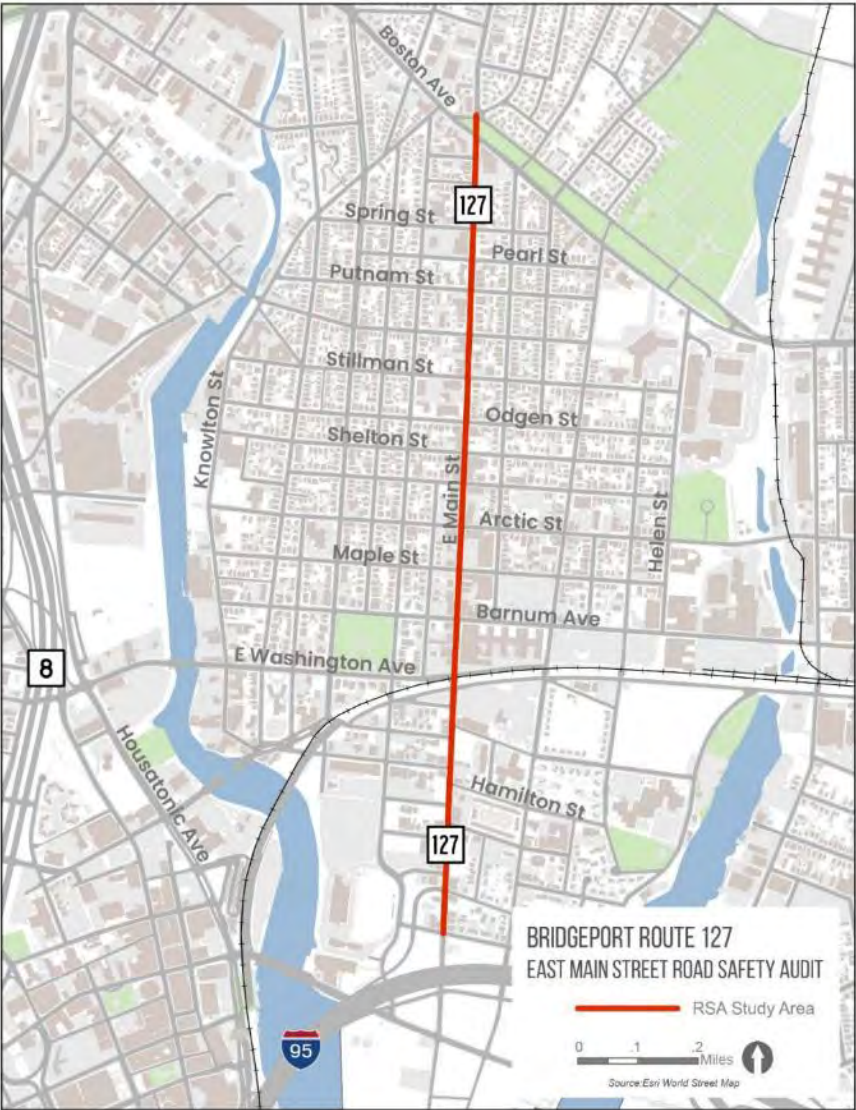
Exhibit 2: Bridgeport RSA Study Area

The study area contains a mix of signalized and unsignalized intersections as well as curb cuts and entrances in to and out of property parcels. This RSA focuses on the major roadway segments and intersections where the safety concerns and pedestrian movements are most concentrated.

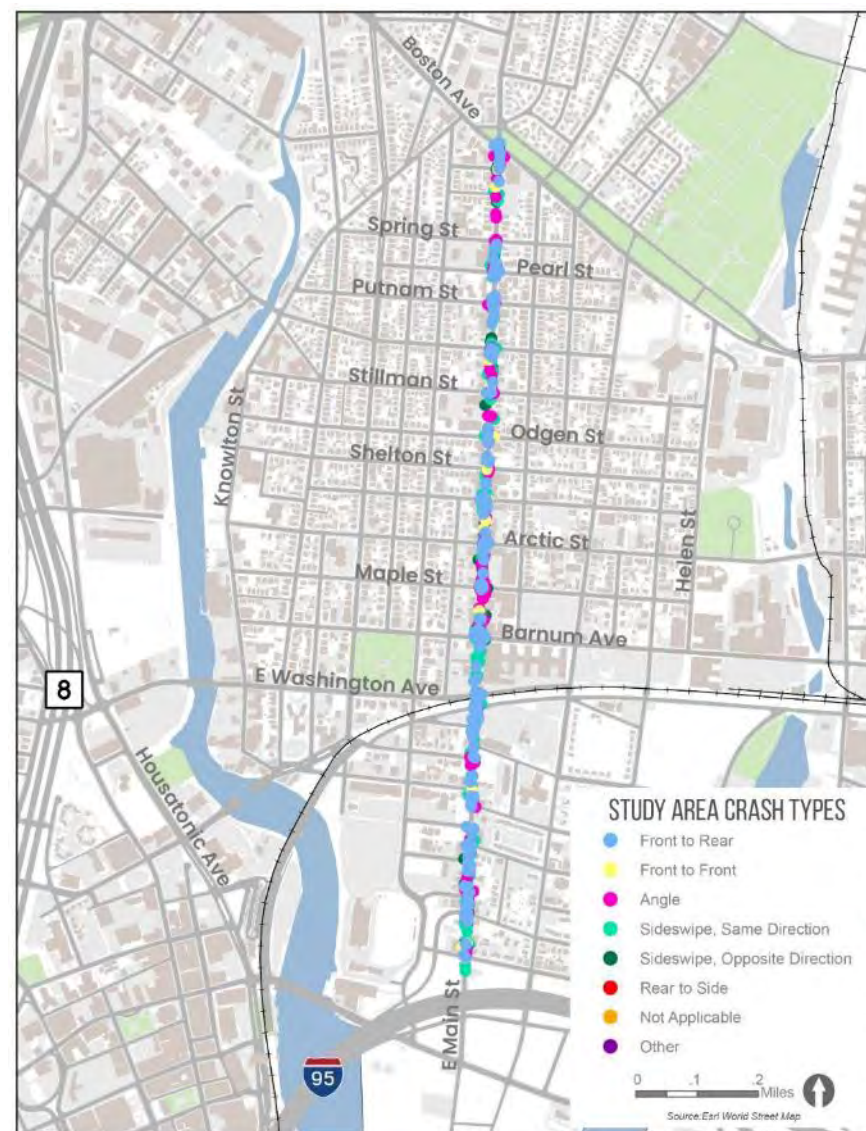
Exhibit 10: Crashes by Type (2017-2022)

**Crashes by Type:** Most crashes were angle and front-to-rear types. Angle crashes are typical in areas with ingress / egress movements at property entrances. Front-to-rear crashes occur most commonly at intersections where cars are queued to make turning movements. Exhibit 9 displays crashes by type and severity. Exhibit 10 displays a map of crashes by location and type in the corridor.

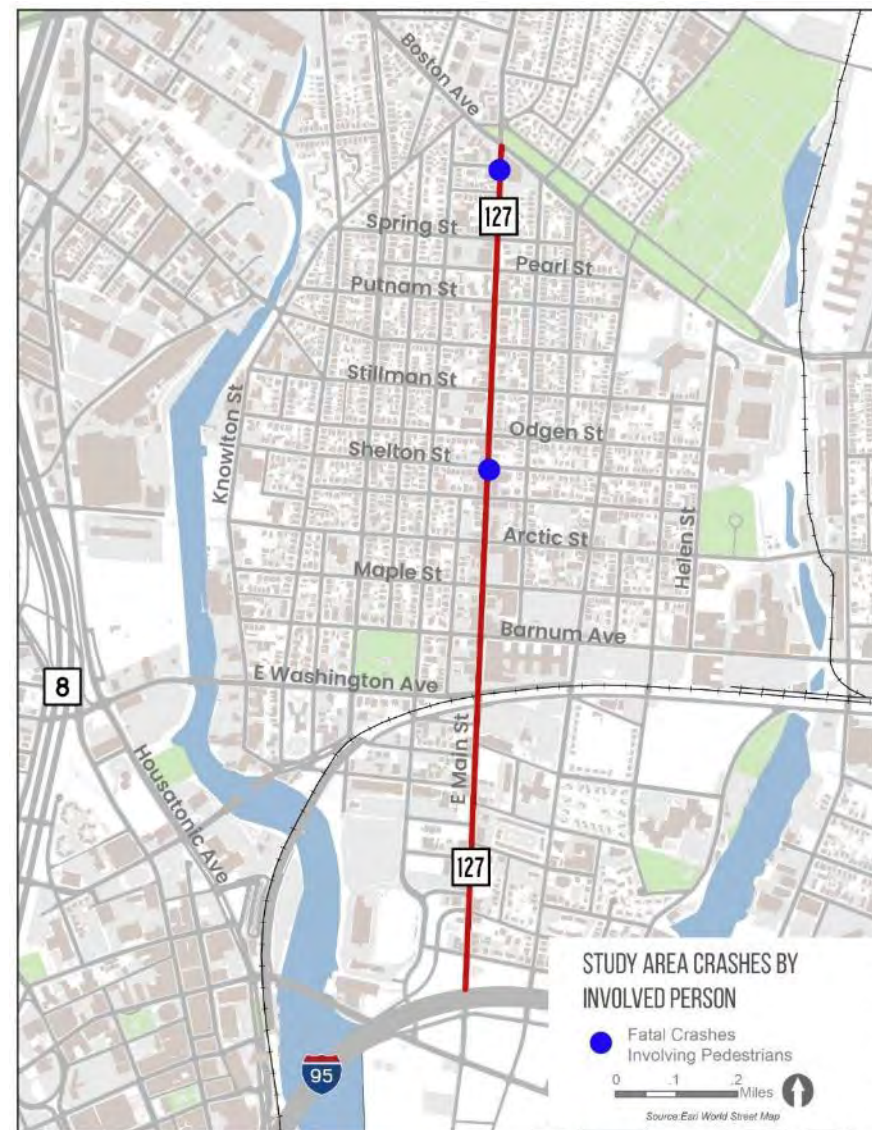
Exhibit 12: Fatal Crashes Involving Pedestrians (2017-2022)

**Crashes by Involved Person:** There were 28 reported crashes involving pedestrians in the six-year period of 2017-2022. Two (2) of these were fatal crashes, one (1) was suspected serious injury crash, and 18 were suspected minor injury crashes, and seven (7) were possible injury crashes. Exhibit 12 displays the locations of fatal pedestrian crashes.

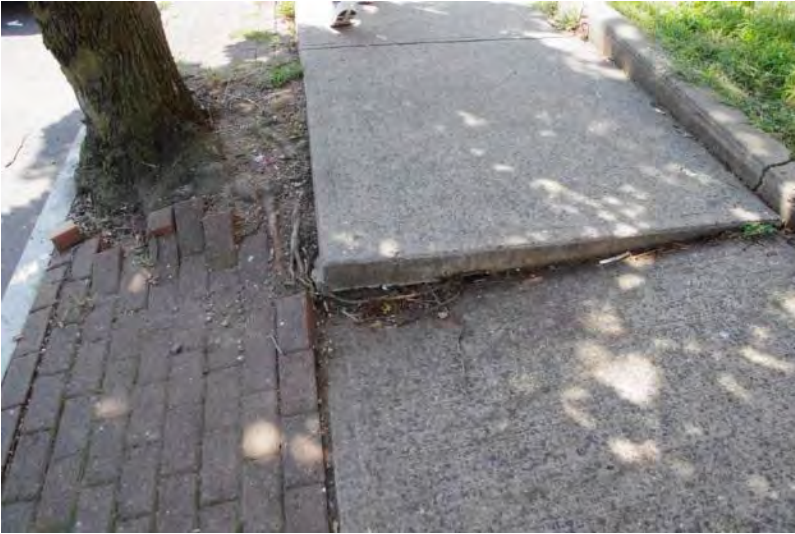
Exhibit 15: Sidewalk in Poor Condition along Route 127 (East Main Street)

- The sidewalks are not ADA-compliant with numerous cracks, gaps, obstructions (e.g., utility poles, roots), excessive slopes, etc. Exhibit 15 displays one example of a sidewalk in poor condition in the corridor.

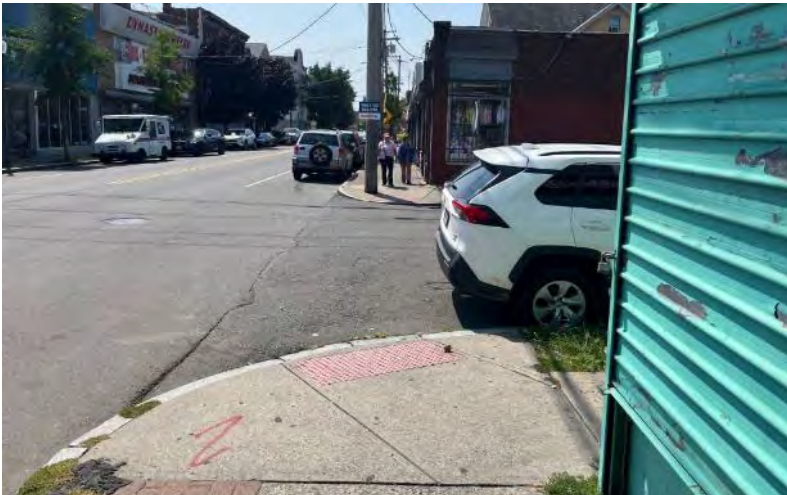
Exhibit 16: Car Parked too Close to Intersection

- Motorists on Route 127 (East Main Street) cannot see driveways or side streets easily. Those exiting driveways or side streets also have visibility obstructions to entering Route 127 (East Main Street) safely. One reason for this is the parking encroachment noted above.

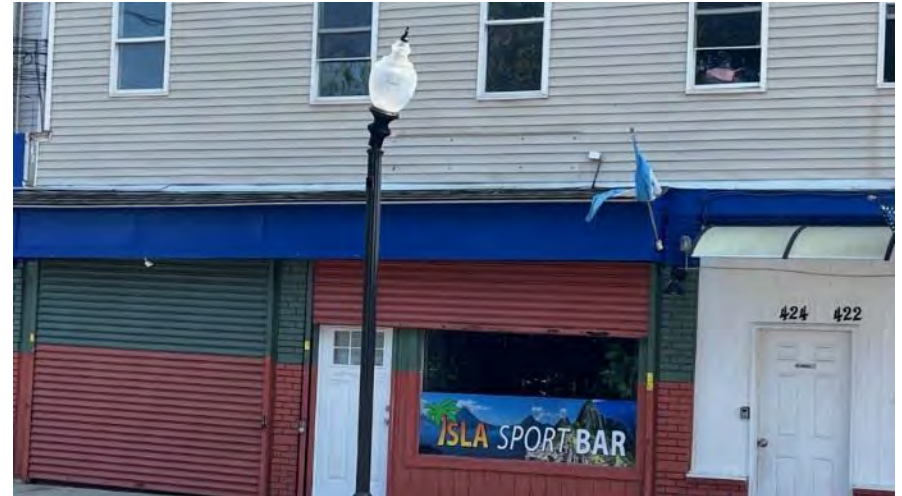
Exhibit 17: Broken Light at on East Side of Route 127 (East Main Street)

- The intersections of Route 127 (East Main Street) at Nichols Street (Intersection 015-337) and Route at the I-95 ramp/Cedar Street (Intersection 015-298) are both signalized intersections that are coordinated in a closed loop system.
- The east side of the roadway has damaged and poor-quality pedestrian lighting, as displayed in Exhibit 17. Some lights are still standing but are broken. Others have only the base remaining.
- The accessible pedestrian signal does work at Cedar Street.
- Cars often park illegally in / out of the three-foot shoulder, as displayed in and Exhibit 18.

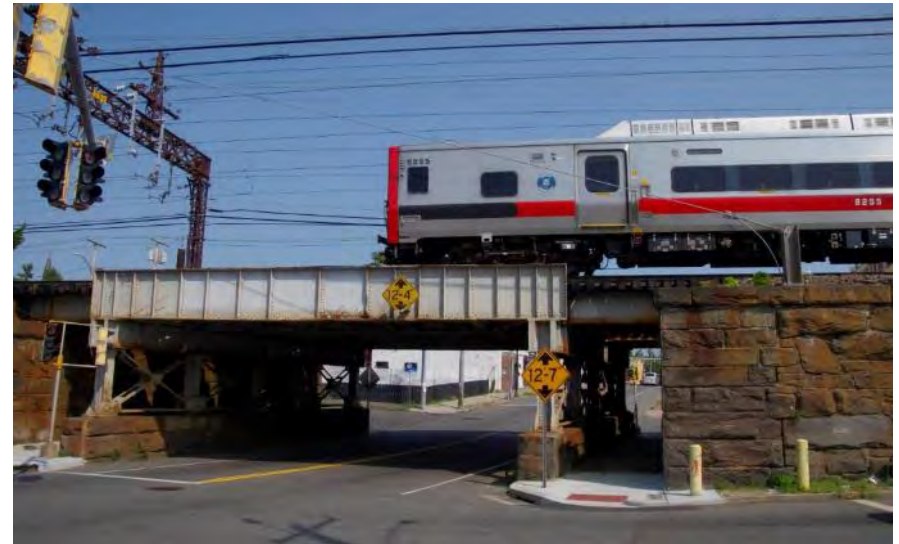
*Exhibit 19: Route 127 (East Main Street) Under Rail*

- There is a downward slope on the roadway / sidewalk from Barnum Ave towards East Washington Avenue and from Crescent Place towards Crescent Avenue. A participant mentioned that flooding occurs at the bridge underpass.

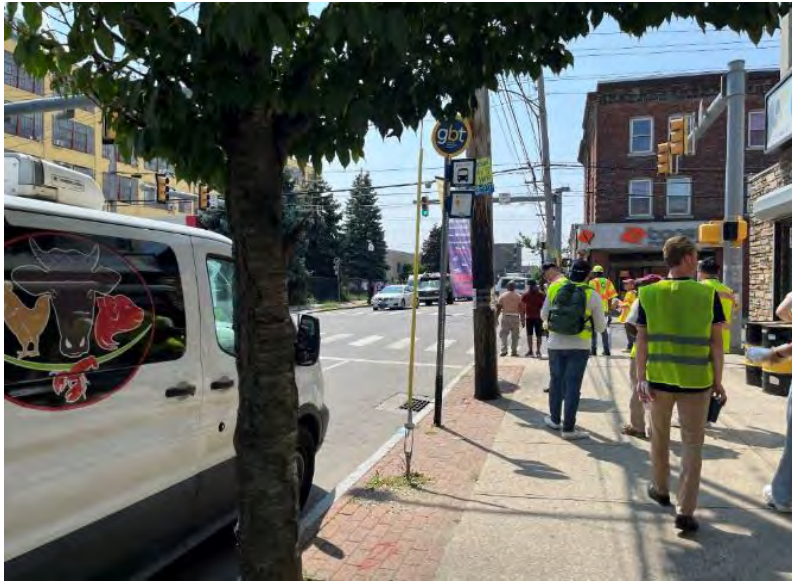
Exhibit 20: Car Parked at Bus Stop

- There is significant tractor trailer activity near Barnum Avenue from the New England Tractor Training School.
- Several participants stated that Barnum School is nearby on Waterview Avenue. The Route 127 (East Main Street) / Barnham Avenue intersection is critical for school travel and students that walk or ride to school.
- The painted crosswalk across the eastern leg of the Barnum Avenue intersection is barely visible.
- Motorists are using the bus stop on the northwest corner of the Barnum Avenue intersection as a parking spot, as displayed in Exhibit 20.
- One participant stated that the corridor gets very congested north of Barnum Avenue.
