# CTfastrak

## ROAD SAFETY AUDIT

New Britain, West Hartford, and  
Hartford

**AUGUST 2025**

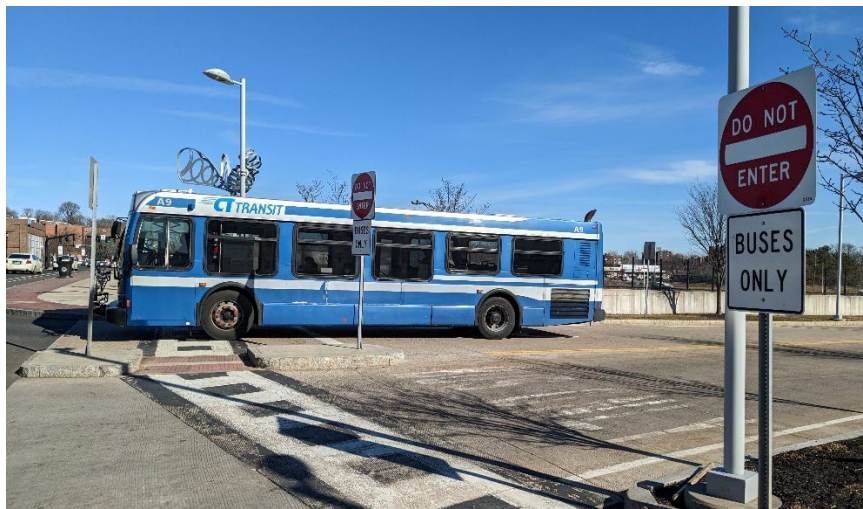
Exhibit 26: Buses only driveway on Main Street

- CTfastrak representatives said that a safety and security concern at this location is that unauthorized drivers (general public) mistakenly take the CTfastrak bus only ramp into the CTfastrak Downtown New Britain Station when exiting Route 72 eastbound at Exit 1C. Properly navigating the exit is confusing to motorists, especially when trying to take a right at the end of Exit 1C onto Route 71 into Downtown New Britain. Some drivers end up incorrectly taking the first right ahead of the intersection onto the ramp into Downtown New Britain Station instead of taking the proper right at the traffic light. Many of the unauthorized drivers who end up in Downtown New Britain Station say they are on their way to the courthouse in New Britain.

Issues related to the Route 72 off-ramp at this location were discussed during the site visit. Recommendations for this location include measures to reduce the number of unauthorized vehicles using the bus ramp and entering Downtown New Britain Station. These potential improvements are intended to be located where the bus only ramp splits off from the off-ramp, whereas most existing countermeasures are located upstream of the split.

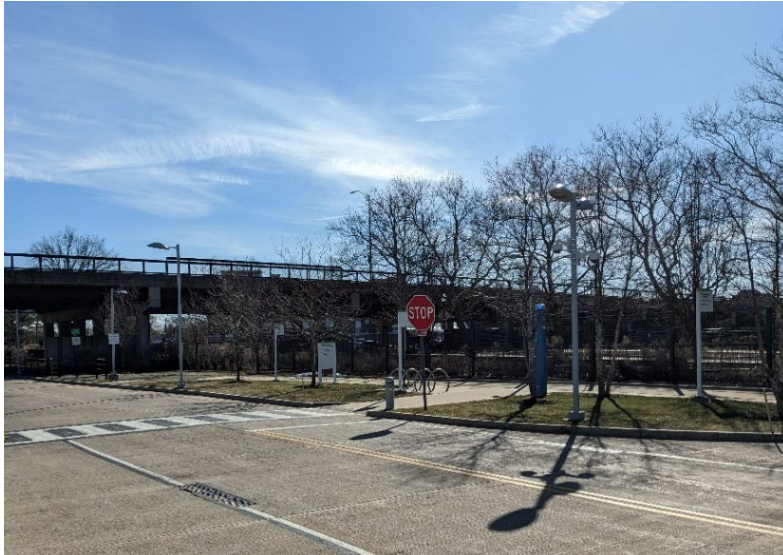
Exhibit 29: Mid-Block crossing at end of station area

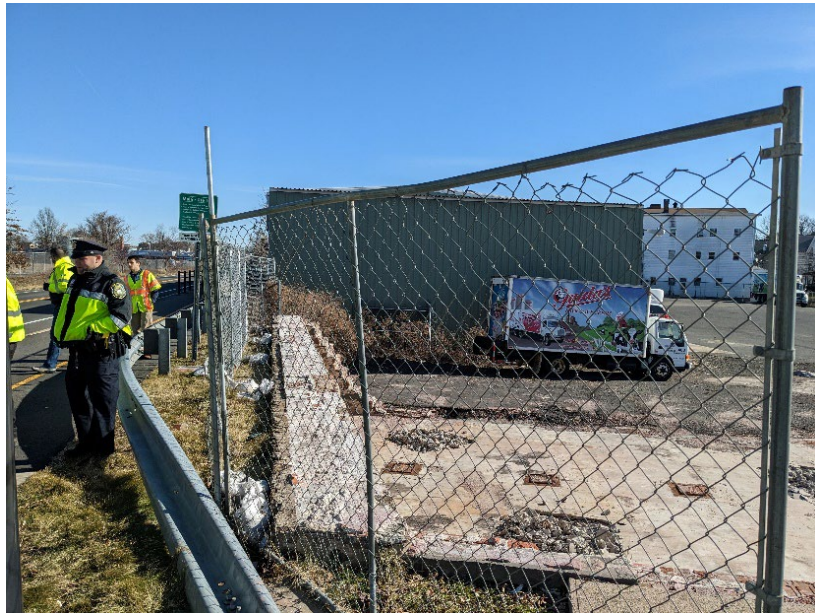
- CTfastrak operators have complained that there is insufficient overhead lighting at this location.
- Unauthorized access onto the CTfastrak fixed guideway is common at this crossing. A motorist illegally entered the guideway here during the RSA field audit. The motorist turned around as soon as the team conducting the field audit (all wearing bright retro-reflective vests) stopped them and instructed them to turn around.
- Prior to the RSA field audit there was an abandoned building located on the southeast corner of this intersection, which was demolished by the City of New Britain in fall of 2023. The building was located close to the roadway and decreased sight lines at this

Exhibit 30: Remnants of demolished building at Stanley Street Crossing

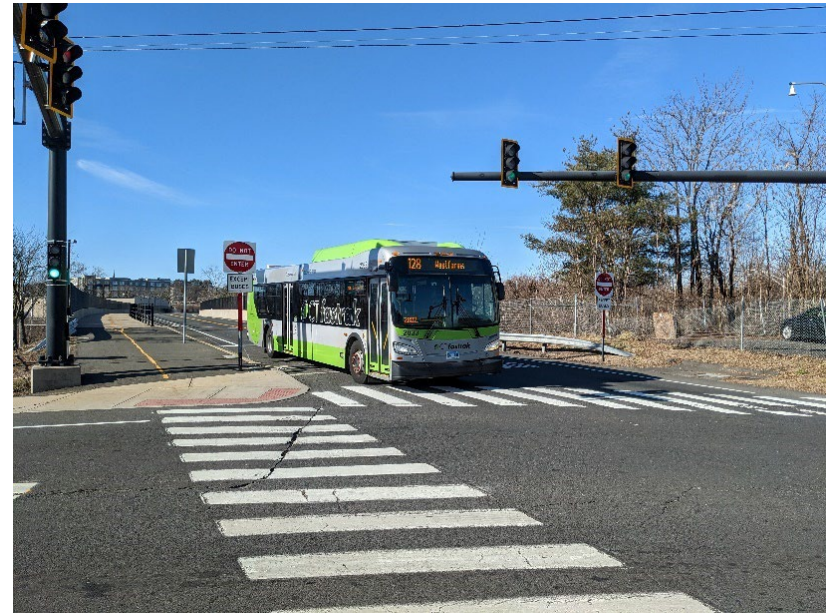
Exhibit 31: East Main Street Station Crossing

- Unauthorized access onto the CTfastrak guideway is common at this crossing, which is displayed Exhibit 31.
- The black on white signage is faded at this location, causing poor visibility.

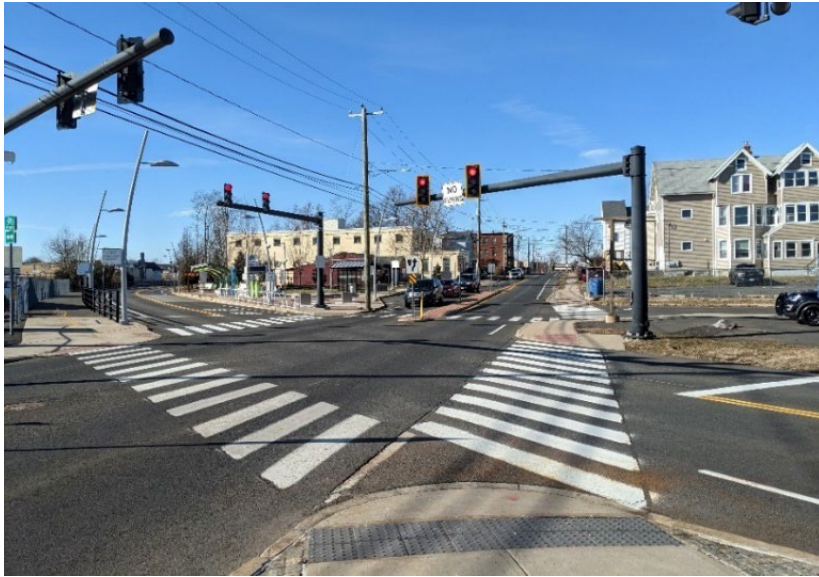
Exhibit 32: East Main Street Station

- The City of New Britain is also relocating the City's Department of Public Works (DPW) garage at this intersection, which creates Transit Oriented Development (TOD) potential at the former DPW garage. It may also result in increased vehicular and foot traffic at this intersection and station.

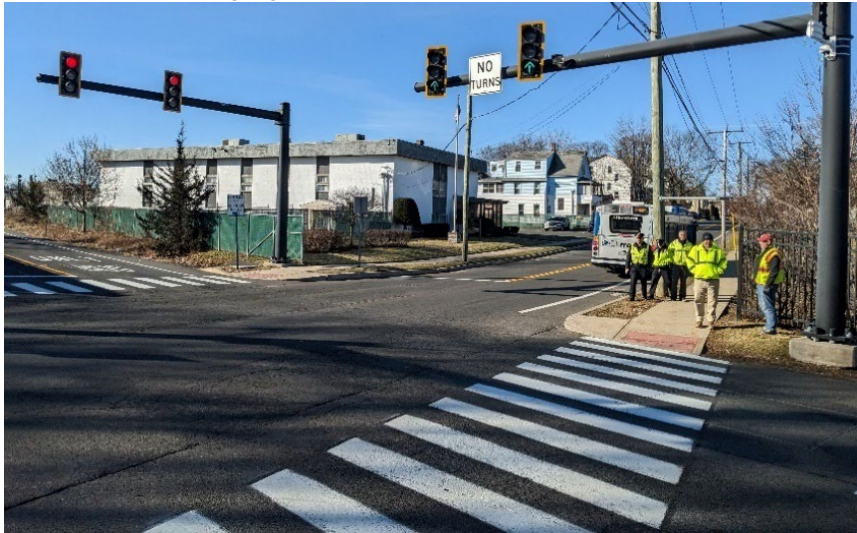
Exhibit 33: No Turns signage

- There are no pedestrian signal heads at this location.
- The pedestrian pushbuttons are not ADA compliant.
- “No Turns” signage may be confusing, as shown in Exhibit 33.
- Unauthorized access onto the CTfastrak guideway is common at this crossing
- The observed signal timing is inefficient. The green light comes on too early and then turns to yellow before the bus can get to the signal. The timing is based on full speed operation.
- Detectors are timed to allow buses to call the green signal before arriving at the intersection, but this is not working correctly due to

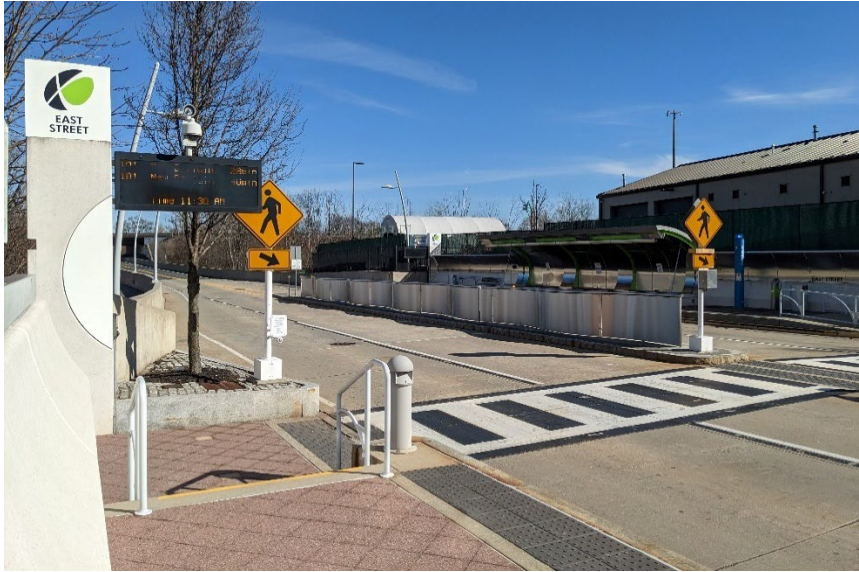
Exhibit 35: Crosswalks at East Street Station

- Pedestrians or cyclists traveling on the multi-use trail must cross the driveway twice rather than having a direct path to the platforms.

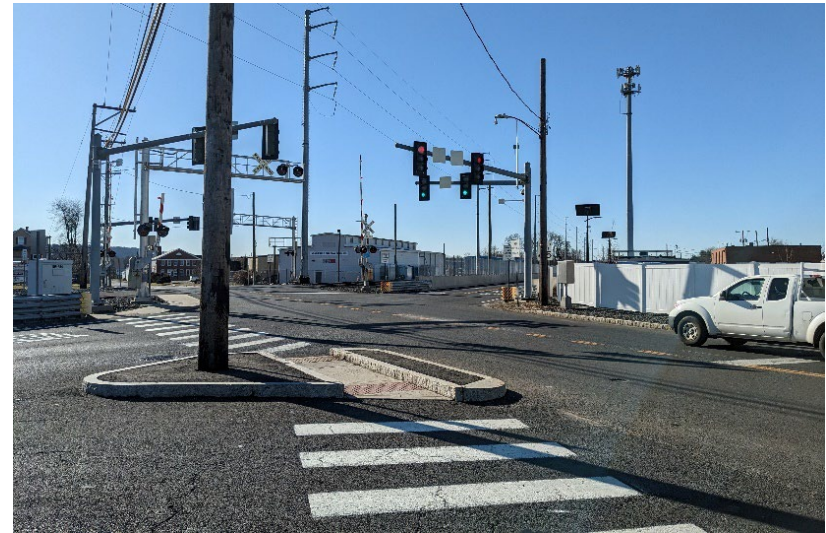
- Motorists were observed running the red light at this location during the RSA field visit.

Exhibit 38: Vehicle stopped at the red light while busway light is green

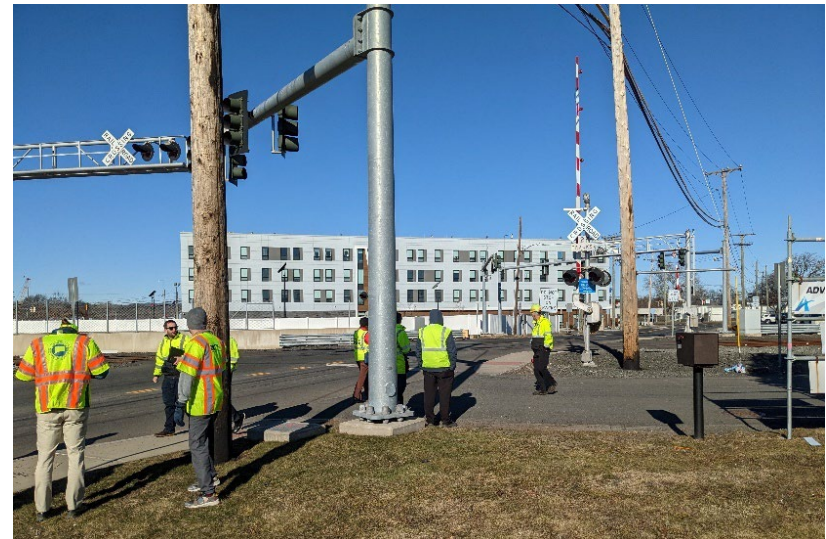
Exhibit 39: Sidewalk condition crossing rail corridor

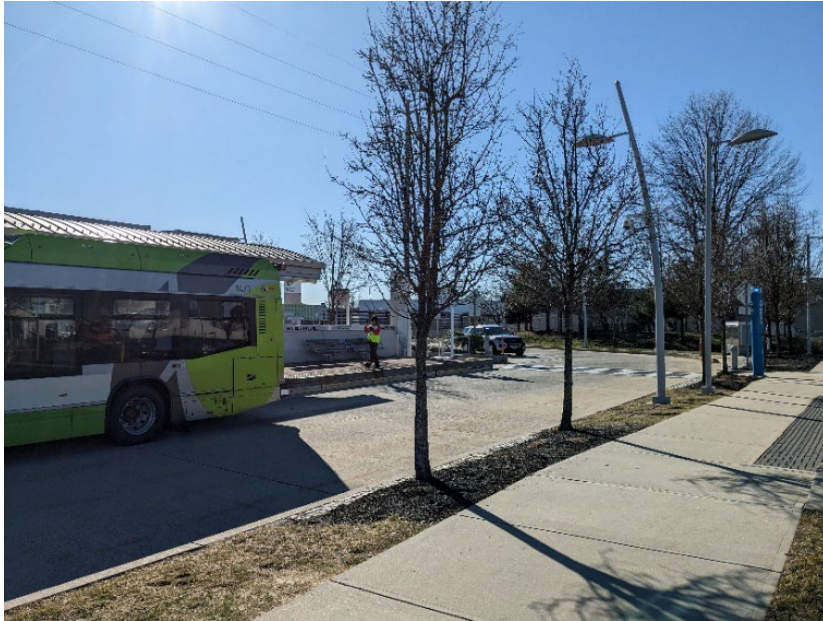
- Like other stations, pedestrian access is ADA-compliant and internal mobility functions well. Exhibit 40 displays sidewalks on site.
- Geometry is a challenge for bus operators maneuvering into and out of Flatbush Avenue Station.

Exhibit 42: Turn radius to enter the station

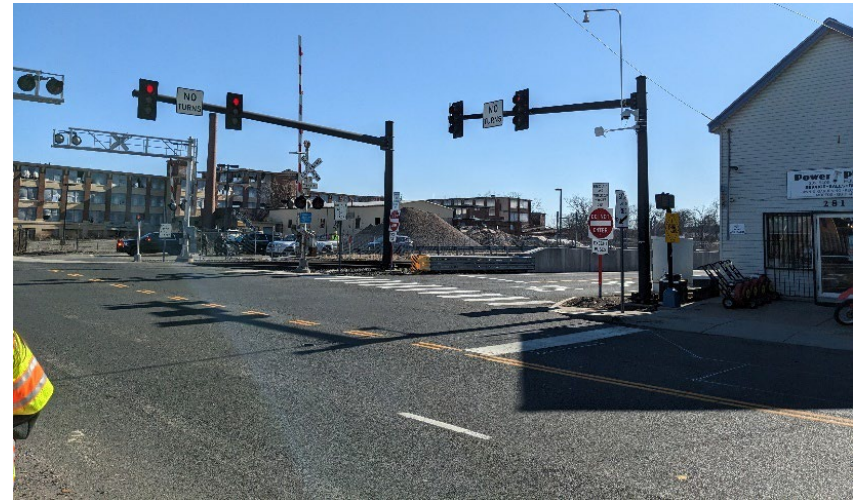
Exhibit 43: Building located very close to the intersection

- Bus-related crashes at this location are often caused by vehicles heading eastbound and running the red light.
- The building on the southwest corner limits sightlines at the intersection, as shown in Exhibit 43. There are limited countermeasures to address this, other than full property acquisition and demolition.

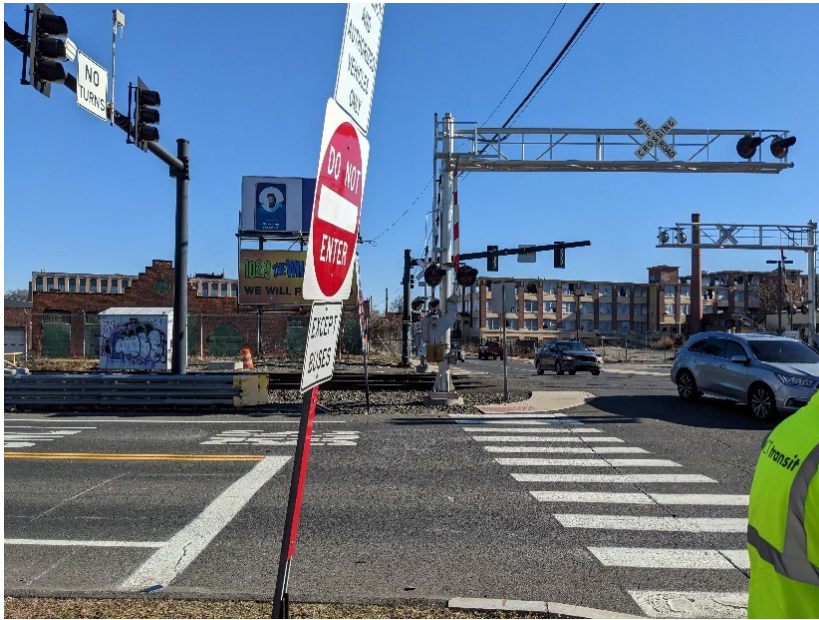
Exhibit 45: Pedestrian signal is blocked by the rail gate

- Pedestrian crossing concerns were communicated by several participants. The Manual on Uniform Traffic Control Devices (MUTCD) suggests that pedestrian signal heads do not cover the railroad crossing and that their placement should be limited to the crossing of CTfastrak only. The pedestrian signals operate on recall, so no pedestrian pushbuttons exist. Several participants noted that this can be confusing for pedestrians and can leave pedestrians uncertain of when to cross. While removal of the pedestrian signal heads is not advised, they could be relocated for better visibility. However, there is limited space between the railroad and the guideway to install new pedestrian equipment.

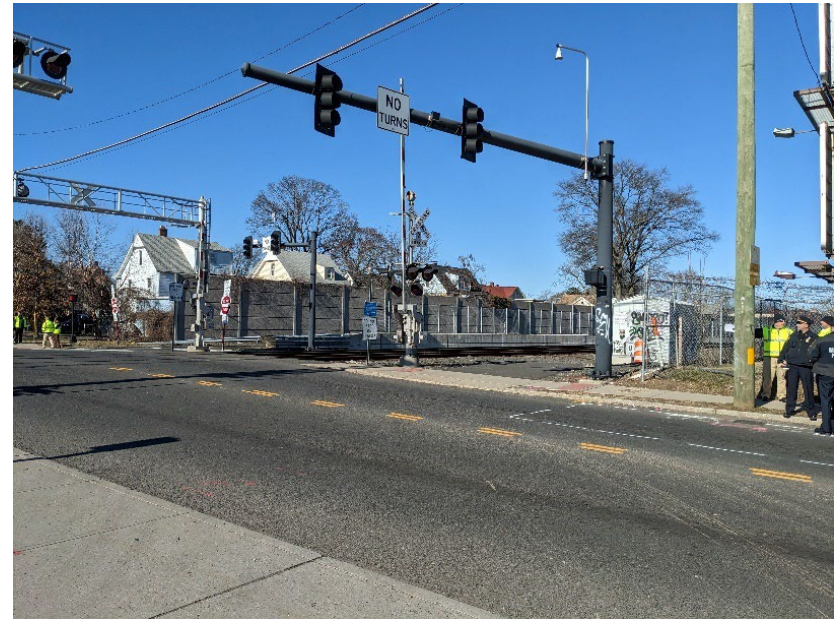
Exhibit 46: Private driveway adjacent to intersection

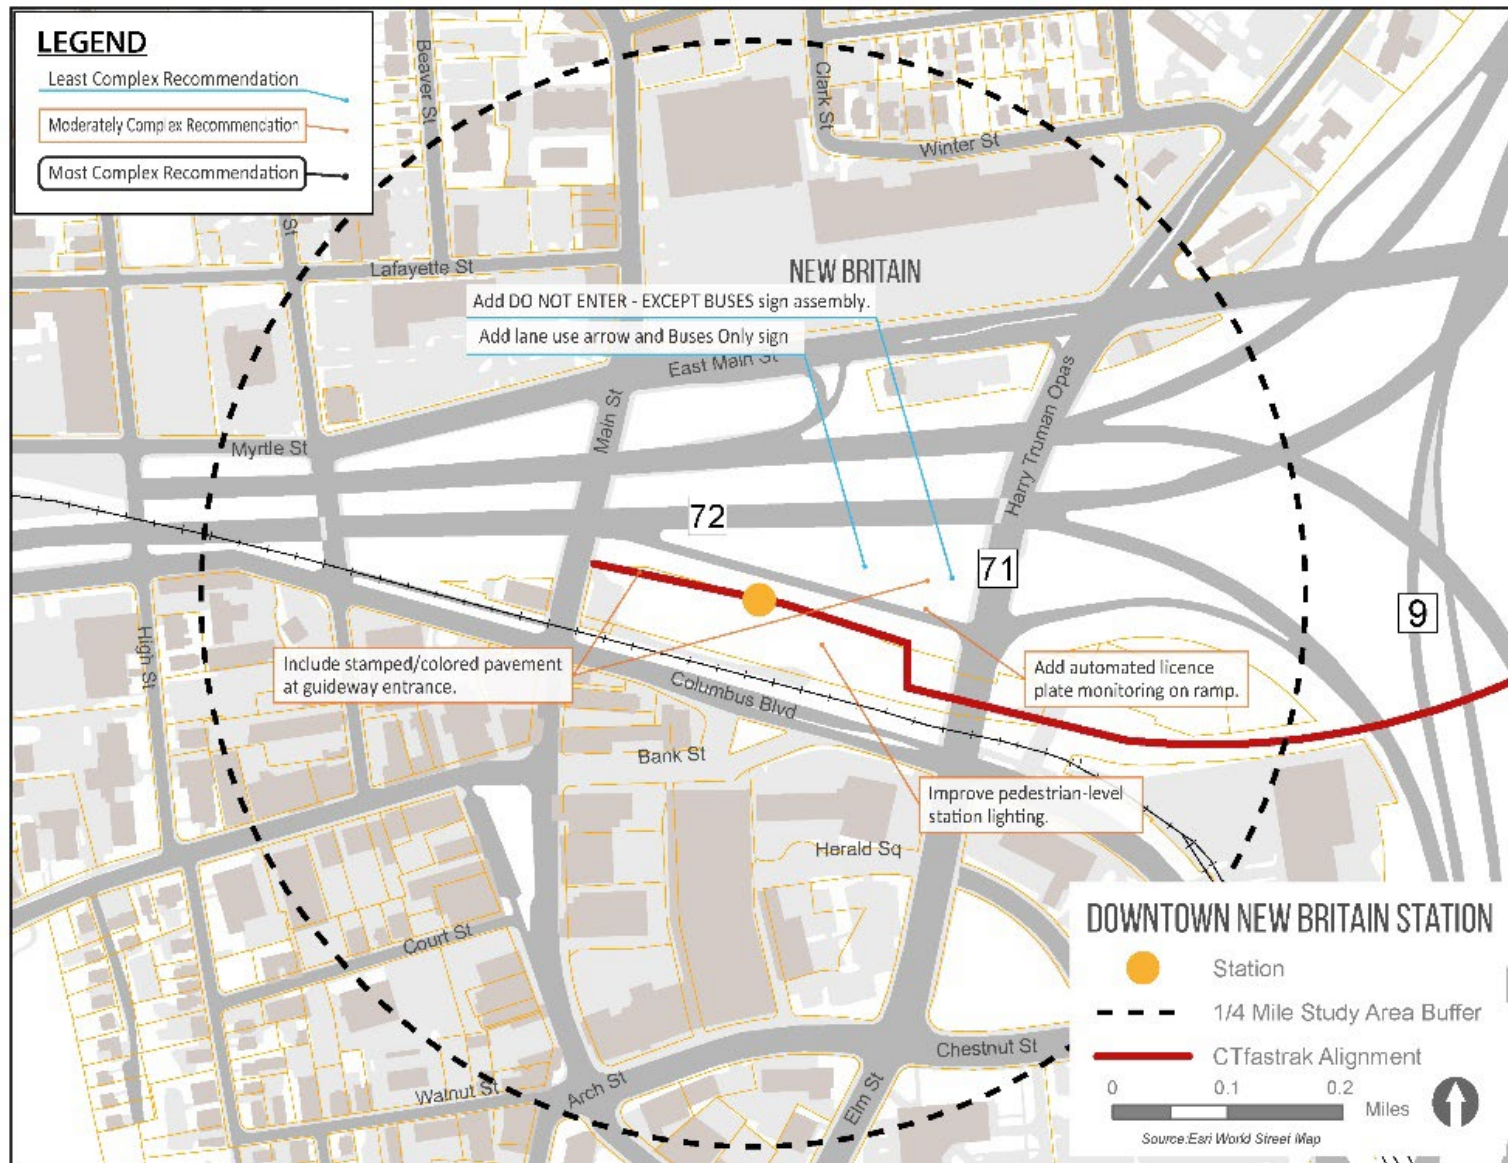
Exhibit 49: Downtown New Britain Station Recommendations

The recommendations in this area focus on improving pedestrian visibility and security within the station, as well as adding signage and pavement treatments to discourage unauthorized access to the guideway.

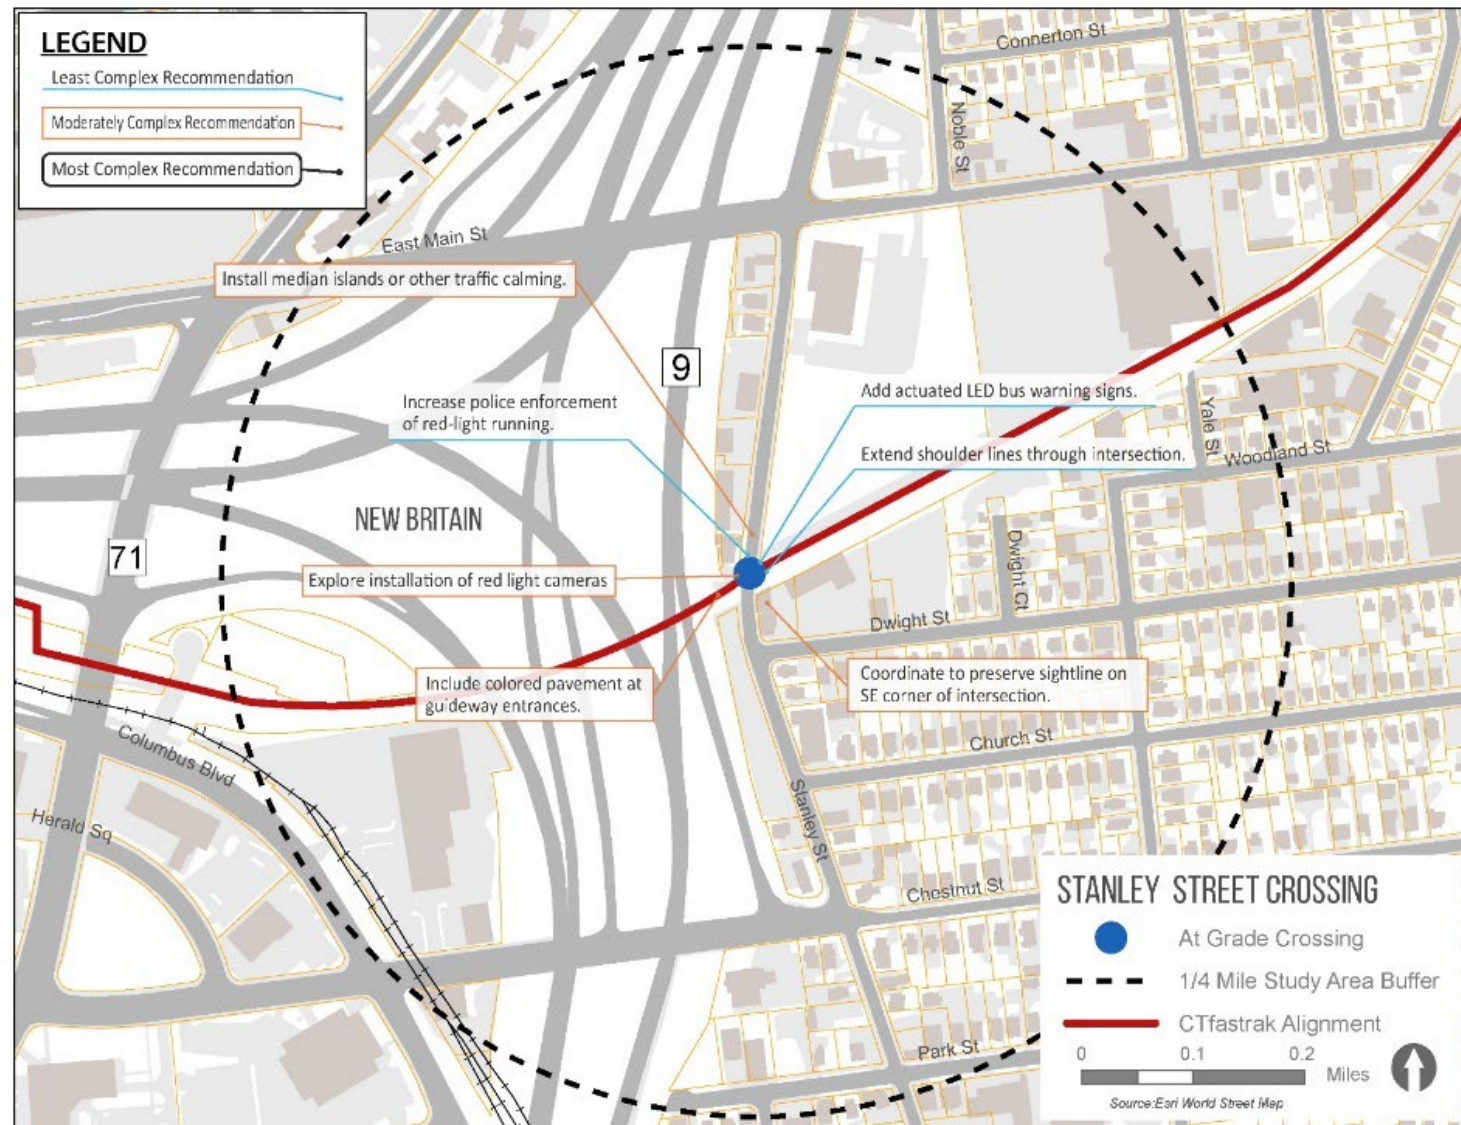
Exhibit 50: Stanley Street Crossing Recommendations

Stanley Street has the highest crash rate on the guideway. The recommendations in this area address the primary cause of these crashes: reducing the frequency of red light running. Other goals are reducing unauthorized use of the guideway, improving guideway efficiency, and better accommodating active transportation.

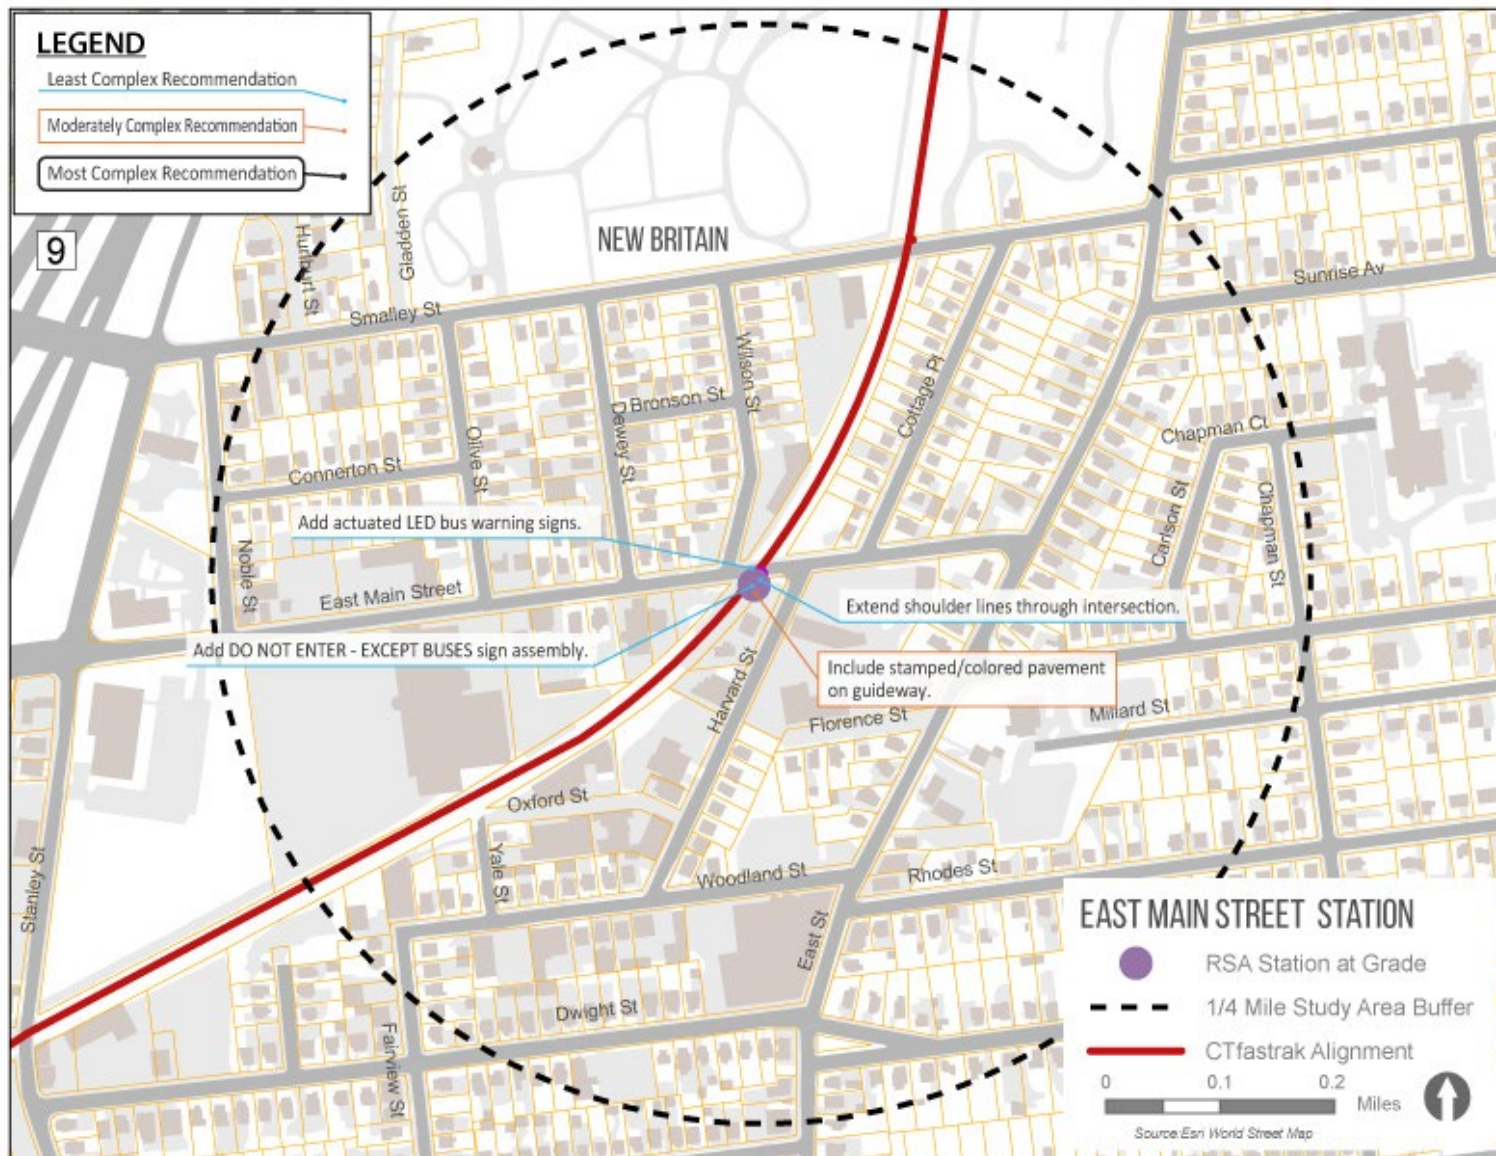
Exhibit 51: East Main Street Station Recommendations

The recommendations in this area address several issues: reducing unauthorized use of the guideway, reducing the frequency of red light running, improving guideway efficiency, and better accommodating active transportation.

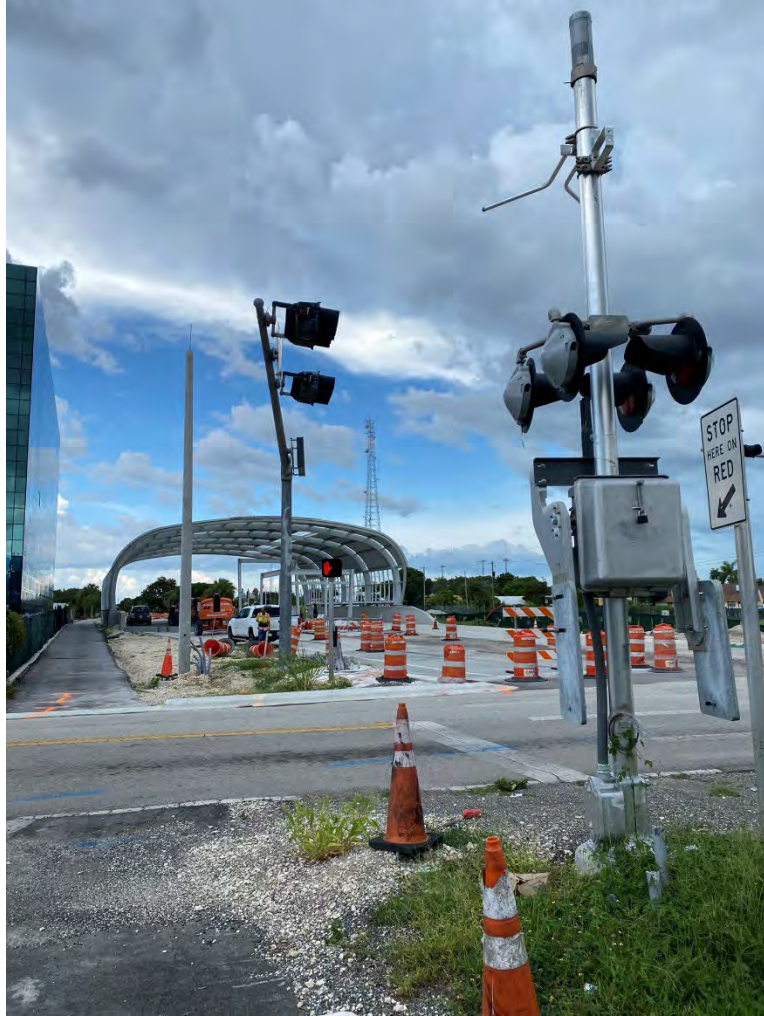
Gates being installed on Miami-Dade Busway ([twitter.com](https://twitter.com))

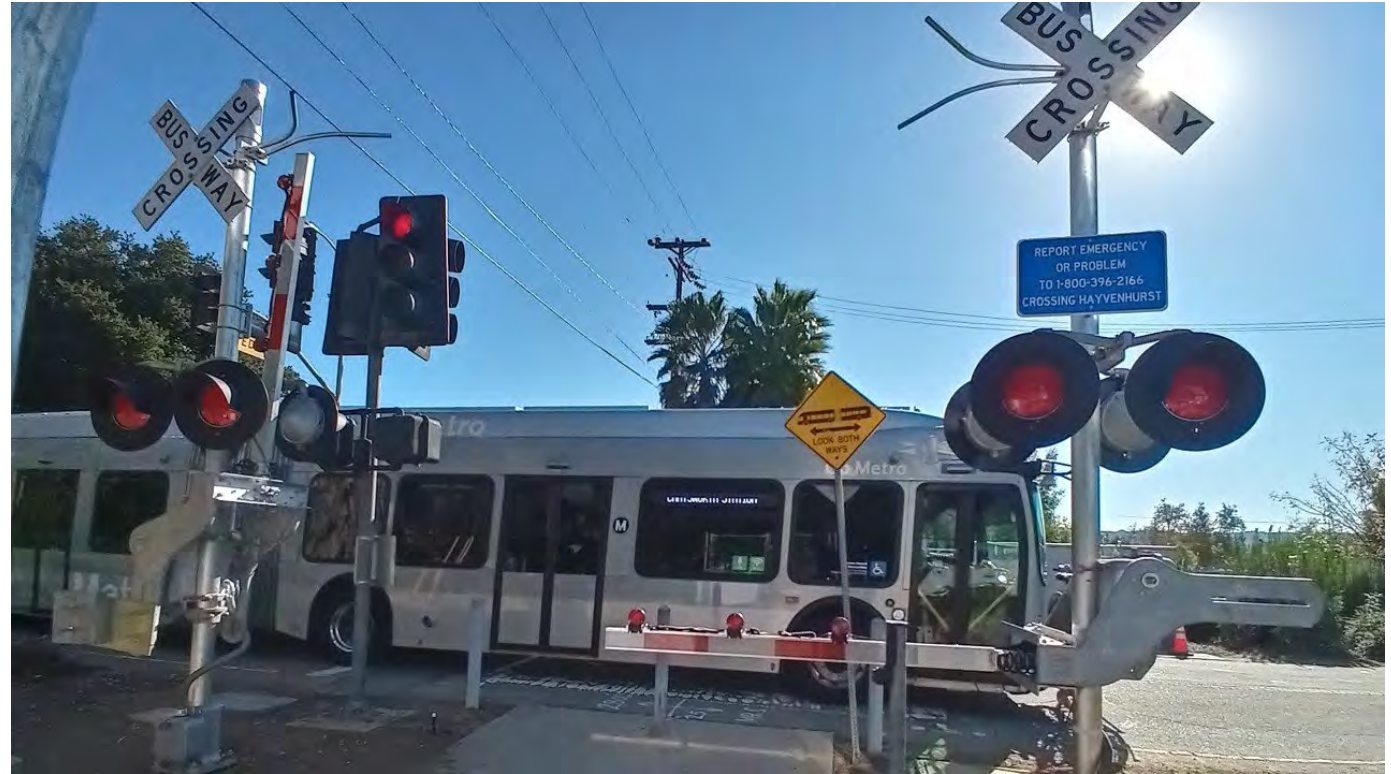
Gates being installed on Los Angeles Pedestrian Crossing ([Youtube.com](https://www.youtube.com))

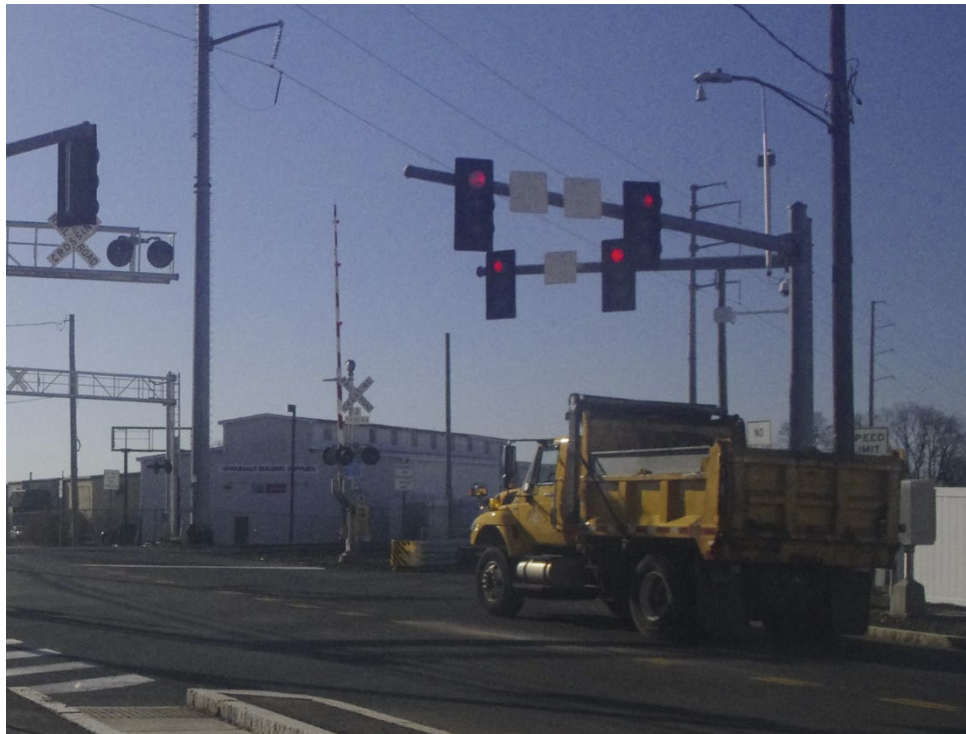
- Signal system appear to be recalling CT**fastrak** phase even without busses
- Very long all red phase appears to be unnecessary. This was originally for school bus facilities, which do not utilize this crossing
  - The WH town rep initially thought I was talking about buses using the narrow driveway adjacent to the track (which they've never done), when I meant buses on Oakwood itself. The 16-second red time is on the Oakwood phase; on the driveway, it's 5 or 6 seconds. Nonetheless, with the buses rerouted, the primary reason for the long all-red is gone.
  - CTDOT confirmed this can be shortened without impacts to railroad preemption. This would only be an issue if this needed to be longer.
  - Frequent reds with very little conflicting traffic creates driver expectation that you will not have issues
    - We witnessed this happen.

- Could all-red extension be explored with presence detection?
  - This is possible for pre-emption (trains can keep the gates down longer) but if buses are already going through at 20 mph instead of 50, they're going to see a bus slowly crossing the track/intersection and stop. Visibility to/from the east should be pretty good because there's no noise wall on that side.
  - Note "Dynamic All-Red Extension" - [connect.ncdot.gov/resources/safety/TrafficSafetyResources/Dynamic All Red Extension.pdf](https://connect.ncdot.gov/resources/safety/TrafficSafetyResources/Dynamic%20All%20Red%20Extension.pdf)
- Pedestrian issues
  - No ped signals to cross CT**fastrak**. This should be adjusted. It is very confusing if you approach CTfastrak. There is no signal head if you are traveling WB that is even visible.

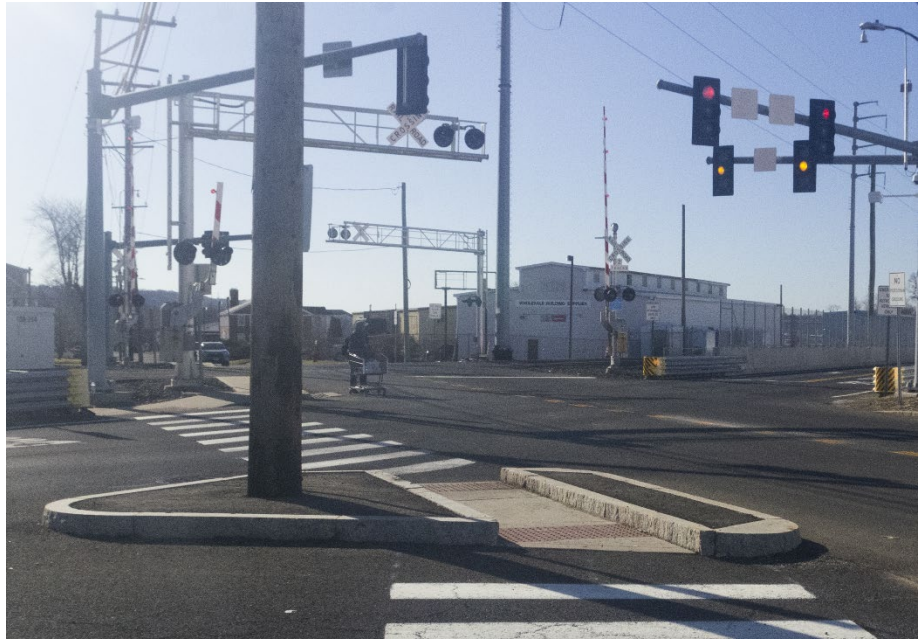
- No ped signals, no pedestal, no push buttons. There's also no way to cross Oakwood at the intersection. There are no pedestrian accommodations on the southwest side of Oakwood at the intersection. The channelized right for buses has a cut-out for peds that's long enough to act as a refuge island, so that should probably have a pedestal, too, if we can't make the Oakwood phase long enough for a ped to get through.
- Sidewalk through railroad crossing is very confusing. Consider
  - Pavement markings delineating space
    - We saw someone pushing a shopping cart go through, and they just stayed in the roadway.

- Separate sidewalk material
- Sidewalk behind main poles
- “NO TURNS” Signage and other black text on white background is faded. There seemed to be issue with these signs throughout the area from that time period.
- Quad gate program-
  - Will install quad gates with median islands of approximately 20-ft in length on approaches. Note that the industrial driveway on northeast quadrant will be converted to right-in/out under current plan.
    - It looks like we might have room for ped refuge between CT**fastrak** and the tracks here, unlike at Hamilton.
    - Consider installing additional median on west side of CT**fastrak** so approaching EB motorist have median as well.
- Note in 2021 – vehicle that was hit and disabled from collision with bus was then hit by train. Driver fled the scene. Likely stolen vehicle.
-

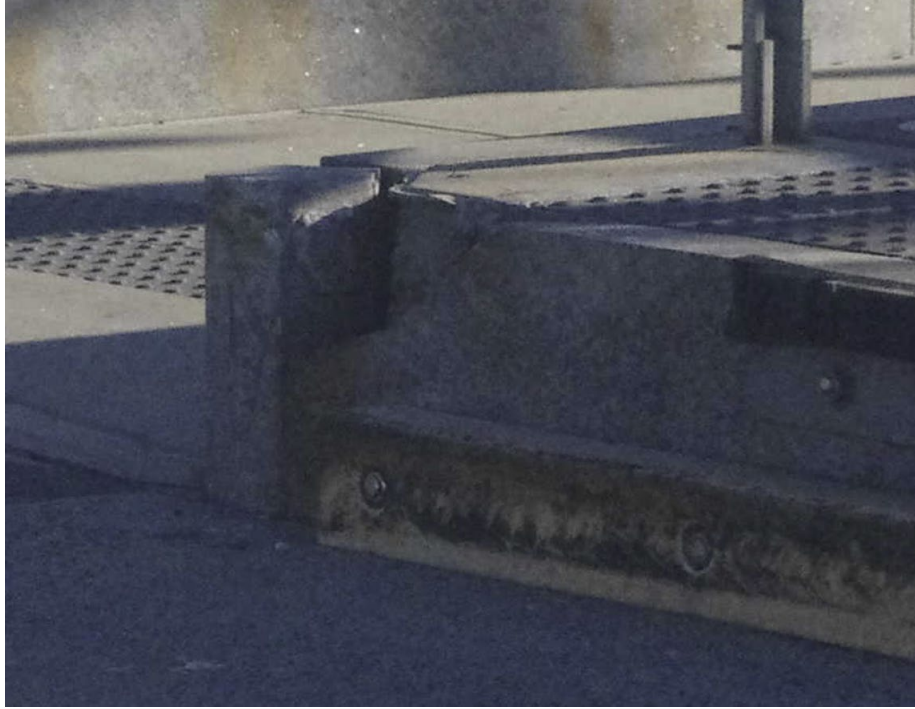
- Granite curb has been hit repeatedly on the NB platform. Some parts have been replaced; existing broken curb may present a tripping hazard.

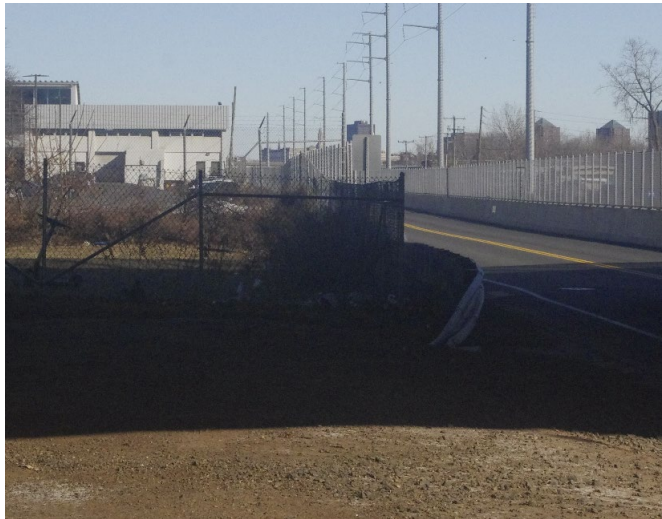
- Note some obstructions to consider
  - Drainage
  - Lighting
  - Transformer
- Sightlines to NB exit to approach is difficult
  - SB stop sign?
  - Signalization
  - Warning lights on approaching bus with detection?
  - Mirror?
  - Note that there are no crashes associated with this, it's more of an operational issue as

buses have to creep forwards.

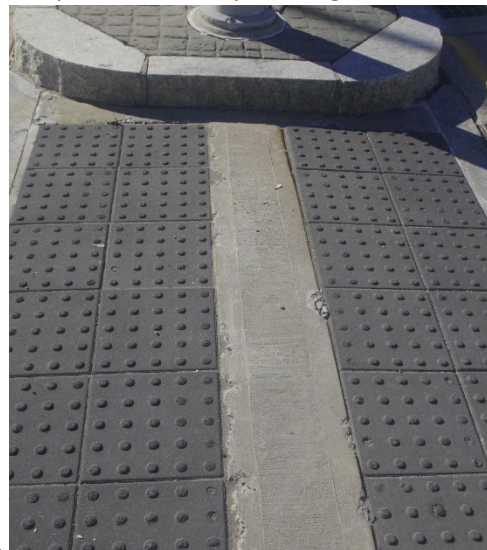
- Station and access appeared well designed overall.
  - Generally, though the ‘refuge’ in the middle of the busway isn’t done very well – it’s only maybe 5’ wide. There’s not enough room for peds to stack up waiting to cross, nor is

there room for a wheelchair or a stroller.

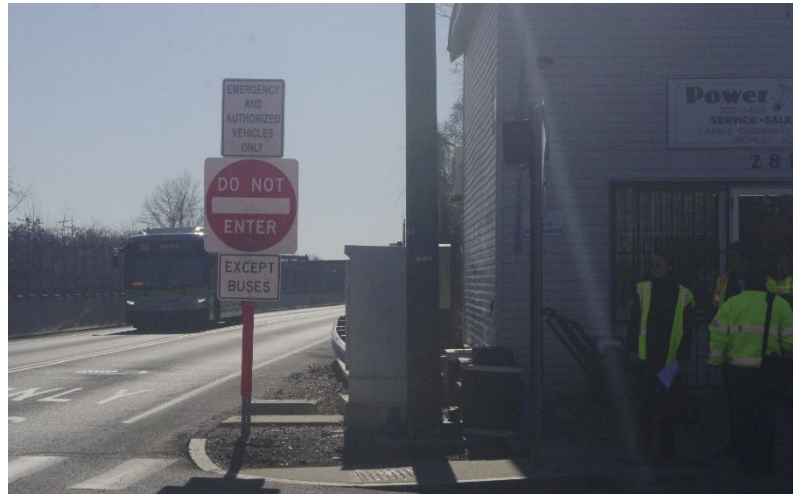
- The curb cut goes nearly to the intersection and with frequent pick-ups and drop-offs, and the sidewalk gets used as a sales floor. It's REALLY close to the

intersection, almost touching the signal cabinet.

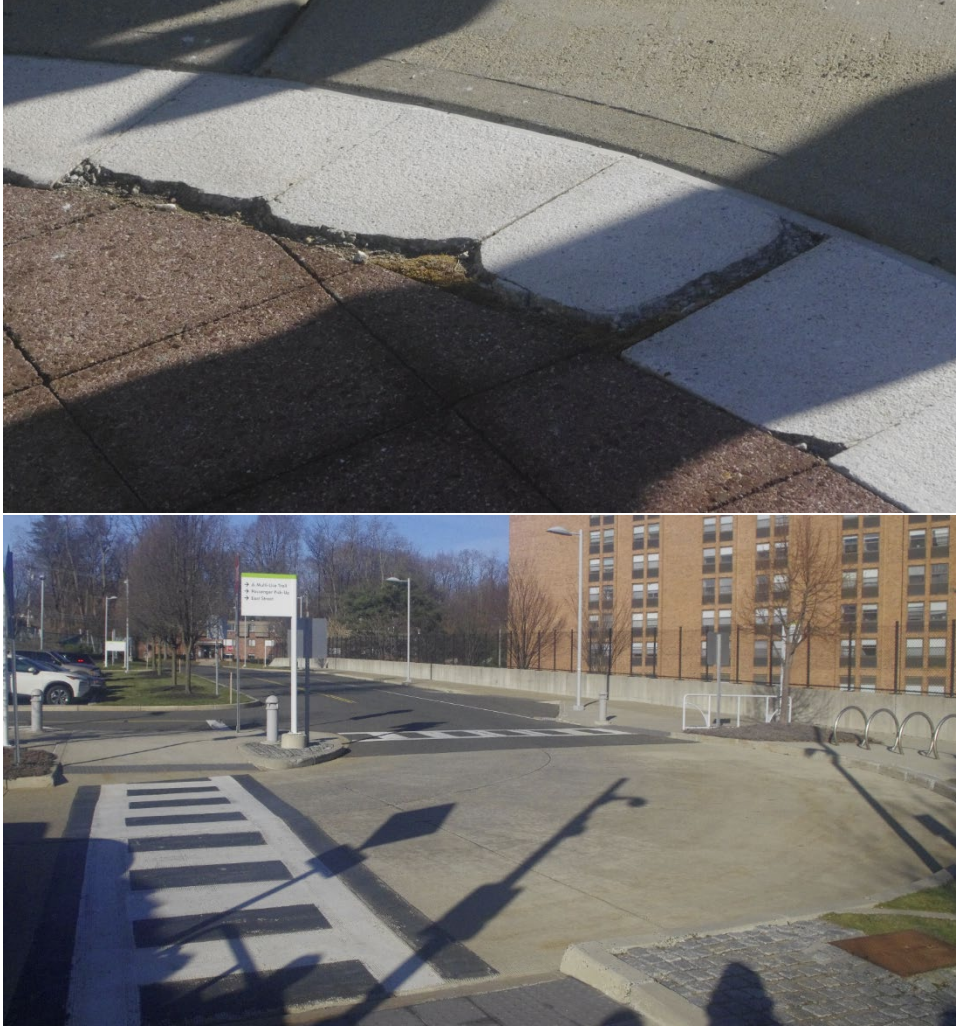
- Design of station works pretty well. Station has additional parking on west side of East Street (near Biltmore) that is leased. There is an RRFB to help crossing at this location, but this was out of service on the day of the RSA. This will be addressed by New Britain DPW staff.
- Some broken pavement at the station that may result in tripping. Also, peds coming from the multi-use trail must cross the driveway twice rather than having a direct path to the platforms.

- 1) Repair the RRFB that crosses East Street and connects to the overflow parking lot on the west side of East Street.
  - **Next Step:** Contact CTDOT Maintenance and/or New Britain Public Works Department

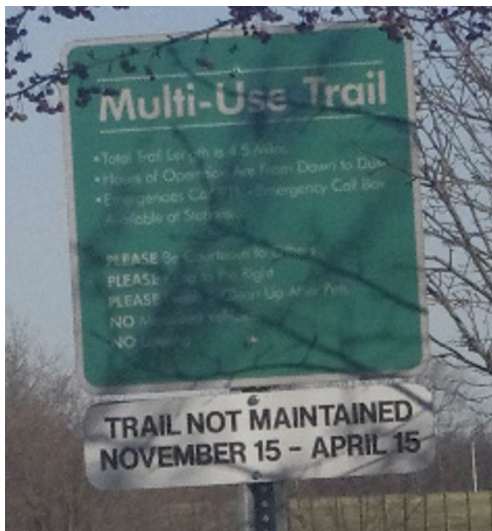
- Overhead lighting is a major concern
- Green straight arrow is present and preferred.
- Trail to the north of this crossing is not maintained from Nov 15 through Apr 15 (5 months), but it is not clear what users are intended to do when it is unusable.

- Crosswalks are only present on 3 legs. Since there are no ped heads, it’s not clear that peds cannot cross the busway when the ped light is green. Buttons are only on 2/4 corners.

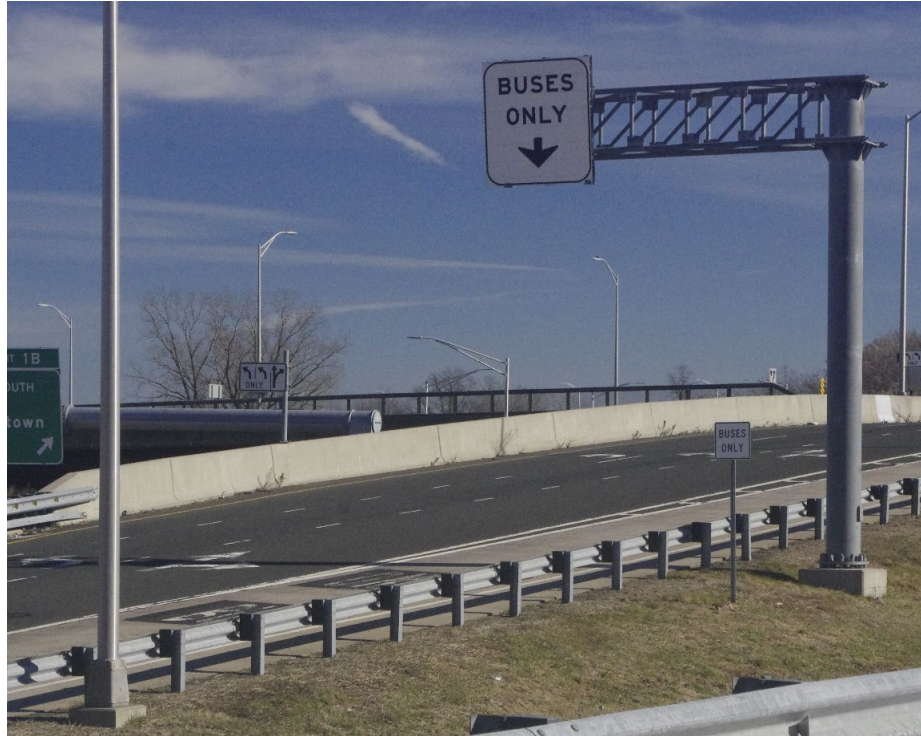
- Driving from Route 72 off ramp is biggest issue
  - The existing ramp is very well delineated with overhead sign over bus lane, two side-mounted signs, different pavement color/texture, a solid white line dividing it from other

traffic, and BUS ONLY pavement markings with contrasting background.

- Drivers that mistakenly take this ramp then arrive at the bus station with no indication of how to get back to the street. Going straight will put them on the busway.
  - The guard mentioned below often can't catch them before they get onto the busway.
  - Adding a sign directing them to turn right (towards Main St) is a possible solution.
- Potential improvements to discourage more drivers: thicker line (1' or more), an additional BUS ONLY marking farther east, a DO NOT ENTER BUS ONLY sign pair at the

gore. Lower these signs to 5' (existing are 7') to put them closer to the driver's view.

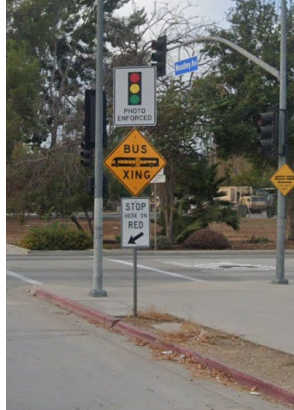
- Replace No Turns signage with arrow signage or add supplemental
- Do Not Enter assembly - angled at 45-deg for increased visibility from side street
- Downstream Do not enter (similar to off ramp design criteria, towards middle or end of red paint proposed)
- Advanced Bus Xing signage (could this get yellow flashing beacon?)

- - Straight arrow / only signage on approach.
- Pavement Markings
  - Red paint on busway near intersections
  - Bus Only markings
  - Continued markings through intersections solid pref, but shoulder / DYCL skip okay
  - Straight arrow marking on approach
- Cross section
  - Approach median (replicate east main street) – quick build with bollards first (80 – 100 ft)
    - Preference for mountable in long term in case of detours
    - Consider bus turning movements in normal routes such as Stanley Street
- Signalization
  - APS Button and signal heads
  - Dynamic Bus Approaching Light (on at all times when main street is red?)
