# Hamden Road Safety Audit

Route 707 (Whitney Avenue): Hamden / New Haven  
Town Line to Millbrook Road

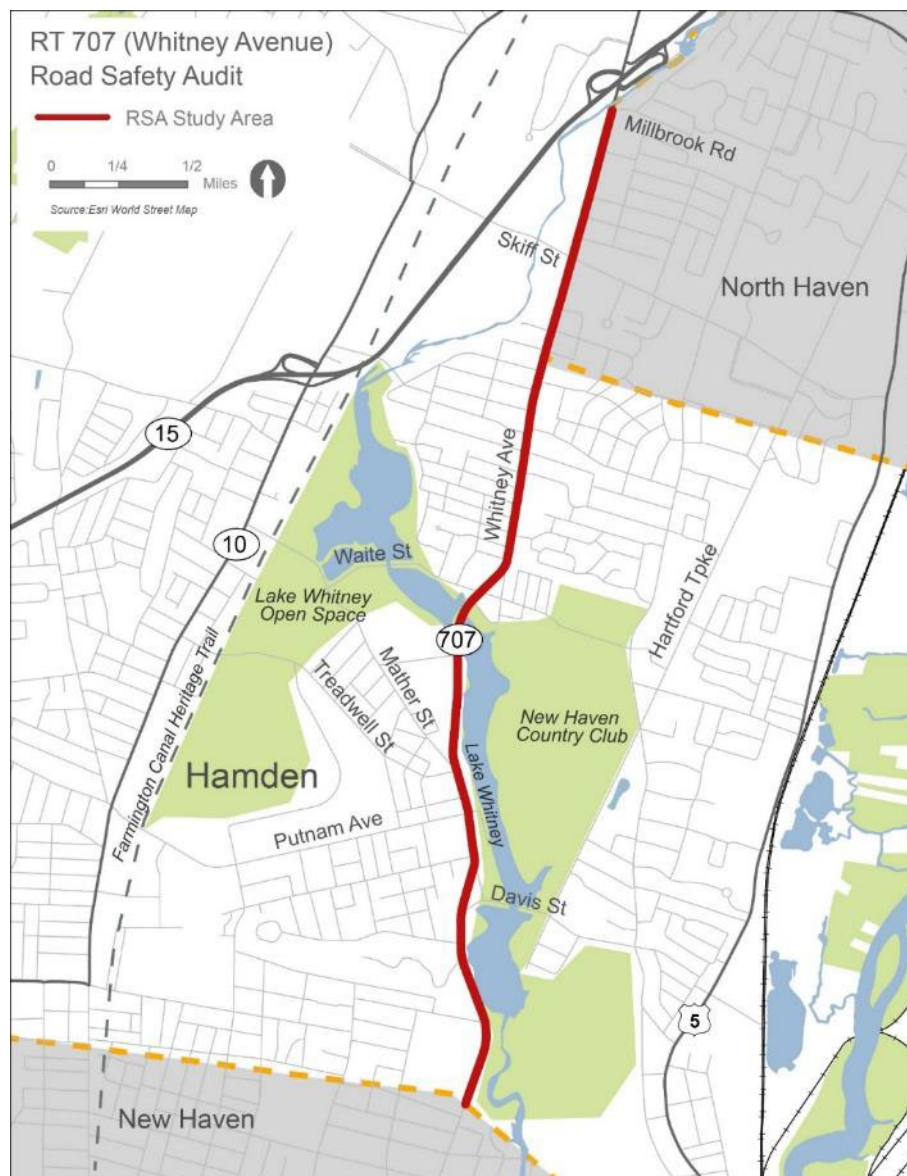
Exhibit 2: Route 707 (Whitney Avenue) RSA Study Area

The study area contains a mix of signalized and unsignalized intersections as well as curb cuts and entrances into and out of property parcels. This RSA focuses on the major roadway segments and intersections where the safety concerns and pedestrian movements are most concentrated.

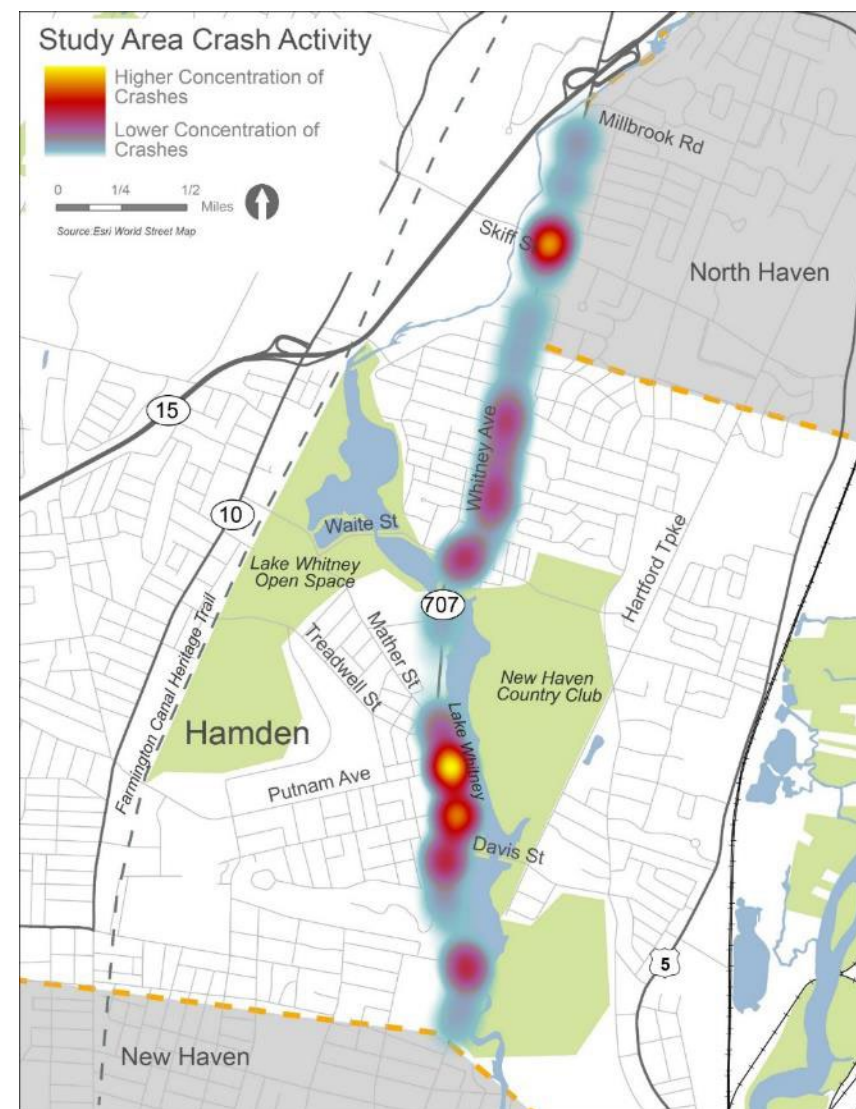
**Crashes:** The study team collected data from the Connecticut Crash Data Repository (CTCDR) for a five-year period between January 2019 and December 2023, the latest available full-year dataset. There were 518 crashes in the study area. Crashes were concentrated at the intersections of Route 707 and Putnam Avenue, Skiff Street, Eli Road / Auger Street / Davis Street, Armory Street, and Waite Street. Exhibit 10 displays the study area crash summary by year and Exhibit 11 displays a study area crash heatmap.

Exhibit 11: Study Area Crash Heatmap (2019-2023)

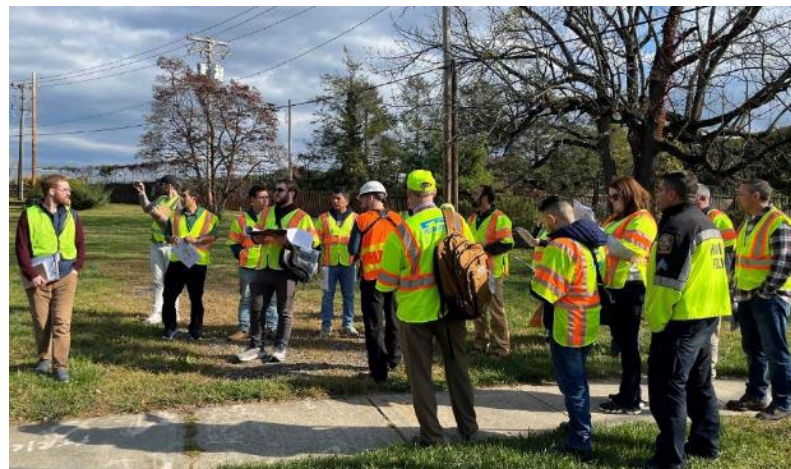
*Exhibit 18: RSA Participants Walking Along Route 707 near Armory Street*

A summary of the team's findings from documenting conditions seen in the field, along with comments by stakeholders from the Town, is presented below. Many of the issues discussed are corridor wide and are presented first. Concerns at specific areas are presented after the corridor wide conditions. Exhibit 18 shows RSA participants walking the Route 707 (Whitney Avenue) corridor.

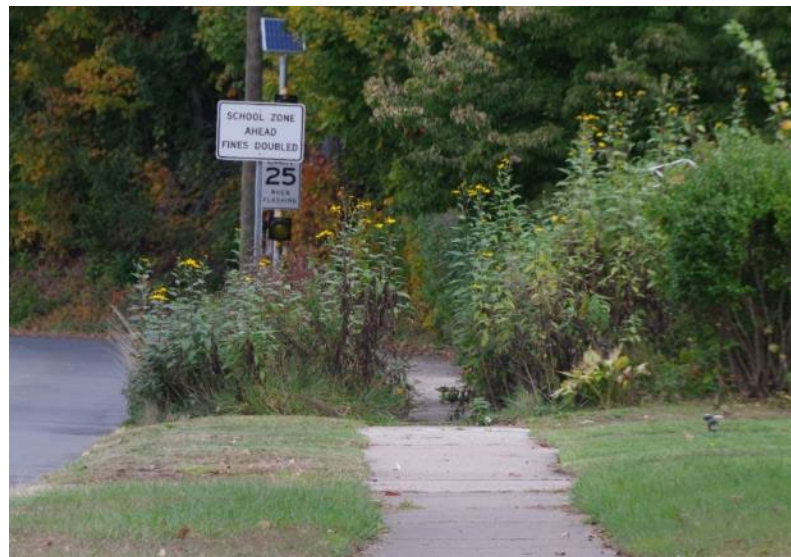
*Exhibit 19: Vegetation Encroaching on Sidewalk*

- The vegetation along the west side sidewalk north of Armory Street is overgrown. There is 4 – 5-foot-wide sidewalk here.
- The sidewalk on the east side of the road borders the Lake Whitney dam and is disconnected from the roadway. It is in fair to poor condition and has limited to no pedestrian-scale lighting.

- **Next Step:** Municipality to consider applying for an [Encroachment Permit](#) through the District permit office
- 2) Repair / replace sidewalk in areas of disrepair.
  - **Next Step:** Municipality to coordinate with adjacent property owners for access management
  - **Next Step:** Municipality to consider applying for an [Encroachment Permit](#) through the District permit office
- 3) Continue planning for road diet implementation in corridor. The implementation of a road diet can reduce speeds and crashes, as well as provide a more defined space for cyclists.
  - **Next Step:** Municipality to continue to coordinate with CTDOT Traffic Engineering to discuss the feasibility of a road diet.
  - **Next Step:** LTA to contact [DOT.TrafficEngineering@ct.gov](mailto:DOT.TrafficEngineering@ct.gov)

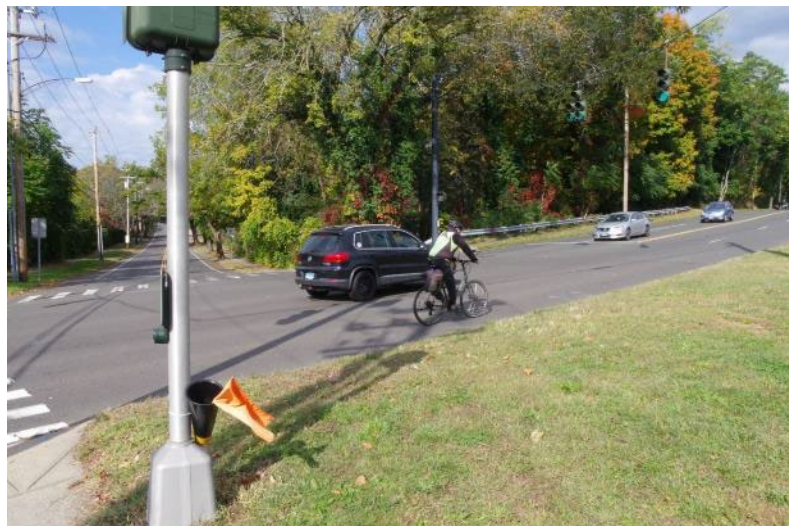
- The travel lane widths appear to be about 10.5 – 11 feet wide in this area. There is no shoulder. If a road diet were to be implemented in this area, bike lanes would likely be less than the five-foot recommended width. Exhibit 20 displays a bicyclist riding through the intersection.

Exhibit 20: Bicyclist Traveling Northbound at Armory Street Intersection

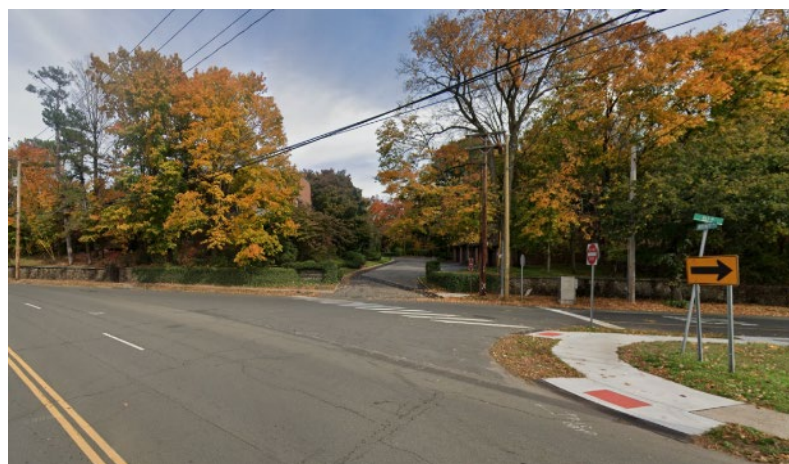
- There are no mid-block crosswalks.
- One participant observed southbound vehicles speeding.
- The crosswalk across Davis Street is faded.
- It is difficult for drivers to merge onto Route 707 (Whitney Avenue) from Eli Road because of sightlines and skew of the intersection.

Exhibit 21: Entrance to Whitney Wood Apartments at Eli Road (Source: Google Maps, August 2024)

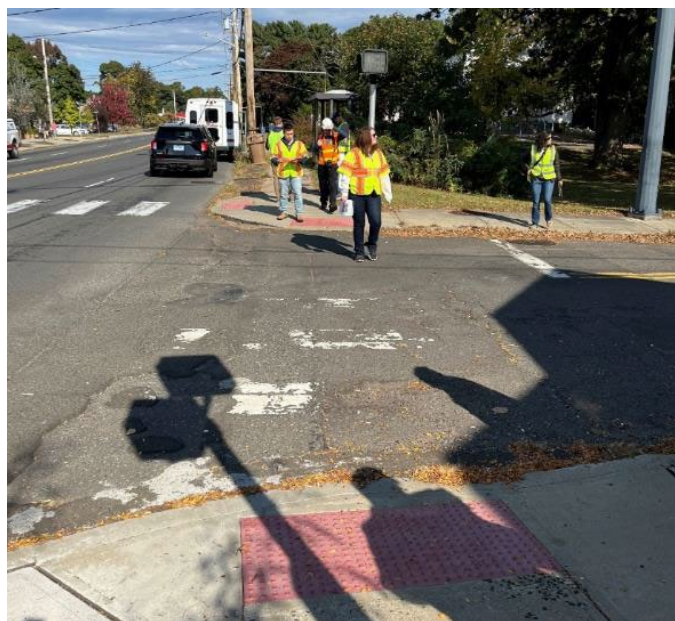
*Exhibit 22: Crosswalk Across Eastern Leg of Putnam Avenue*

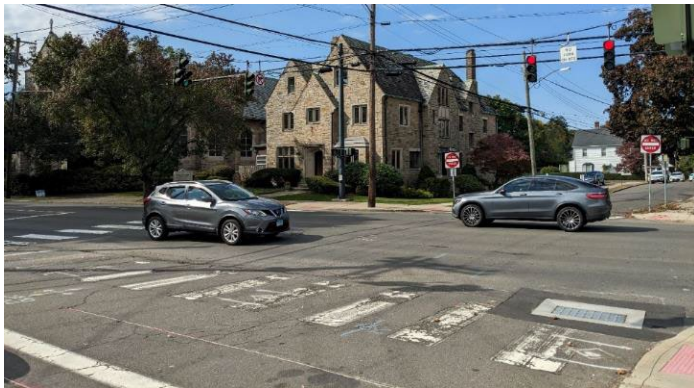
Exhibit 23: Route 707 (Whitney Avenue) at Park Avenue

- Participants stated that the area could benefit from streetscape design enhancements.

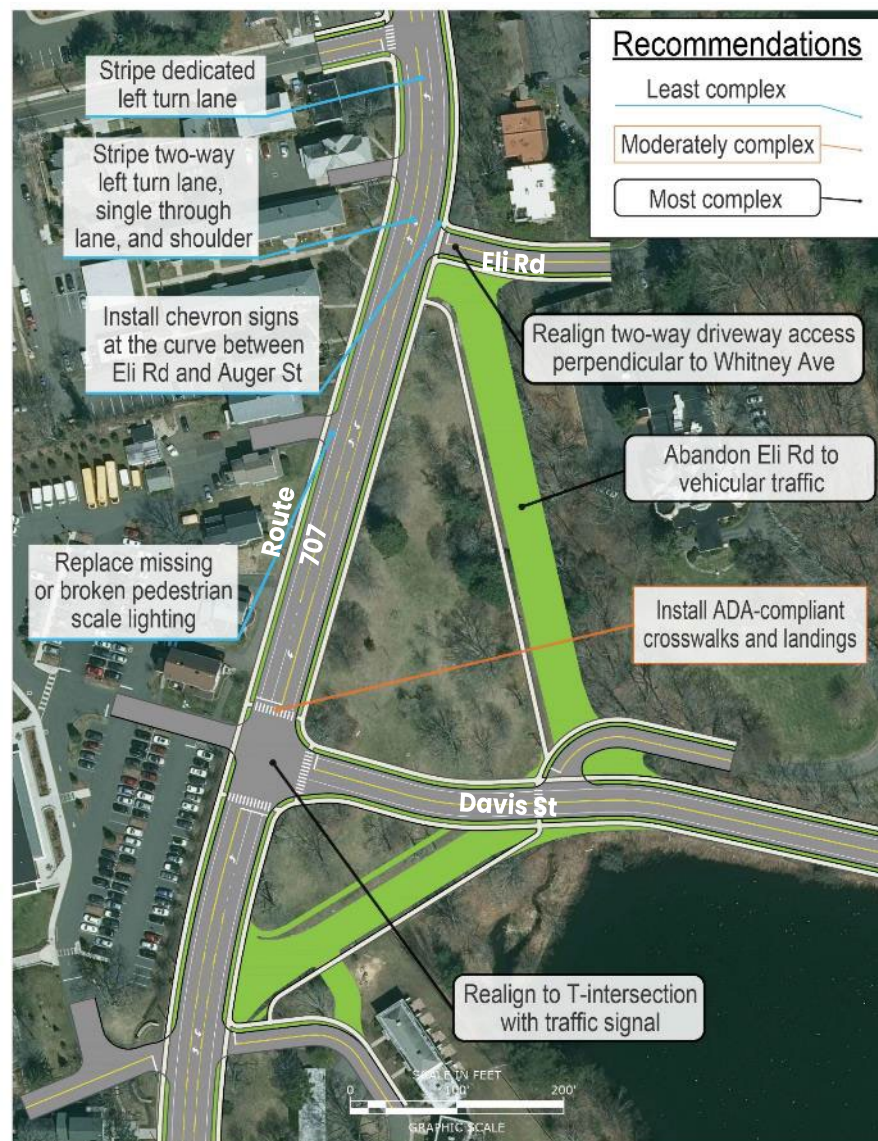
Recommendations in this area focus on roadway lighting, school zone speed reduction, speed reduction at curves, and the realignment of the intersection at Eli Road, as displayed in Exhibit 25 and Exhibit 26. If Davis Street and Eli Road are realigned as show in Exhibit 25, significant impacts to Eli Whitney Park would occur, which could involve fulfilling Section 4f requirements. Exhibit 26 is an alternative concept and was developed to show reduced impacts to Eli Whitney Park.

Exhibit 25: Route 707 (Whitney Avenue) Preliminary Concept

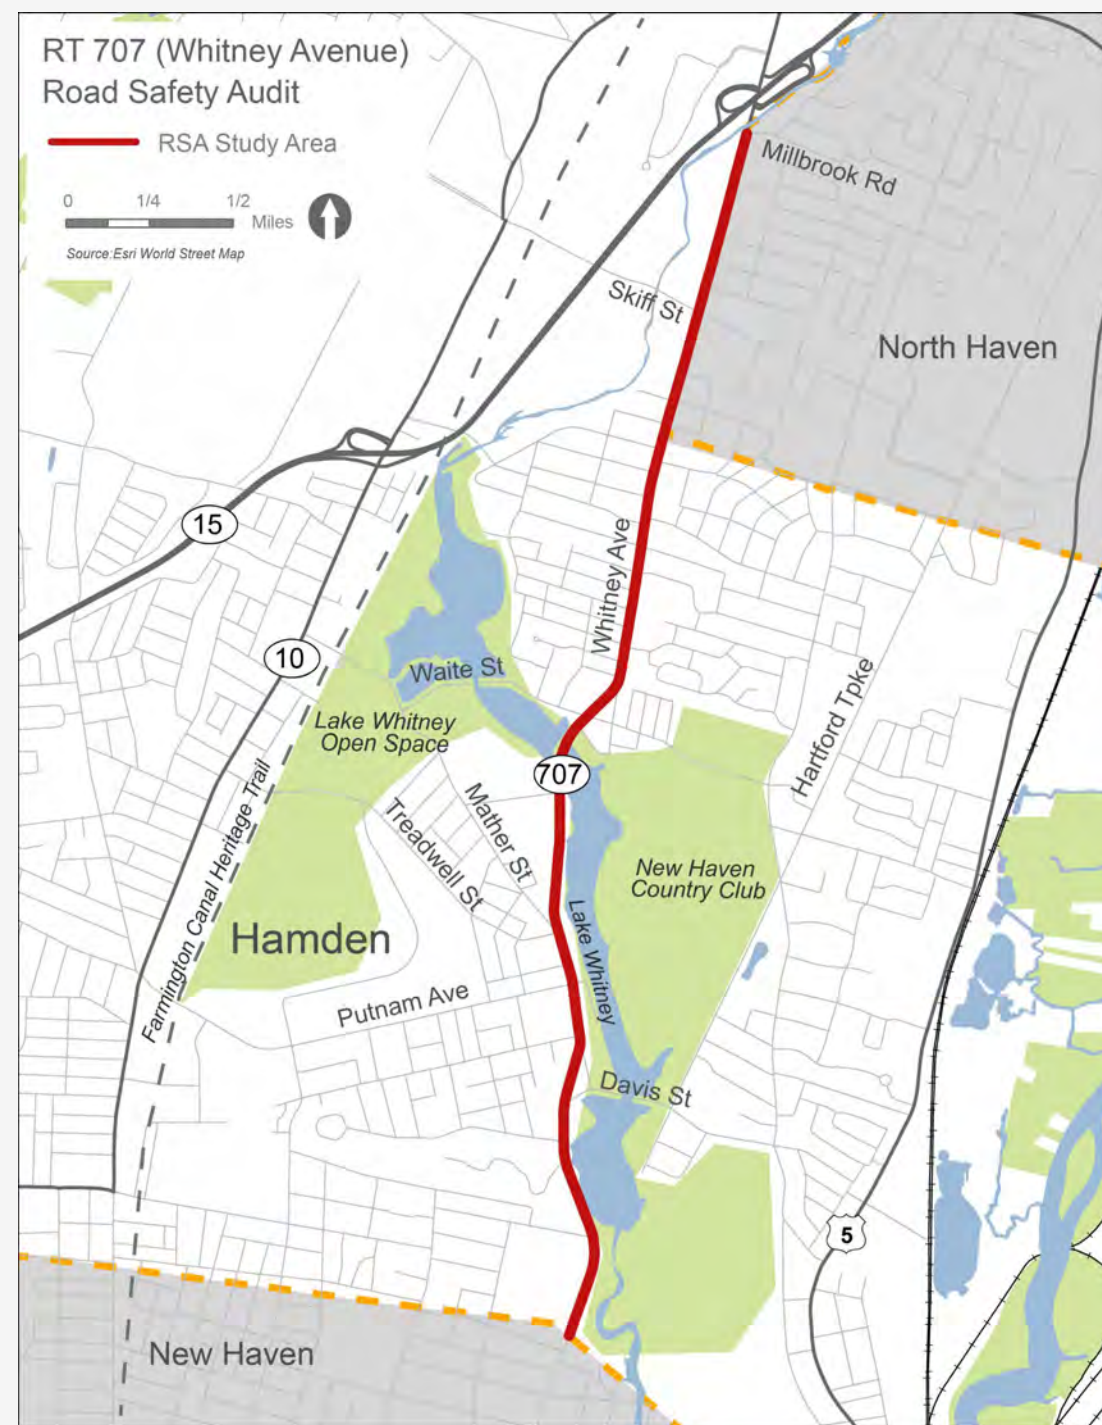
- Route 707 (Whitney Av)
- City of New Haven/Town of Hamden Town Line to Millbrook Rd
- 3.25 miles

*Note: Hamden and North Haven town line is roadway centerline from Short Hill Rd to Millbrook Rd*

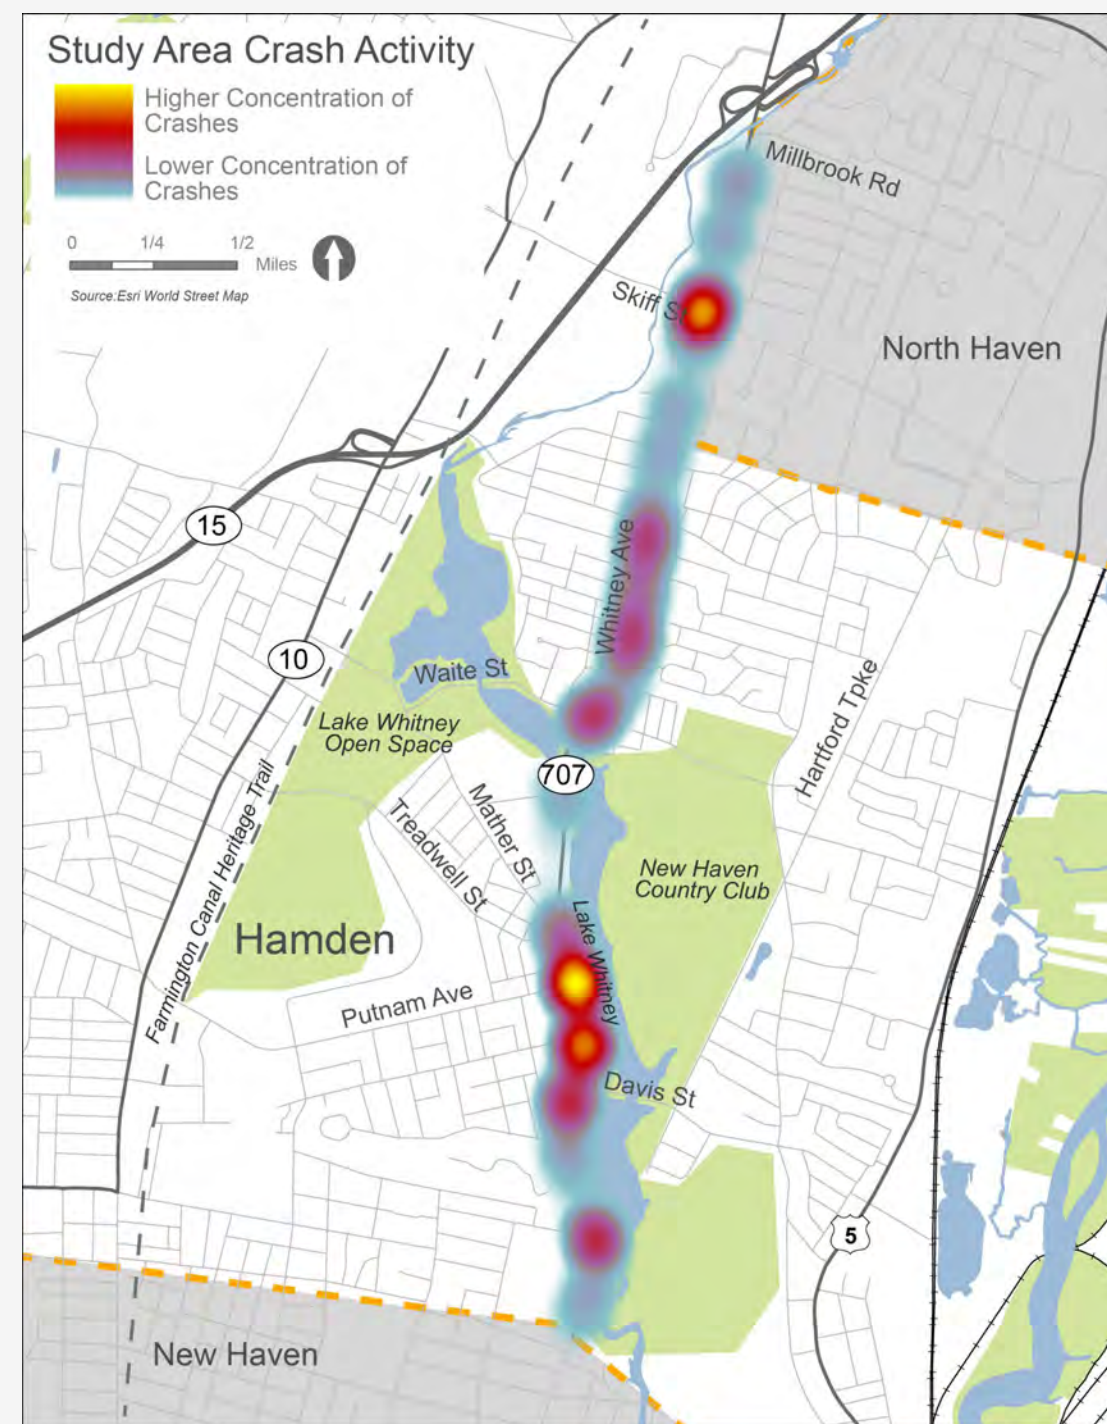
# Crash Hotspots (2015 – Jan 2024)

- Putnam Av intersection
- Wilbur Cross interchange
- North of Spring Glen businesses
- Vicinity of Davis St and Hamden Hall

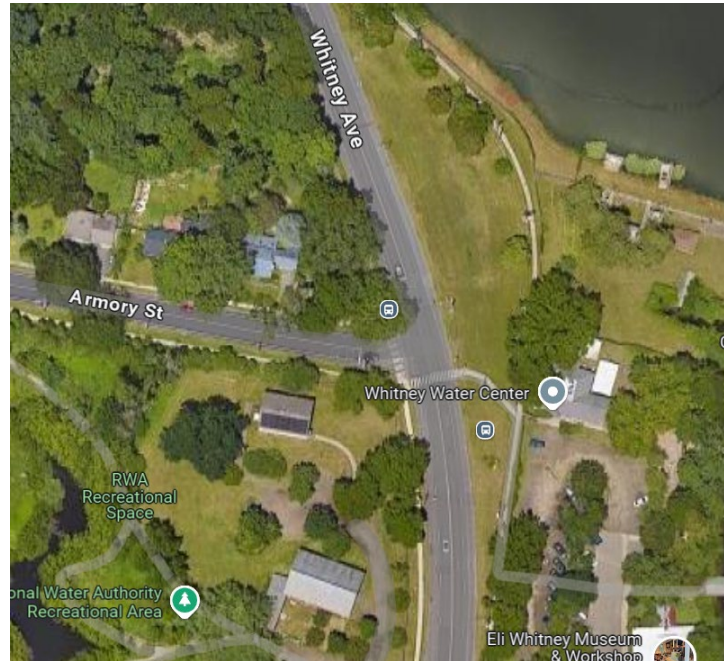
### Location 1: Intersection Route 707 and Armory Street

For each noteworthy feature that you observe along the walking route, write a number at the location on the map below. Write a brief description of your observation for that number under the Notes section. See the attached RSA Field Considerations list for suggested items to observe.

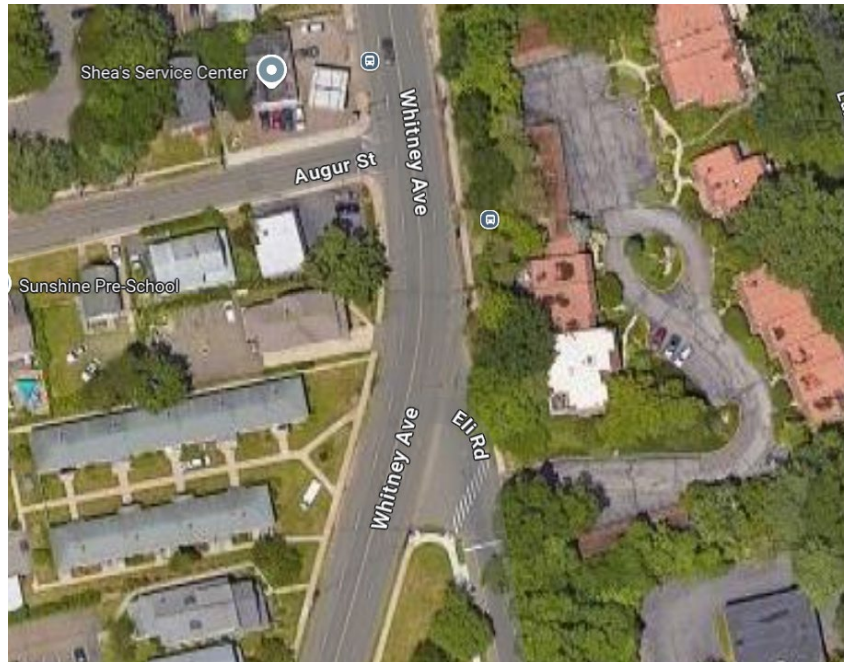
### Location 2: Intersection Route 707 and Eli Road/Augur Street/Davis Street

For each noteworthy feature that you observe along the walking route, write a number at the location on the map below. Write a brief description of your observation for that number under the Notes section. See the attached RSA Field Considerations list for suggested items to observe.

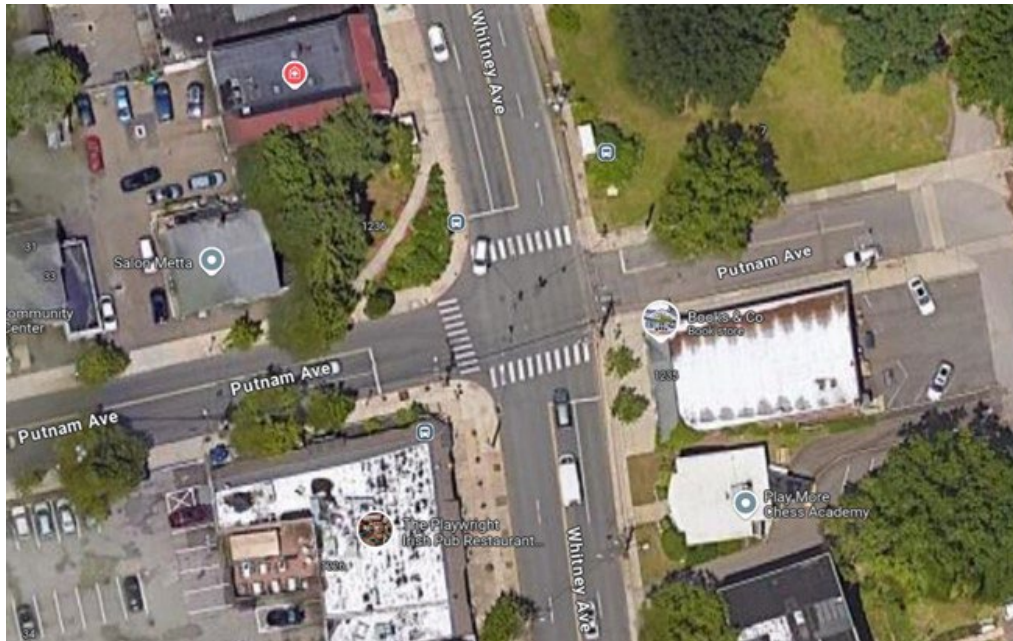
### Location 3: Intersection Route 707 and Putnam Avenue

- **Location 3: Intersection of Route 707 and Putnam Avenue:**
  - No pedestrian scale lighting
  - Signage for cross street (Putnam Avenue) is lacking
  - Crosswalks are in poor condition

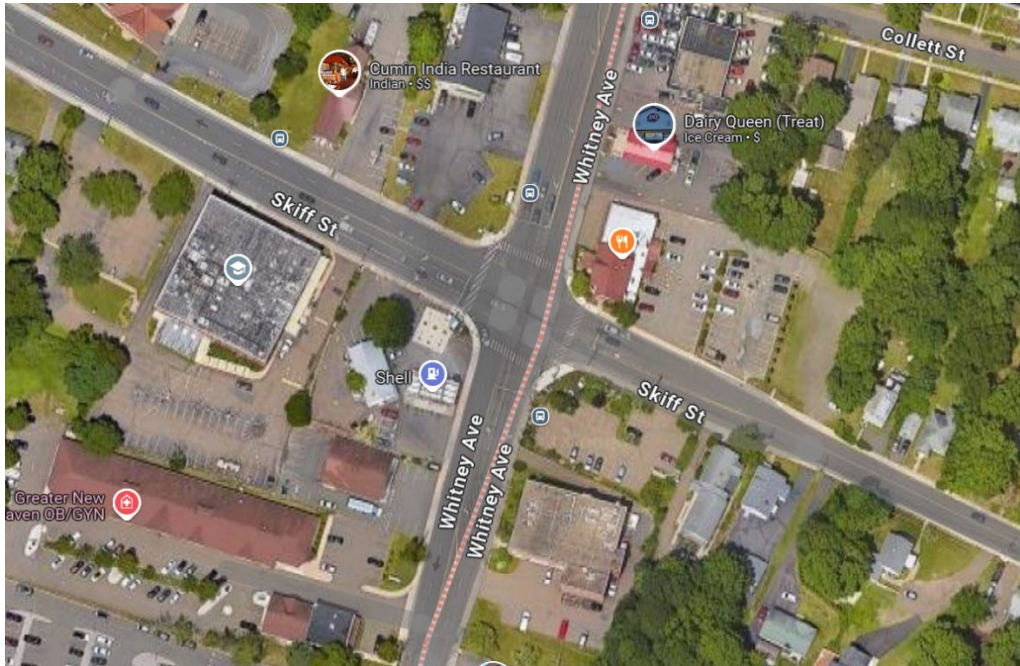
### Location 6: Intersection Route 707 and Skiff Street

- Very wide intersection. Crosswalks across all legs, but long crossing distances
  - A lot of east/west traffic in this area on Skiff Street
  - It was noted that there are many drivers who disobey the right turn on red signage
