# MADISON ROAD SAFETY AUDIT

US Route 1: Wall Street to Hammonasset Connector (Route 450)

SEPTEMBER 2024

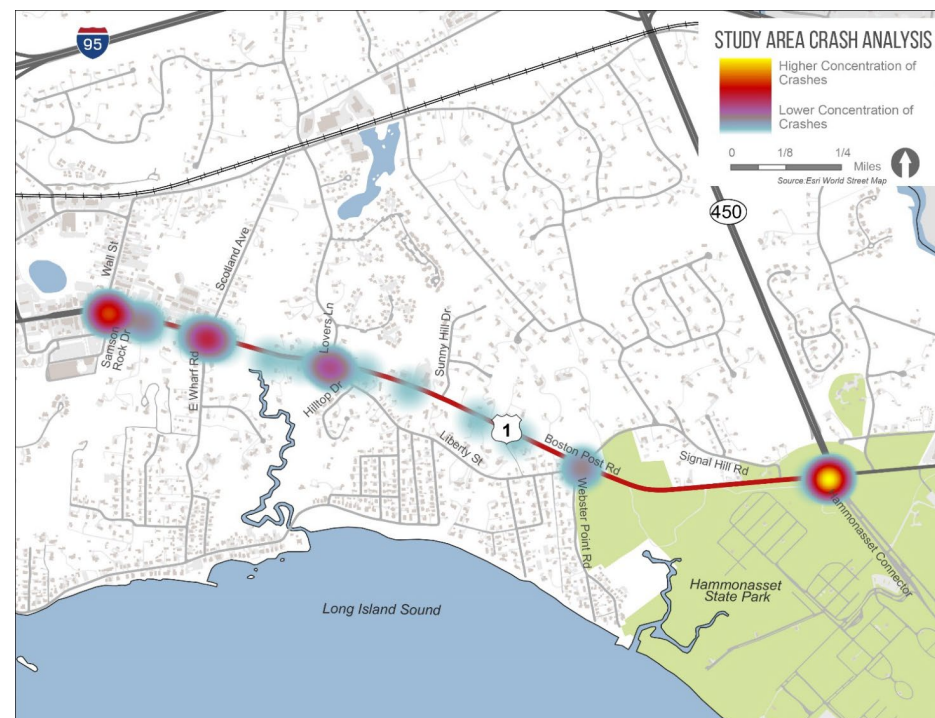
Exhibit 7: Study Area Crash Heatmap

**Crash Severity:** Most crashes were classified as “no apparent injury” or “property damage only”. There were three (3) minor injury and two (2) serious injury crashes reported. Exhibit 10 displays the severity of crashes and their locations.

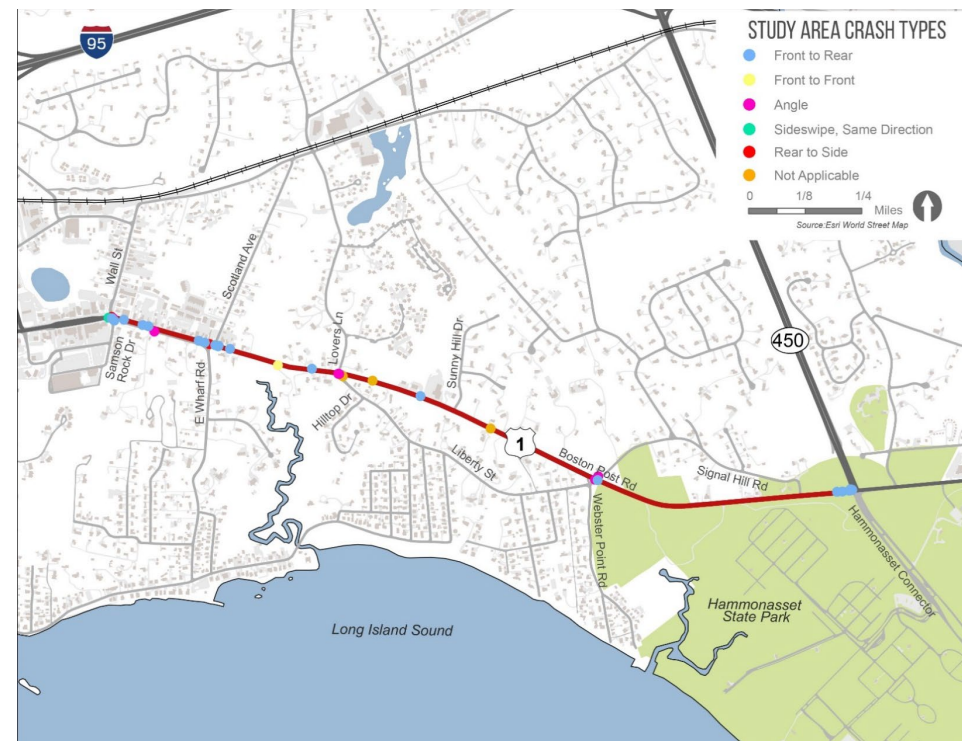
Exhibit 9: Crashes by Type

**Crashes by Type:** Most crashes were front-to-rear (rear end) and angle types. Front-to-rear crashes occur most commonly at intersections where cars are queued to make turning movements. Angle crashes are typical in areas with ingress / egress movements at property entrances. Exhibit 8 displays crashes by type and severity. Exhibit 9 displays a map of crashes by location and type in the corridor.

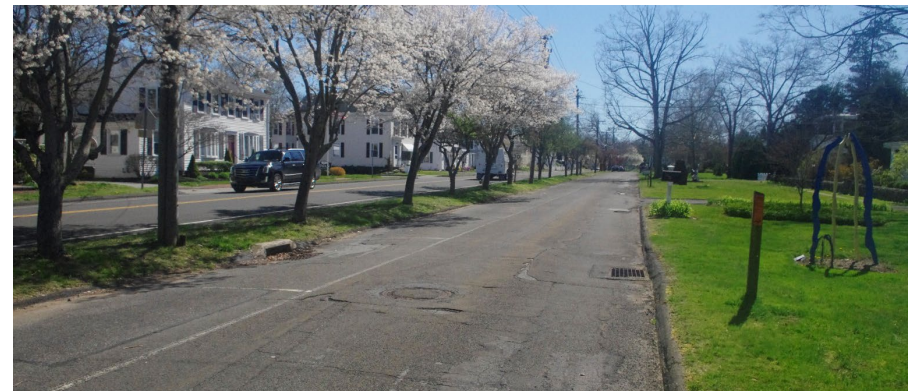
*Exhibit 13: Poor Pavement Conditions on Old Boston Post Road*

- Old Boston Post Road is used as a sidewalk and bike lane, however, poor pavement conditions force users into the roadway and parking lane. Conditions of Old Boston Post Road are displayed in Exhibit 13.
- The US Route 1 sidewalk on the north side has heaving and missing bricks.

- 4) Repair / replace heaving and missing bricks on the north sidewalk.
  - **Next Step:** Municipality to consider applying for an [Encroachment Permit](#) through the District permit office

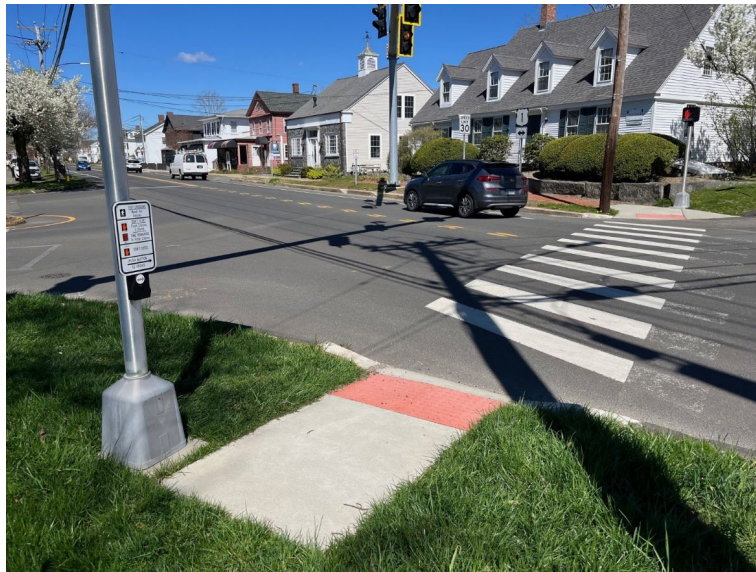
*Exhibit 14: Crosswalk Across US Route 1 with Tactile ADA Pad and No Sidewalk*

- There are challenging sightlines for turning movements in this area.
- Drivers speed as they leave the Madison Center area.
- There are limited pedestrian facilities. The east side of the intersection has a crosswalk with pedestrian signal. The southeast corner curb ramp has a tactile Americans with Disabilities Act (ADA) pad, but this landing only provides

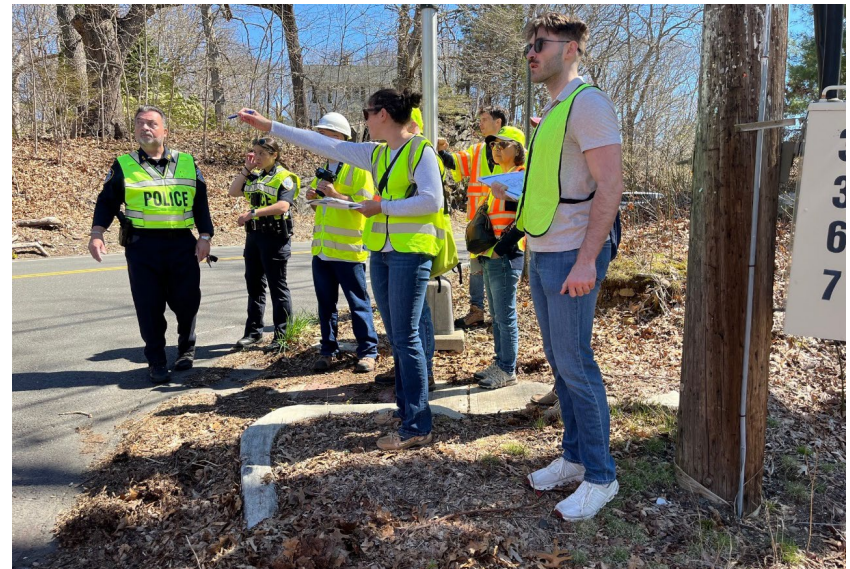
*Exhibit 15: Southbound View of US Route 1*

- There is poor visibility for all users at this location because of the roadway geometry.
- Participants stated that speeding is a major concern.

- Residents in the area have requested a crosswalk and audible push buttons at this intersection. The existing push buttons have ADA ramps on both sides of US Route 1 but do not have a crosswalk connecting them or have further connections to a sidewalk network. This area is currently being upgraded with crosswalk, pavement markings, accessible pedestrian signal (APS), and countdown indications. Exhibit 15 shows the RSA group at the intersection.
- Police noted that, despite the No Turn on Red (NTOR) sign, drivers often still make right turn movements. The eastbound NTOR was originally installed in 1999 at the request of the municipality to address high right turn speeds and resultant speeding onto Liberty Street.

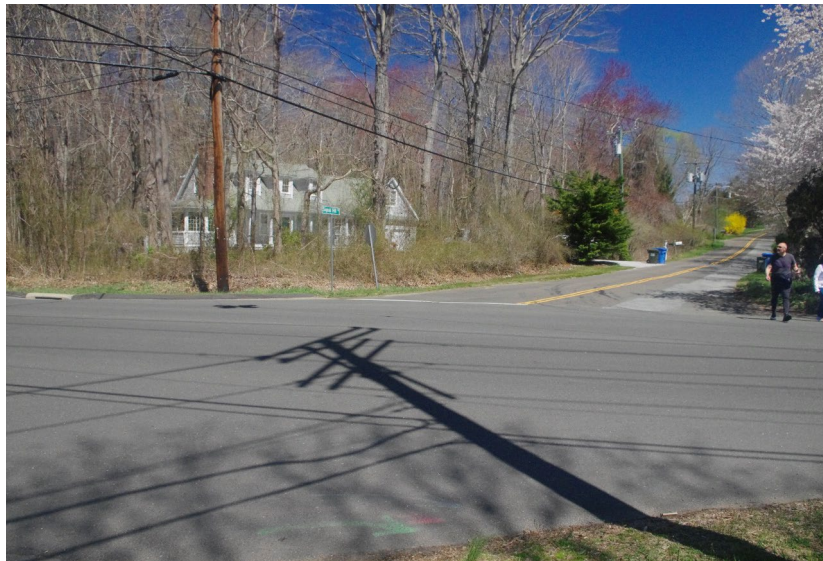
*Exhibit 16: No Pedestrian Facilities at Signal Hill Road and US Route 1 Intersection*

- Residents in the area have requested a crosswalk at this location.
- A new condominium project nearby is expected to generate higher pedestrian volumes.
- High speeds are a problem, and a beacon light is the only form of traffic control at this location.
- This is the location of the western terminus of the Shoreline Greenway Trail, which places users onto the roadway network.
- There are no crossings or sidewalks at this intersection, as shown in Exhibit 16.

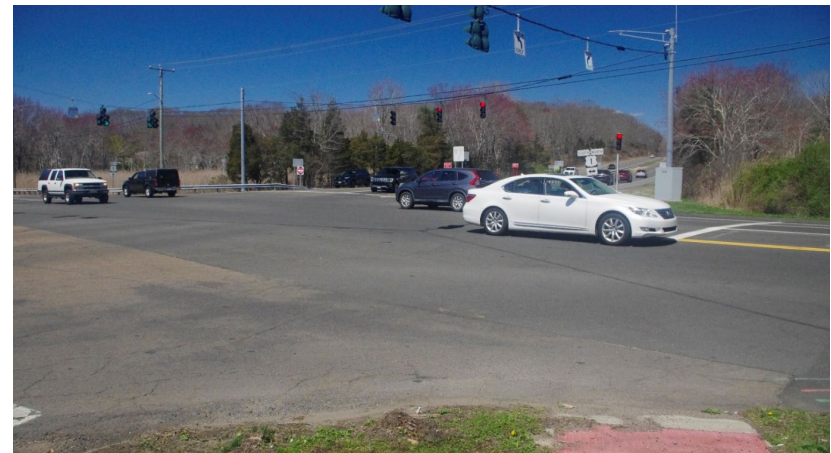
*Exhibit 17: Minimal Pedestrian Accommodations at US Route 1 and Hammonasset Connector (Route 450)*

- CTDOT has a project underway for pedestrian signal upgrades.
- Participants discussed high speeds, particularly from vehicles travelling south from the Hammonasset Connector. There are no crosswalks at this wide intersection. The only pedestrian amenities are pushbuttons and ADA ramps at the northeast and southeast corners of the intersection, as displayed in Exhibit 17.

- There are visible areas where people have climbed over vegetation to access the Shoreline Greenway Trail.

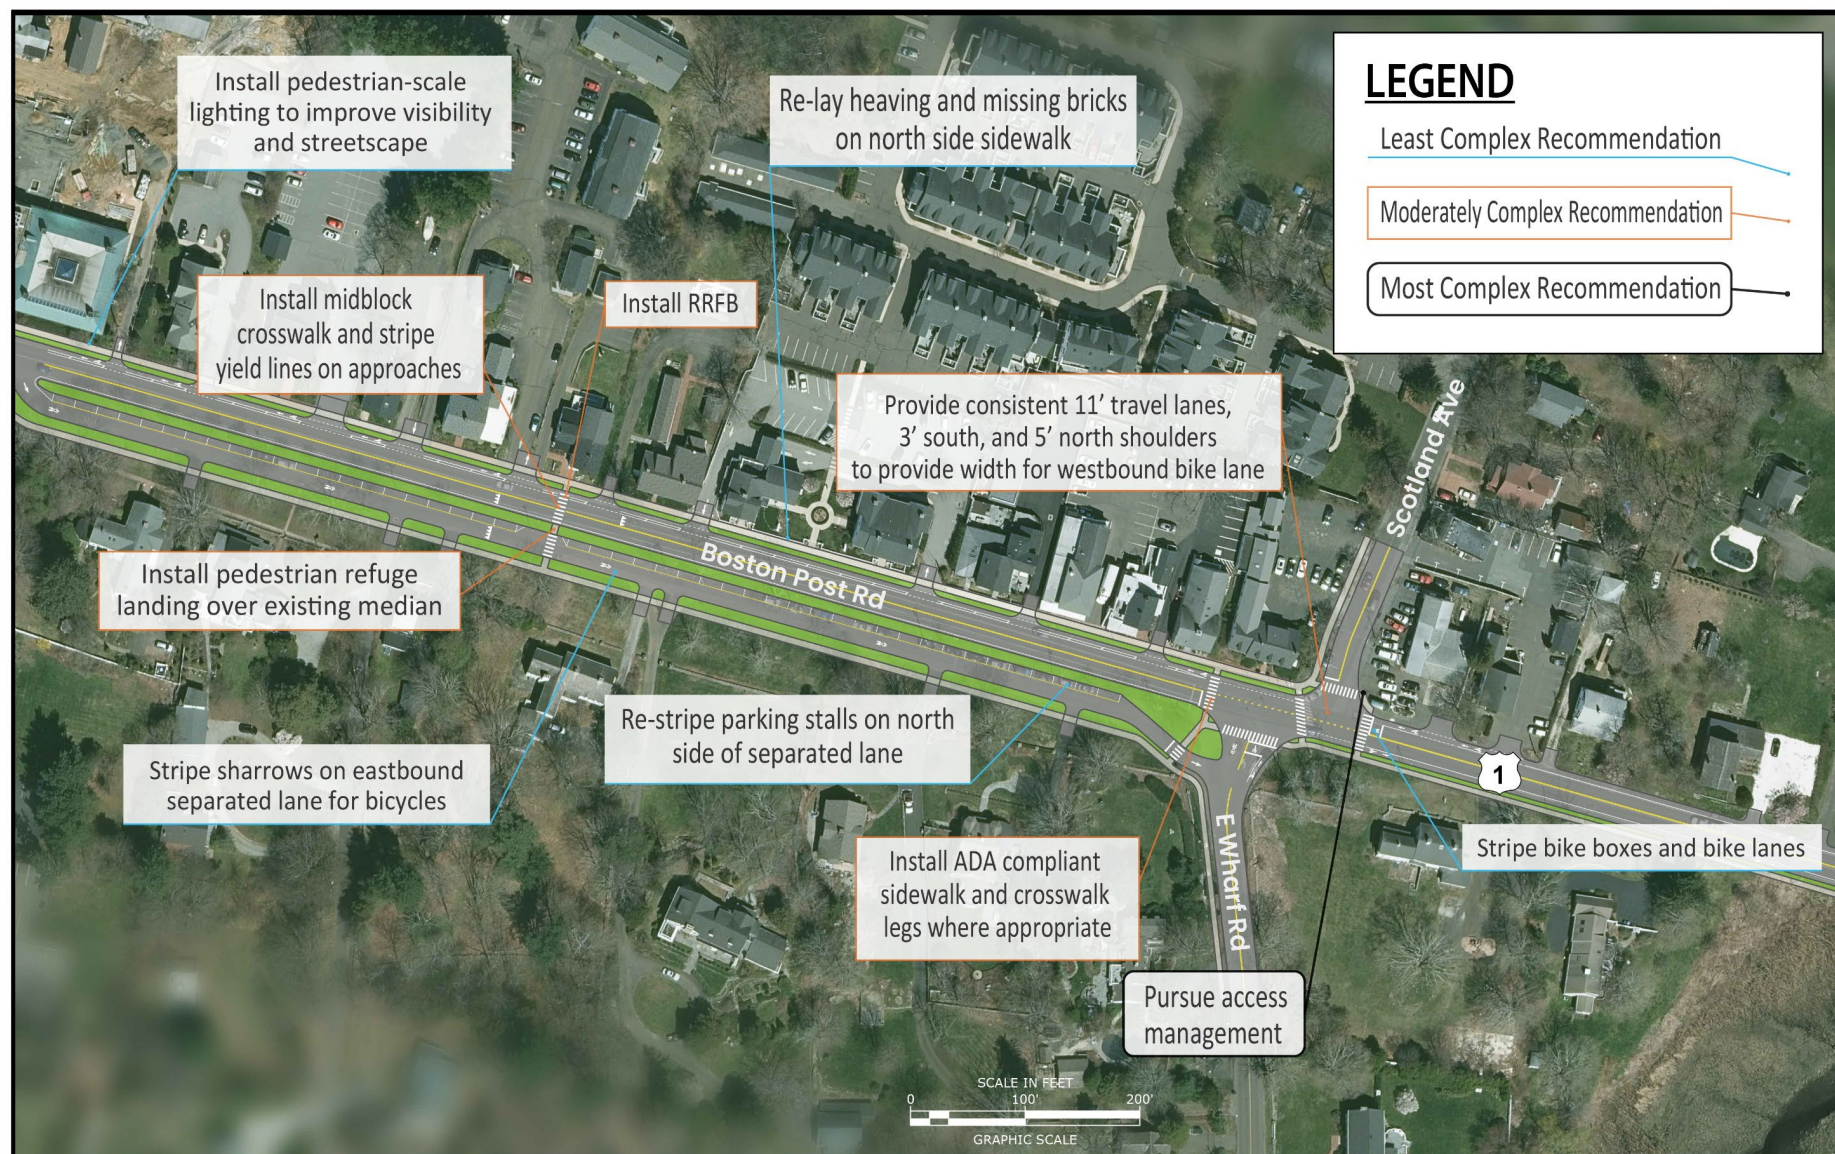
Exhibit 19: Representative Concept

Based on the findings discussed during the RSA, a set of recommendations for the study area was compiled. These recommendations are organized by study area location. The RSA team walked the length of the corridor starting at Wall Street and travelling east to Hammonasset Connector. The sections below are not intended to reduce the importance of other aspects of the corridor, but rather to organize the recommendations in a coherent way. Many of the recommendations identified by the RSA team are applicable to any / all intersections or roadway segments in the study area. A table of recommendations organized by location is presented in Exhibit 18. A concept drawing of the roadway segment of US Route 1 between Wall Street and Scotland Avenue is presented in Exhibit 19.

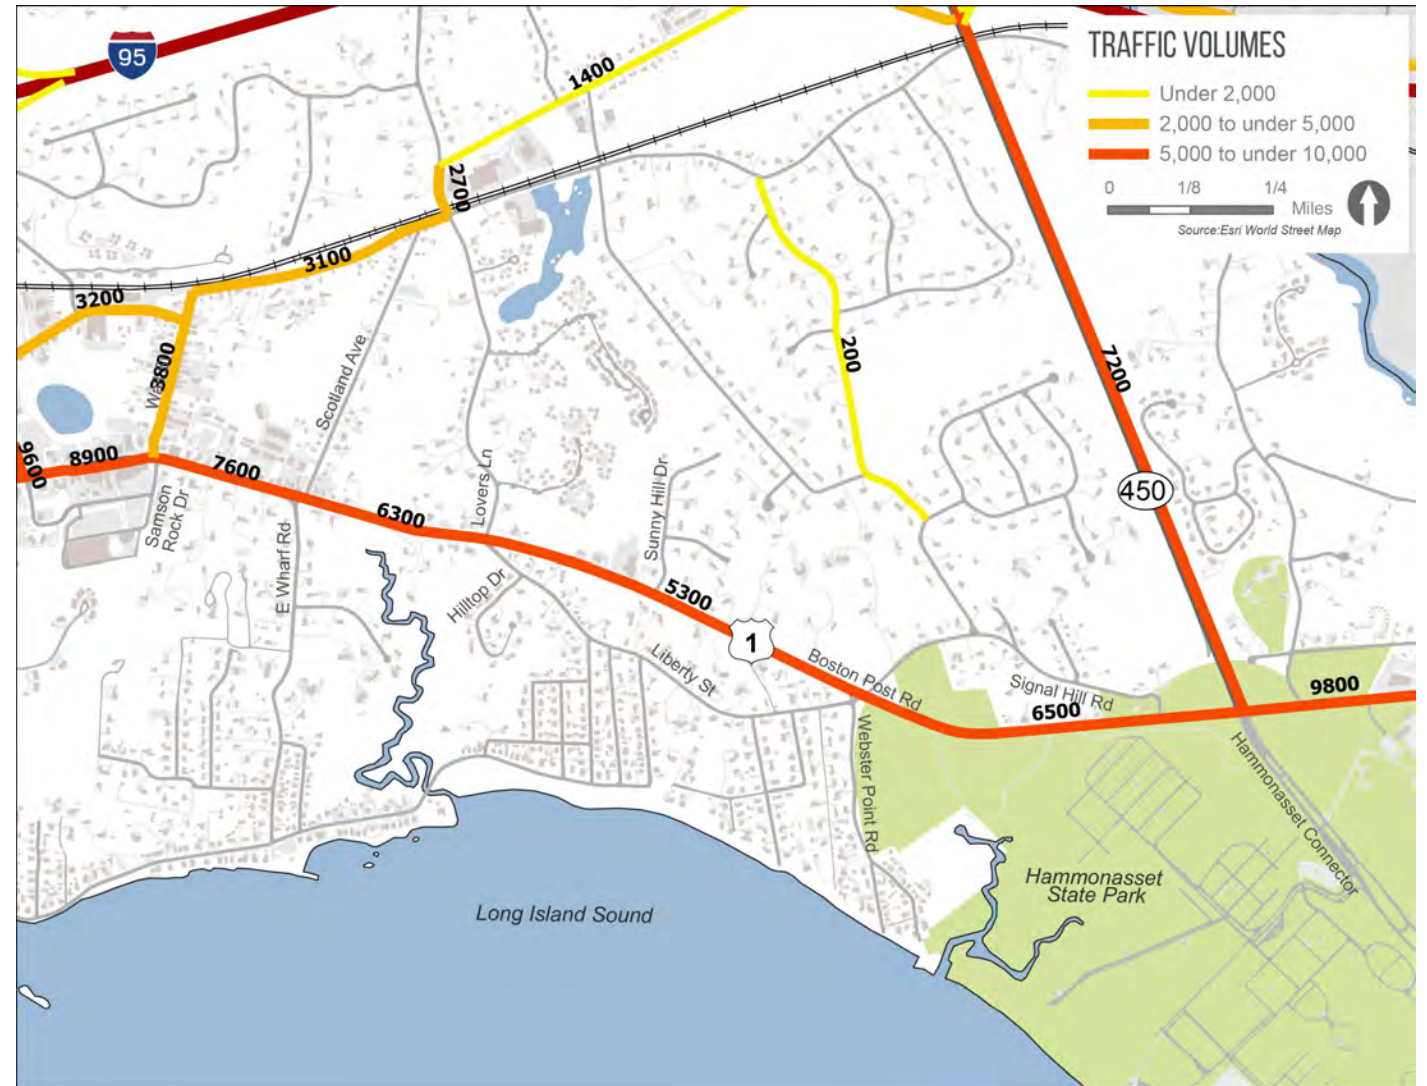
- Highest volumes directly outside of Town center

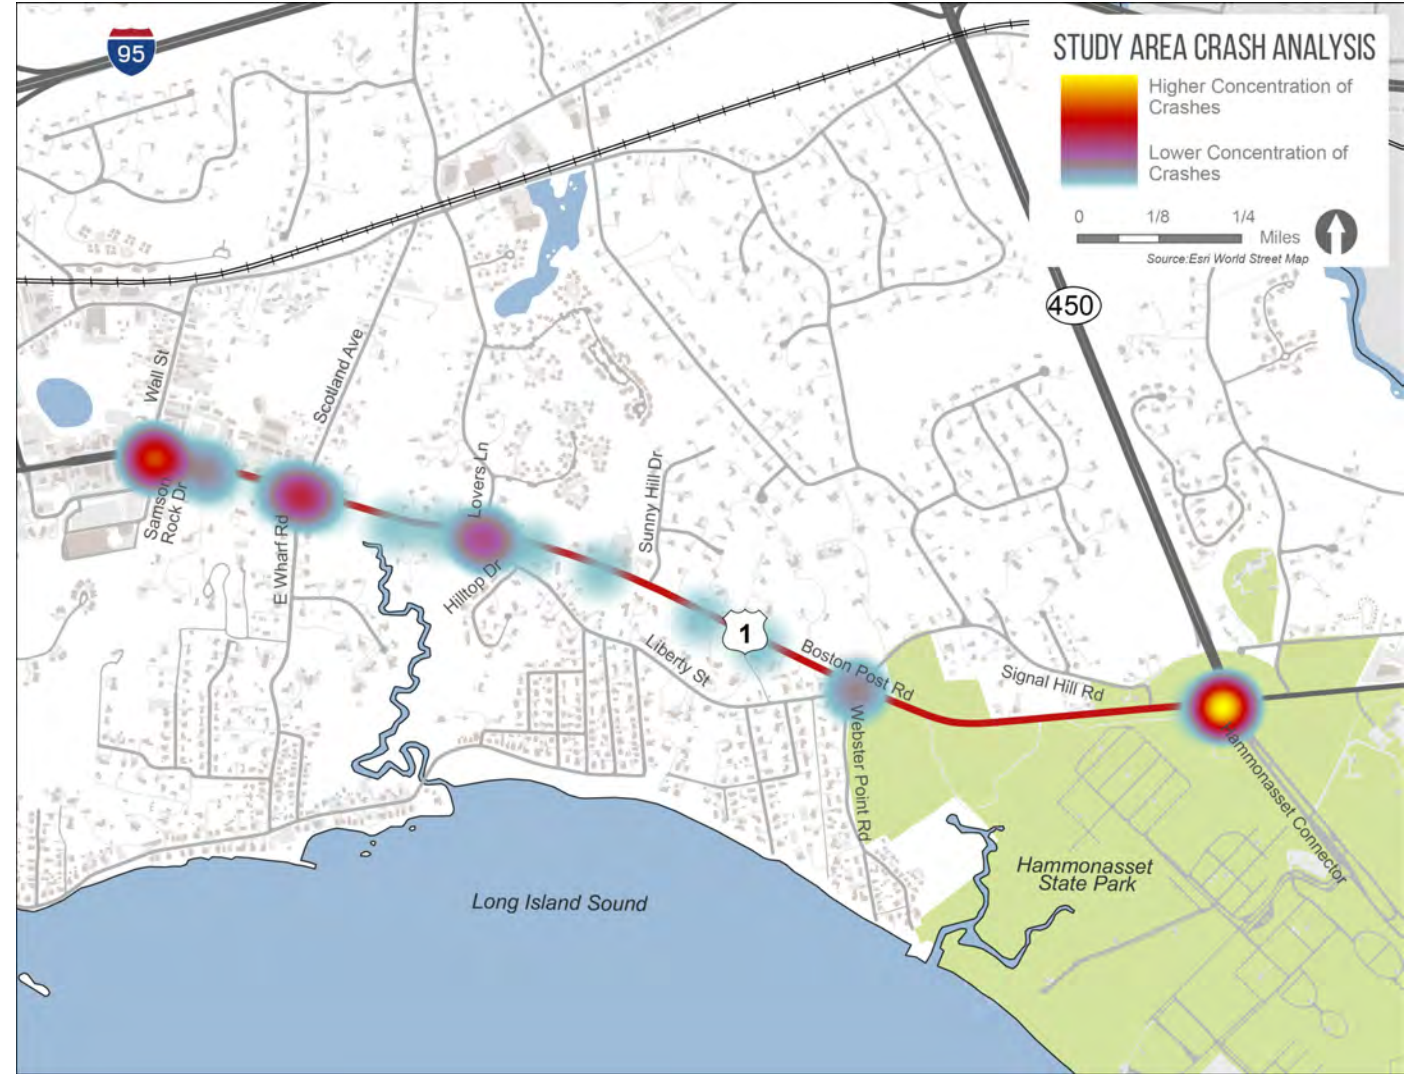
Crash Hotspots  
(5 Year Crash Total approx.)  
49 crashes total

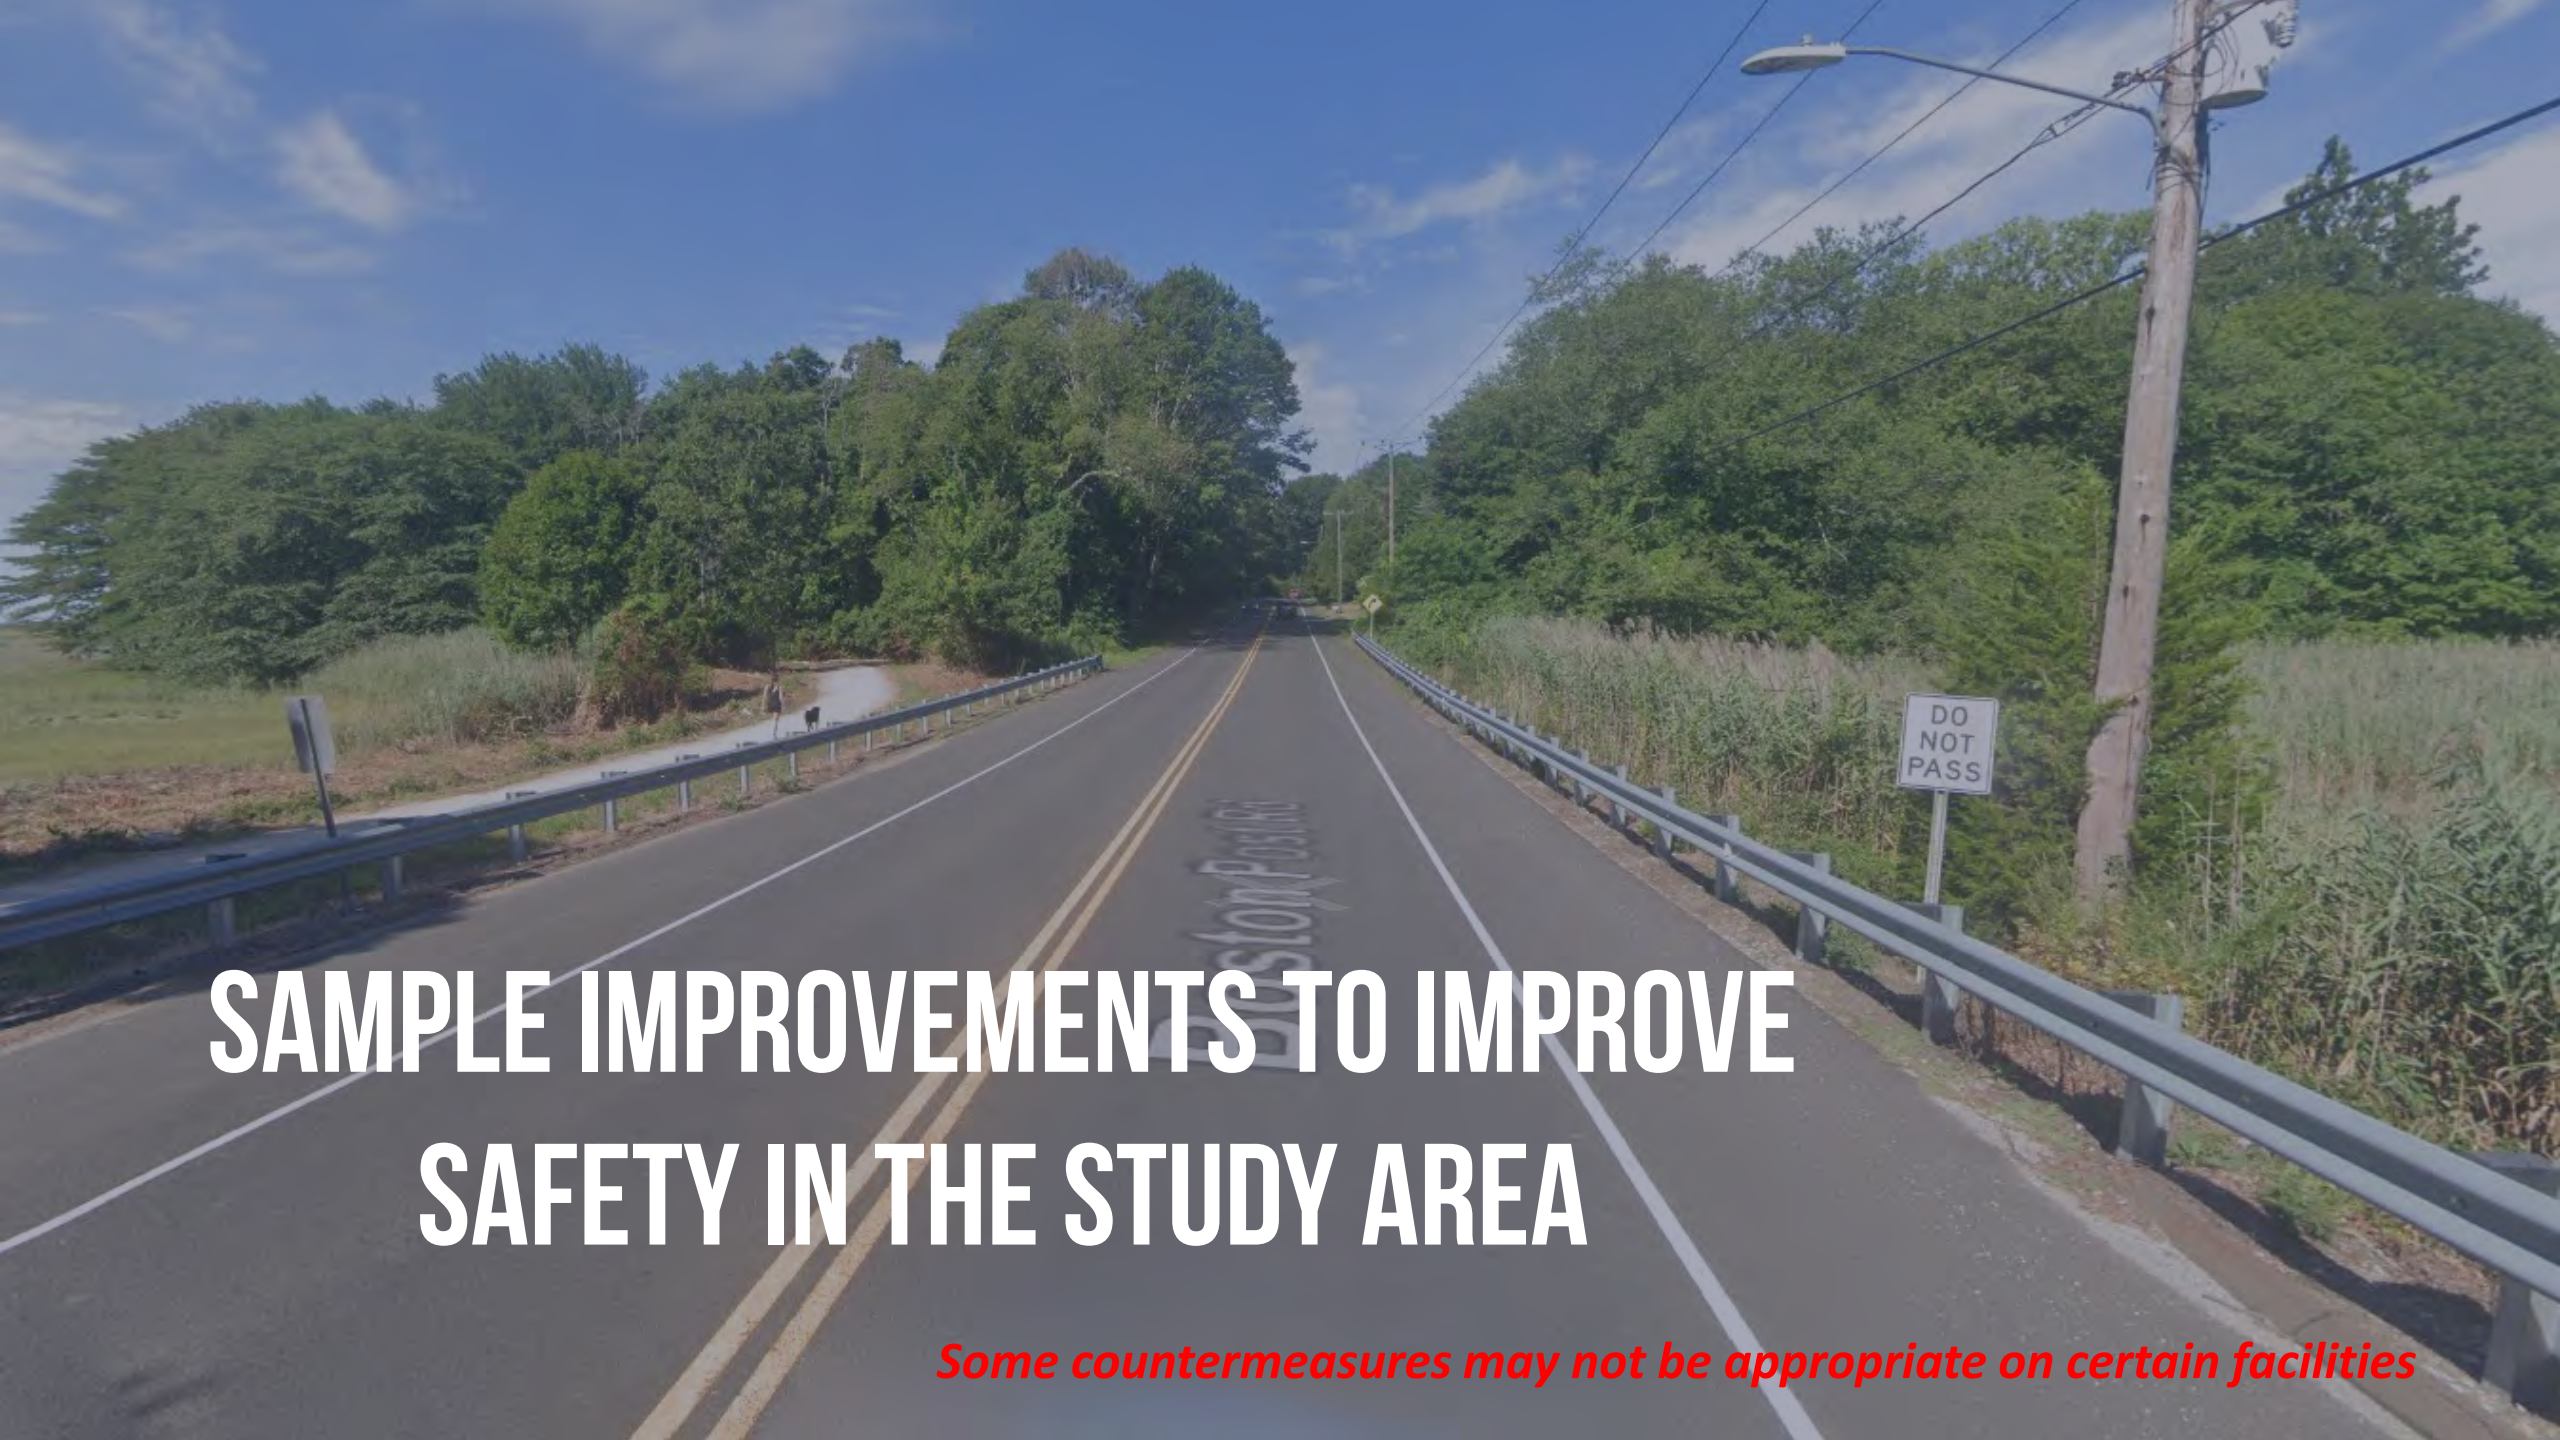
- Interstate, regional, and local traffic
- I-95 diverted traffic causes congestion
- Low-visibility driveway curb cuts due to horizontal, vertical alignments, vegetation
- Pedestrians and bicyclists use Route 1 even with access to Shoreline Greenway Trail

A photograph of a two-lane asphalt road with a double yellow center line and white edge lines. The road stretches into the distance, flanked by dense green trees and vegetation. On the right side, a metal guardrail runs along the edge of the road. A white rectangular sign with black text that reads "DO NOT PASS" is mounted on a post next to the guardrail. A tall wooden utility pole with multiple power lines is also visible on the right. The sky is blue with some light clouds. The overall scene is a rural or suburban road environment.
