# SOUTH WINDSOR ROAD SAFETY AUDIT

Route 5 (John Fitch Boulevard) between town lines of East Hartford and East Windsor

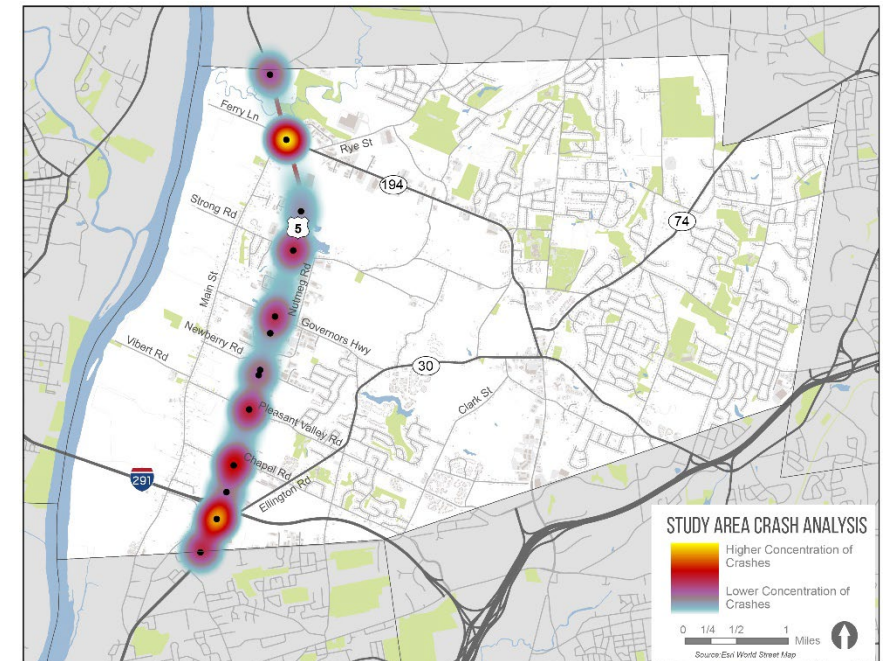
Exhibit 8: Study Area Crash Heatmap

**Crashes:** Based on data retrieved from the Connecticut Crash Data Repository (CTCDR) for the five-year period between January 2018 through December 2022, there were a total of 484 crashes in the South Windsor RSA study area. Crashes were concentrated highest at the intersections of Route 5 with Route 194 (Sullivan Avenue) and the I-291 EB Ramp / Route 30 (Ellington Road). An analysis of crash rates per million entering vehicles at each intersection was performed. Exhibit 6 displays the study area crash summary, Exhibit 7 displays the crash rates per million vehicles entering the intersection, and Exhibit 8 displays an overall study area crash heatmap.

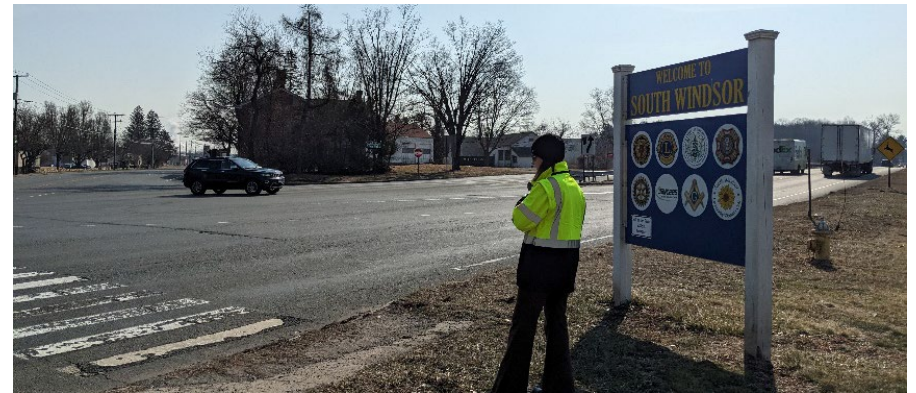
*Exhibit 15: View southeast on Route 5*

- Truck and heavy vehicle traffic in this area is high and produces excessive noise. Residents on Main Street can hear truck traffic.
- Intersection does not meet all Americans with Disabilities Act (ADA) compliance requirements.
- Existing crosswalk is very long and diagonal across the intersection, which is not desirable.

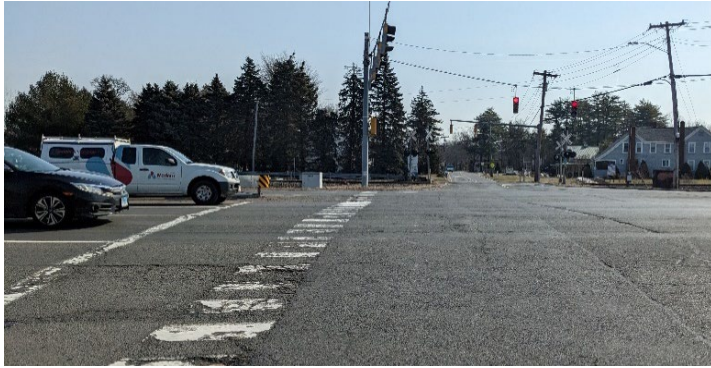
*Exhibit 16: Strong Road crosswalk over Route 5*

- Intersection does not meet all ADA compliance requirements.
- The railroad crossing has unclear stop bar lines for vehicles.
- The pedestrian crosswalk distance is long and does not connect to sidewalks on the either side of the road as shown in Exhibit 16.
- A portion of the width of the crosswalk has faded away and the current width is about three feet, well below the eight-foot minimum.
- Transit users have no facilities at bus stops.

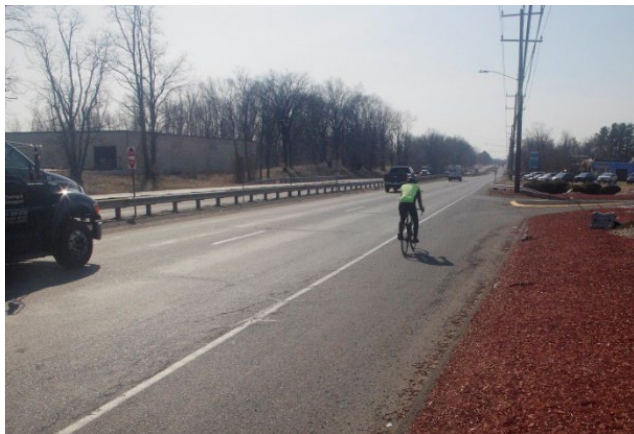
*Exhibit 17: Southbound view of Route 5*

- Town officials noted that access management is needed at this intersection with many businesses and curb cuts in a ¼ mile vicinity.
- Like Sullivan Avenue, the POCD identifies this intersection area to be a neighborhood hub. Exhibit 17 shows a bicyclist using the shoulder of Route 5.

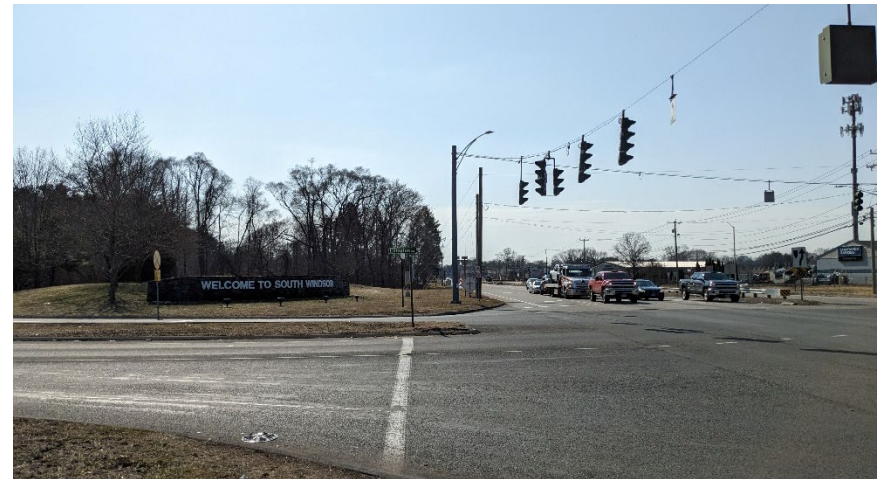
*Exhibit 18: Minimal pedestrian accommodations at Route 5 and Route 30 (Ellington Road)*

- There are no crosswalks or pedestrian amenities at this notably wide intersection except green light push buttons, seen in Exhibit 18.
- There is no dedicated bicycle infrastructure or amenities, and it was noted that bicyclists do use this road.

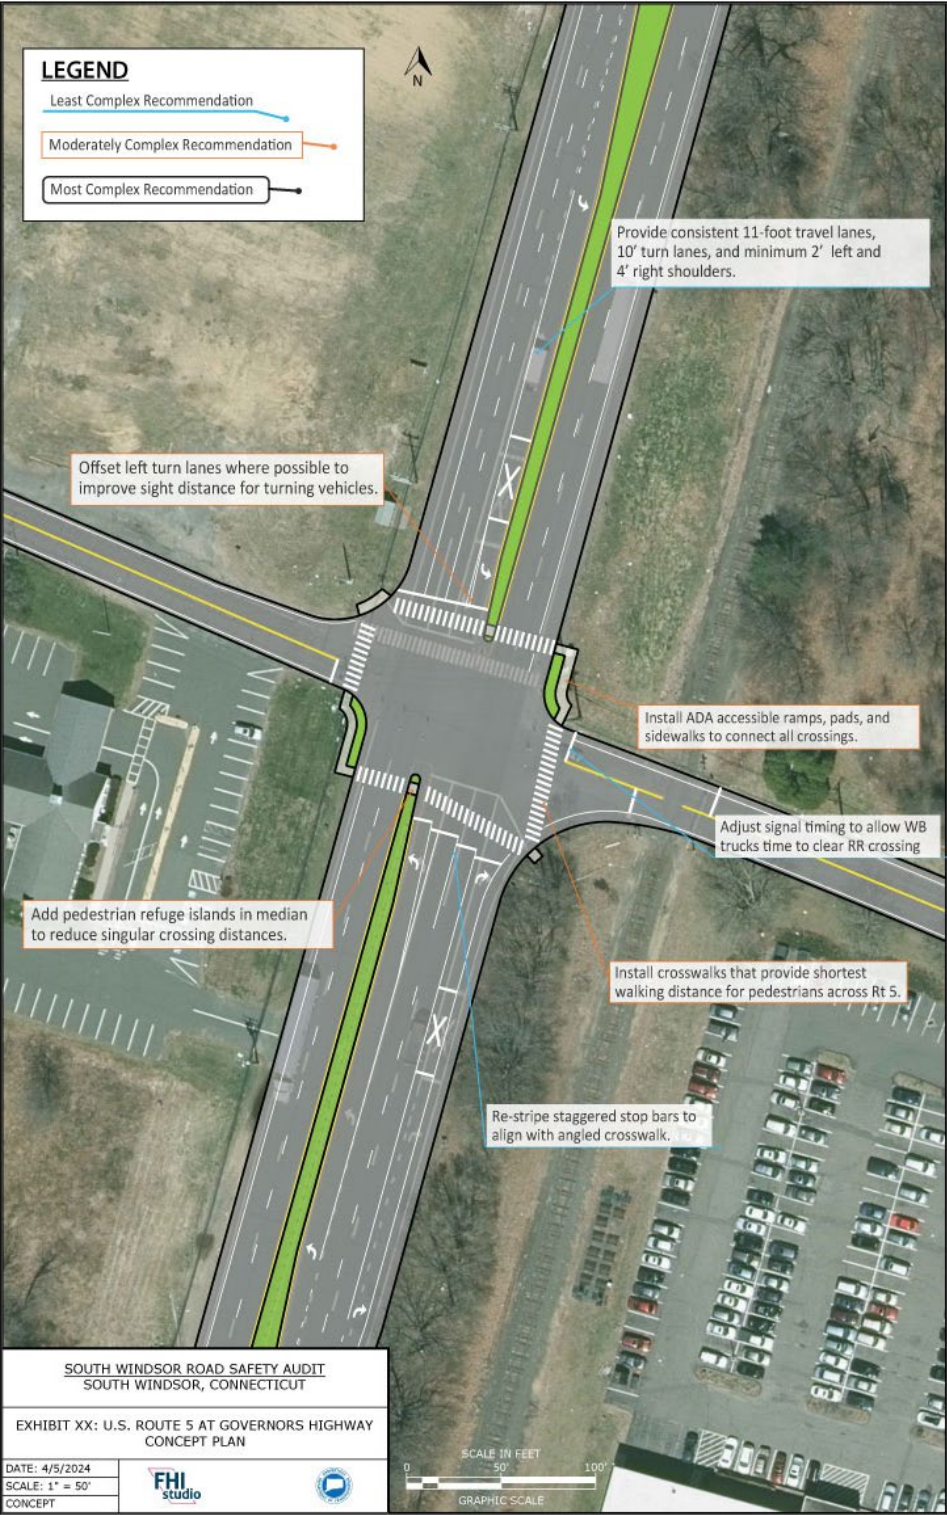
Exhibit 20: Representative Concept

- 1) Provide consistent 11' travel lanes, 10' turning lanes, and a minimum of 2' left and 4' right shoulders in order to reduce travel speeds and provide additional room for bicyclists. See Exhibit 20 for concept details.

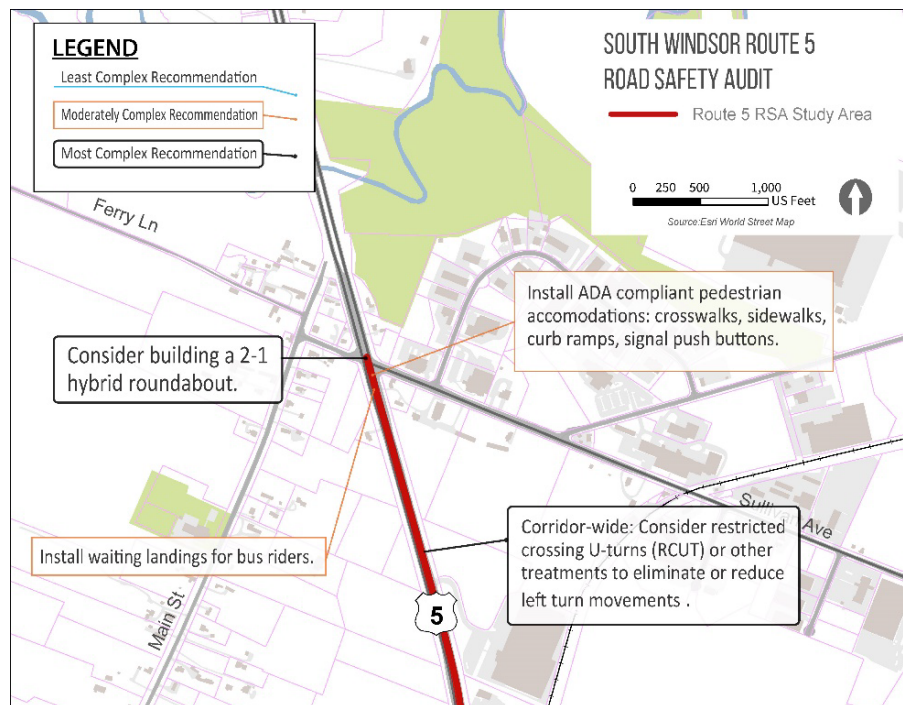
Exhibit 21: Sullivan Avenue Recommendations

The recommendations for the intersection of Route 5 and Route 194 (Sullivan Avenue) are focused on pedestrians, bicyclists, and transit users while maintaining capacity for the high vehicular volumes through the corridor. The Town of South Windsor has identified this intersection as a “neighborhood hub” in the POCD, which emphasizes the importance for accommodating network users of all modes. Exhibit 21 displays the recommendations for the area.

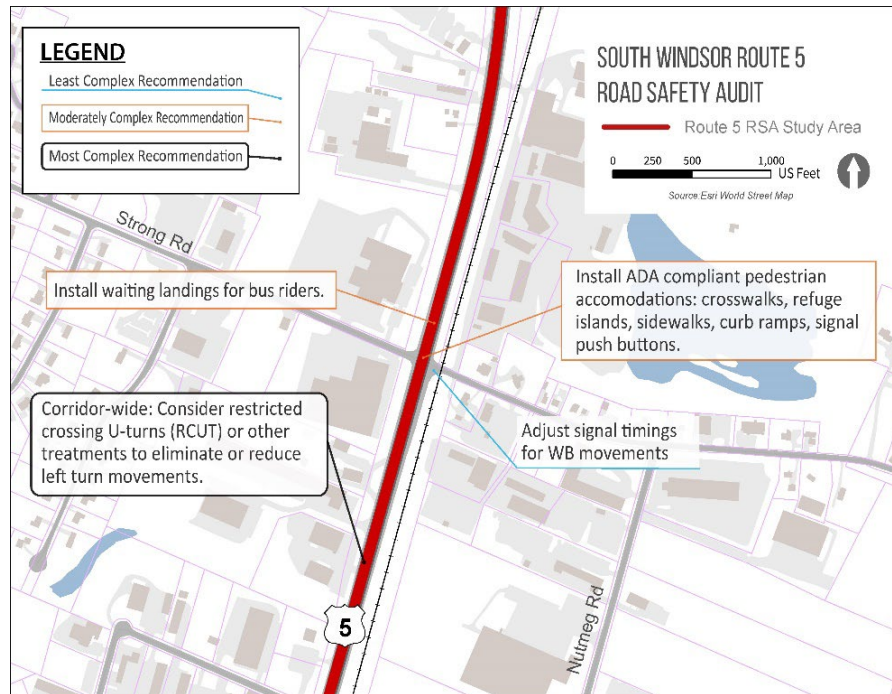
Exhibit 22: Strong Road Recommendations

The intersection at Strong Road is adjacent to the freight rail line that runs parallel to Route 5. The focus at this intersection is also on pedestrian facilities and increased safety. Exhibit 22 displays a map with the recommendations.

- 1) Adjust signal timings so that westbound traffic, particularly trucks, do not get caught between the at-grade railroad crossing and the intersection.
  - **Next Step:** LTA to send request to DOT.TrafficEngineering@ct.gov
- 2) Provide consistent 11' travel lanes, 10' turning lanes, and a minimum of 2' left and 4' right shoulders. See Exhibit 20 for concept details.
  - **Next Step:** LTA to send request to DOT.TrafficEngineering@ct.gov
- 3) Re-stripe staggered stop bars to align with angled crosswalk. See Exhibit 20 for concept details. CTDOT to provide 11-foot travel lanes with the next resurfacing project. Typical Vendor-In-Place paving (VIP) cycles can range between 10 and 20 years.
  - **Next Step:** Contact DOT.TrafficEngineering@ct.gov for more information

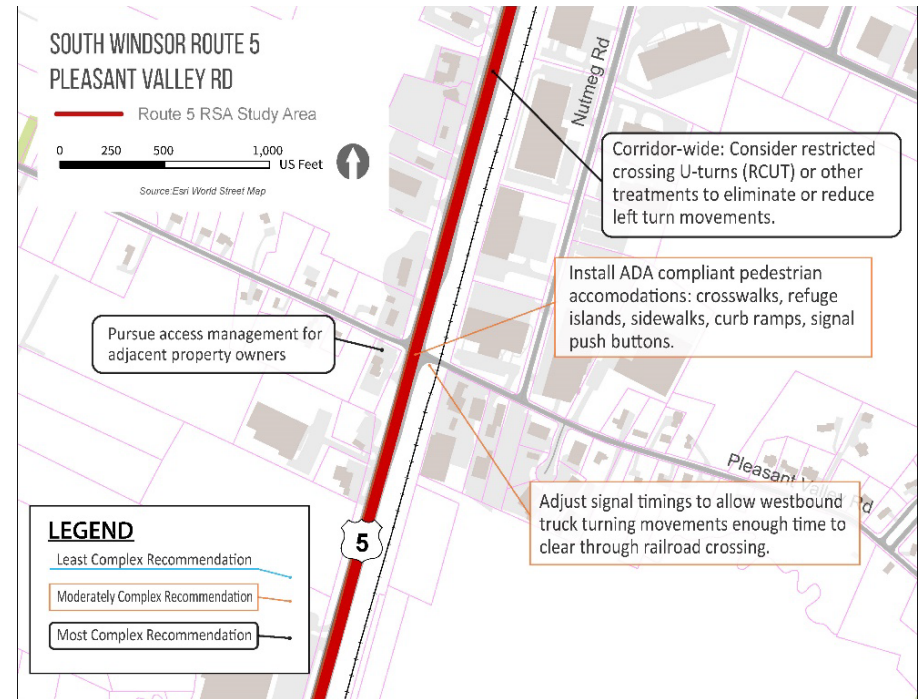
*Exhibit 23: Pleasant Valley Road Recommendations*

The recommendations at Pleasant Valley Road are like those at Strong Road and are shown below in Exhibit 23 but with an added emphasis on reducing the number of curb cuts and driveways. This intersection has been included in a state project for traffic signal improvements/replacement. Concerns and recommendations will be provided to the project engineer. Coordination will be required.

- 1) Adjust signal timings so that westbound traffic, particularly trucks, do not get caught between the at-grade railroad crossing and the intersection.
  - **Next Step:** Contact LTA to send request to DOT.TrafficEngineering@ct.gov
- 2) Provide consistent 11' travel lanes, 10' turning lanes, and a minimum of 2' left and 4' right shoulders. CTDOT to provide 11" travel lanes with the next resurfacing project. Typical Vendor-In-Place paving (VIP)

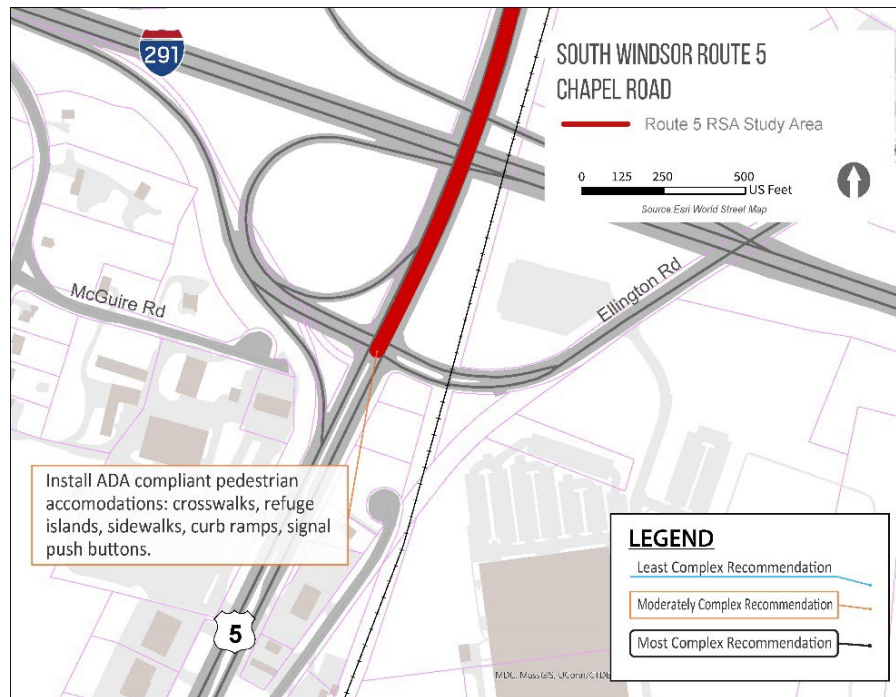
Exhibit 25: I-291 / Route 30 (Ellington Road) Recommendations

The intersection of Route 5 and Route 30 (Ellington Road) sees high volumes and many turning movements due to the I-291 eastbound ramps. There is no connection to a nearby sidewalk network, however there are pedestrian signal buttons. Recommendations at this intersection are focused on pedestrian safety and are shown in Exhibit 25.

- 1) Provide consistent 11' travel lanes, 10' turning lanes, and a minimum of 2' left and 4' right shoulders. CTDOT to provide 11-foot travel lanes with the next resurfacing project. Typical Vendor-In-Place paving (VIP) cycles can range between 10 and 20 years. See Exhibit 20 for concept details.
  - **Next Step:** Contact DOT.TrafficEngineering@ct.gov for more information
