# STONINGTON ROAD SAFETY AUDIT

US Route 1 (Stonington Road): Hewitt Road / Masons Island Road  
to Collins Road / Wamphassuc Point

NOVEMBER 2024

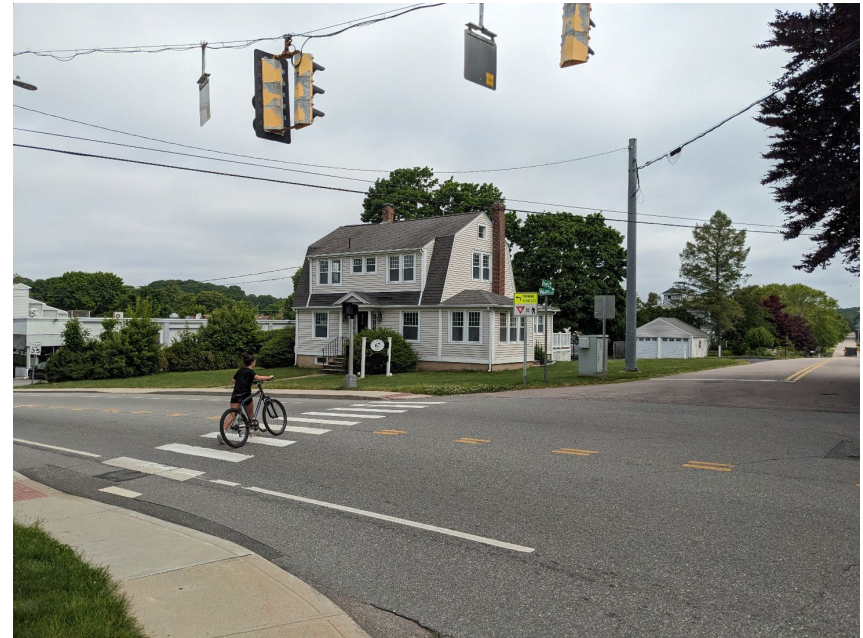
Exhibit 18: Bicyclist Using the Pedestrian Crossing Facilities

- The study team observed several pedestrians and bicyclists moving through the intersection, as shown in Exhibit 18.

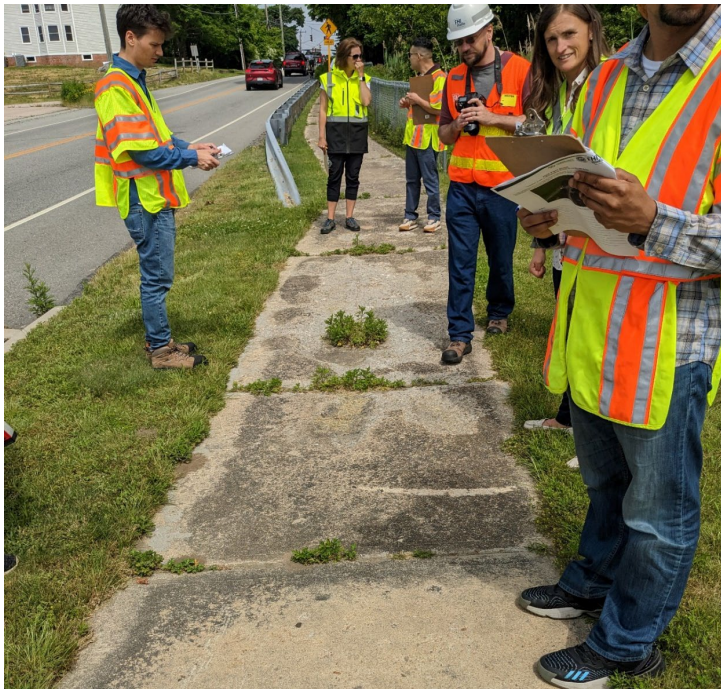
Exhibit 19: Sidewalk Condition on North Side of US Route 1

- This intersection (Intersection 137-228) is a signalized intersection that has a side street green.
- The overgrown vegetation continues into the shoulder on the northside of US Route 1.
- The sidewalk on the north side of US Route 1 is more than 30 years old and in poor condition, as displayed in Exhibit 19. As a result, the sidewalk is not ADA- compliant.

- 1) Repair or replace sidewalk on north side of US Route 1, west of Masons Island Road / Hewitt Road.
  - **Next Step:** Municipality to contact [Southeastern Connecticut Council of Governments](#) (SCCOG) for potential funding sources
  - **Next Step:** Municipality to check available ROW for feasibility
  - **Next Step:** Municipality to research and consider need for [Encroachment Permit](#)
- 2) Complete sidewalk on north side of US Route 1, east of Masons Island Road / Hewitt Road.
  - **Next Step:** Municipality to contact [SCCOG](#) for potential funding sources
  - **Next Step:** Municipality to check available ROW for feasibility
  - **Next Step:** Municipality to research and consider need for [Encroachment Permit](#)

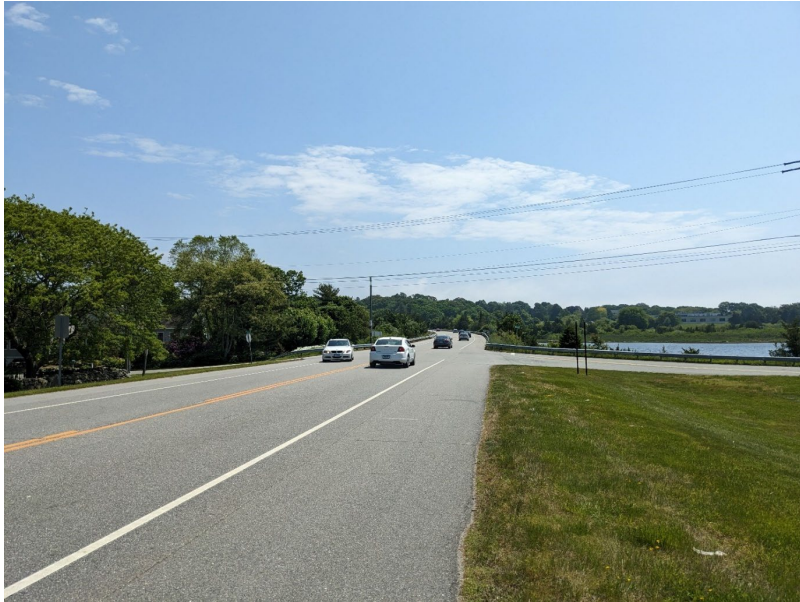
*Exhibit 21: High Speeds and Wide Shoulders Approaching Wilcox Road*

- 4.3 US Route 1 (Stonington Road) at Cove Road / Wilcox Road
- This area has a higher speed limit (45-50 MPH), and many drivers were observed to be traveling above it.
  - It is difficult to make a left turn out of Cove Road because of high speeds and limited visibility.
  - The shoulders are wide (more than six feet) at this location, as displayed in Exhibit 21.
  - There are no sidewalks or bicycle facilities in this area.
  - The number and location of culverts and drainage create challenges for a consistent sidewalk and bicycling network. The [Hazard Mitigation & Climate Adaptation Plan](#) provides additional information on this topic.

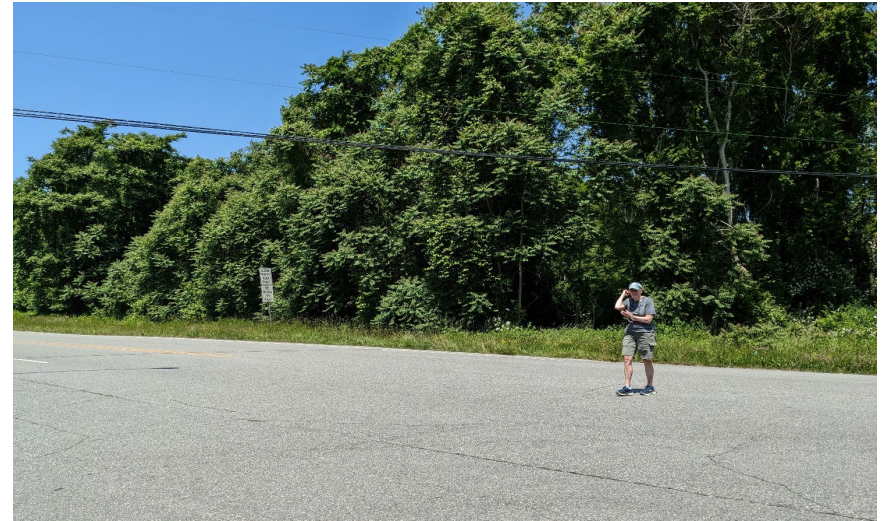
*Exhibit 22: Pedestrian Crossing US Route 1 at Lords Hill Road*

- Motorists travel at high speeds, especially heading eastbound down the hill.
- US Route 1 has centerline rumble strips in this location.
- There is a westbound climbing lane at this location.
- Visibility is poor for motorists. When turning onto US Route 1, the sightlines are poor from the side streets.
- The Town reported that many pedestrians cross US Route 1 at this location. A pedestrian crossing US Route 1 is displayed in
