# West Hartford Road Safety Audit

Route 44 (Albany Avenue): North Main Street to Prospect Avenue

APRIL 2025

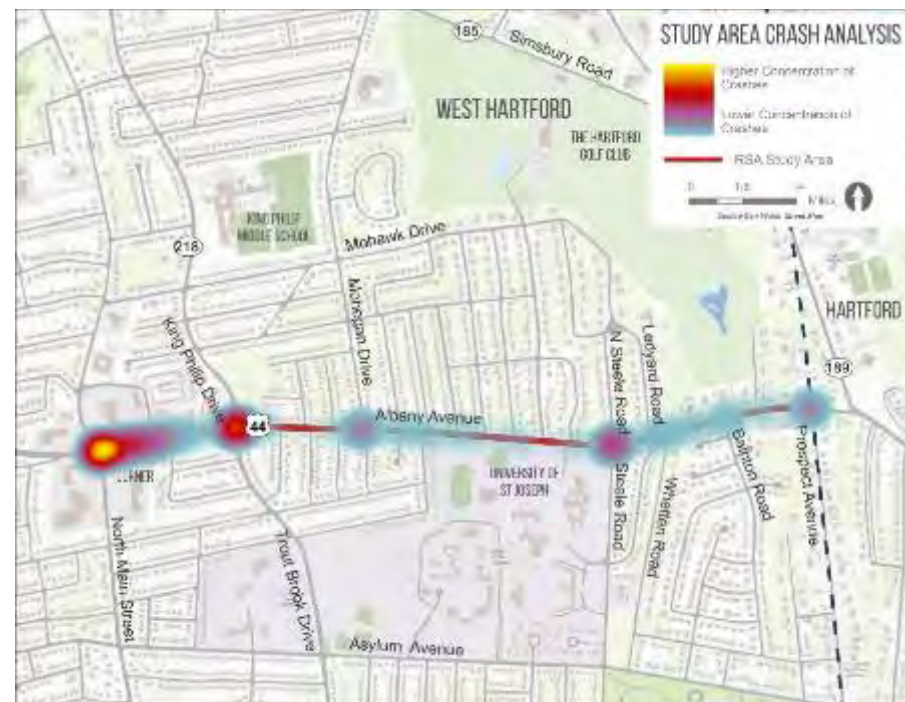
Exhibit 12: Study Area Crash Heatmap

**Crashes by Type:** Most crashes were angle and front-to-rear (rear end) types. Angle crashes are typical in areas with ingress / egress movements at property entrances. Front-to-rear crashes occur most commonly at intersections where cars are queued to make turning movements. Exhibit 13 displays crashes by type and severity. Exhibit 14 displays a map of crashes by location and type in the corridor.

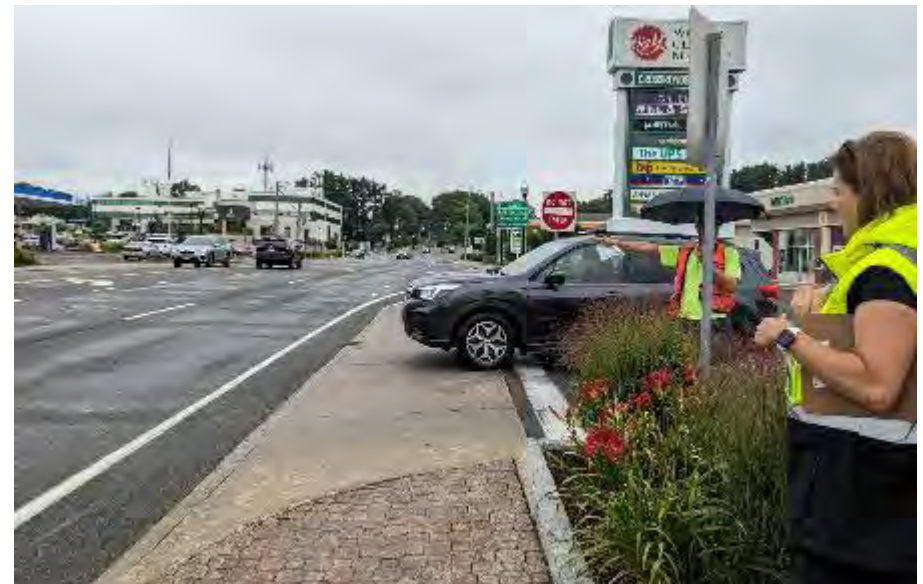
*Exhibit 19: Driver Making a Left Turn onto Route 44*

- The left ingress and egress turns to and from the east driveway on the north side of Route 44 are difficult as show in Exhibit 19.
- There are right turns occurring during pedestrian crosswalk phases at the intersection.
- The many curb cuts and driveways in the vicinity increase the number of conflict points on the road.
- The southwest corner of the intersection with Starkel Road has uneven pavement and the sidewalk in this area shows wear.

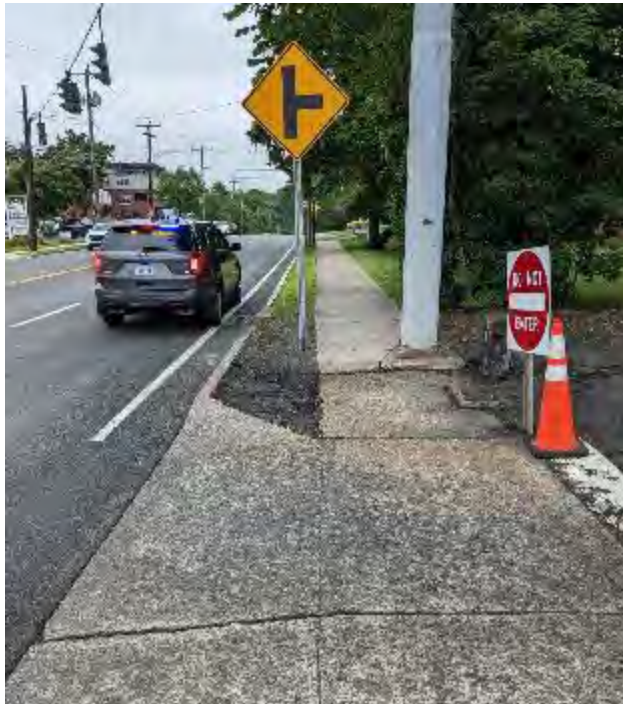
*Exhibit 20: Damaged Sidewalk and Driveway Apron*

- Big Y is changing ownership which could open an opportunity for access management.
- Sidewalk and driveway aprons show wear in many locations, with heaving pavement and damage at the entrance to Crown Market, as displayed in Exhibit 20.

| Recommendation | Location | | | | | |
|---|---|---|---|---|---|---|
| Repair existing sidewalks in poor condition | • | | | | | |

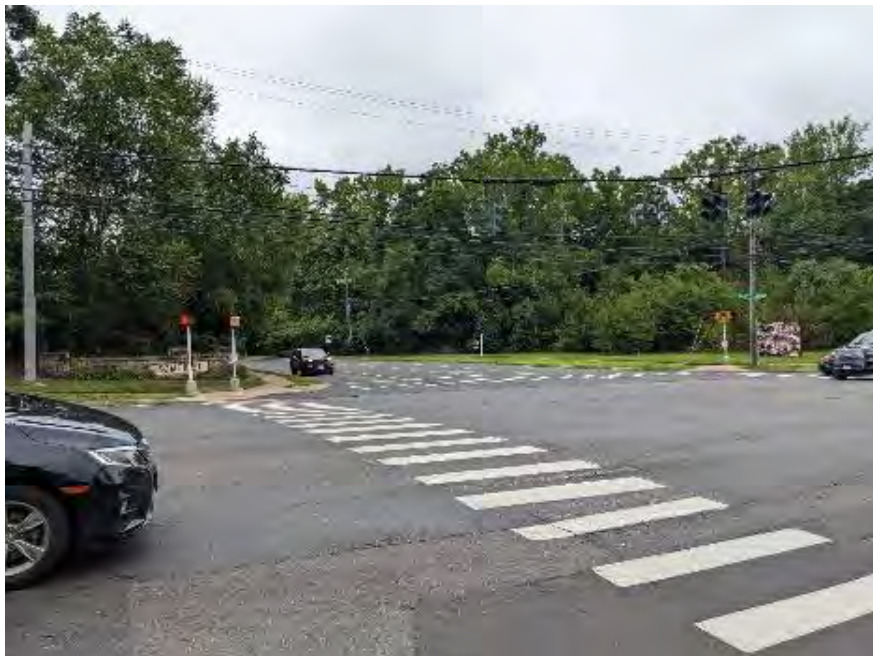
*Exhibit 22: Long Crossing Distance at Intersection*

- Pedestrian crosswalk distances are notably long, as displayed in Exhibit 22.
- The sidewalk in this area narrows to 4' and is often overgrown with grass or in generally poor condition, as shown in Exhibit 23.
- Eastbound red-light running is common due to high speeds as drivers travel downhill towards the traffic signal.
- Lighting is poor between King Phillip Drive/Trout Brook Drive and Mohegan Drive.
- Right turns often occur during pedestrian crosswalk phases.
- A road diet was discussed east of Trout Brook Drive on Route 44.
- Southbound approach does not have a protected left turn arrow.

- 1) Install pedestrian facilities and additional crosswalk legs at signalized intersections.
  - **Next Step:** Town may apply to install ADA compliant ramps and additional pedestrian facilities via [Encroachment Permit](#)
  - **Next Step:** Contact LTA to coordinate with [DOT.TrafficEngineering@ct.gov](mailto:DOT.TrafficEngineering@ct.gov)
- 2) Repair existing sidewalks in poor condition.
  - **Next Step:** Municipality may apply for an [Encroachment Permit](#) through the District 1 permit office
  - **Next Step:** Contact LTA to coordinate with [DOT.TrafficEngineering@ct.gov](mailto:DOT.TrafficEngineering@ct.gov)
  - Consider looking applying for the Community Connectivity Grant Program.

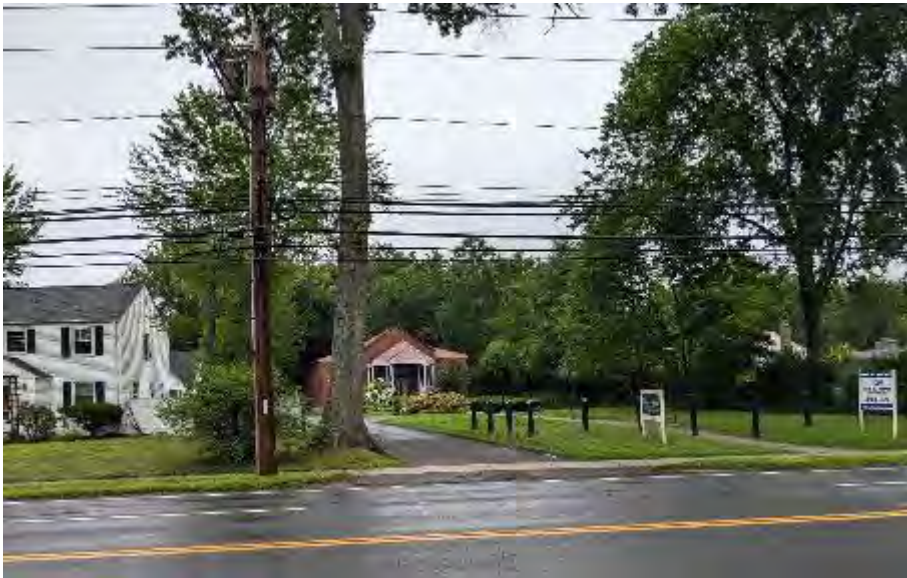
*Exhibit 24: Lack of Pedestrian Scale Lighting*

- Sidewalk conditions on both sides of Route 44 (Albany Avenue) are in generally poor condition.
- High-risk lane weaving was noted in this area.
- Lighting is poor for pedestrians. There are many shadows cast and generally poor visibility in the area, as displayed in Exhibit 24.
- A pedestrian recall phase was requested at the crosswalk due to proximity to a synagogue. Many members live on the south side of Route 44 and cross to the north side of the street to access the synagogue. They often cross where it is most convenient and do not travel all the way to the signal before crossing. The signalized crosswalk is displayed in Exhibit 25.

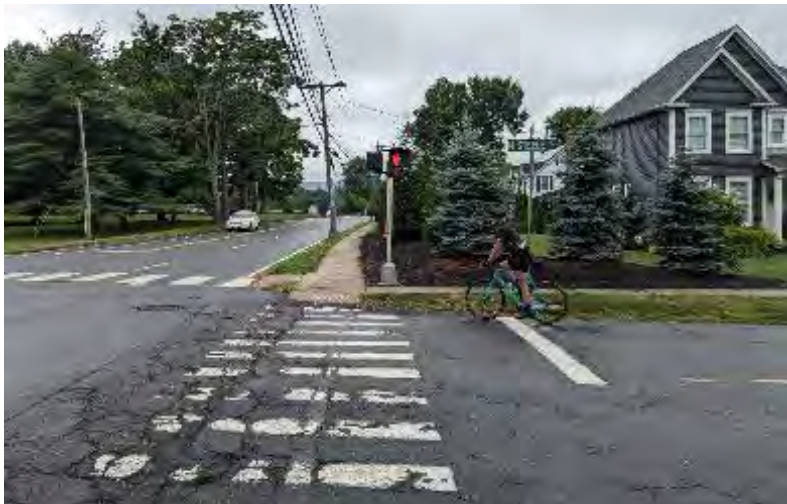
*Exhibit 26: Lack of Sidewalk and Narrow Shoulder on South Side of Route 44*

- There is a gap in the sidewalk network on the south side of Route 44 that begins at Whetten Road. The shoulder is narrow, and vegetation encroaches into the roadway, as shown in Exhibit 26.
- There are transit stops that show evidence of use, as displayed in Exhibit 27. Many lack amenities and/or are not ADA-compliant. One example includes the eastbound bus stop at St. Mary's, which has a bus shelter with a bench, but no direct sidewalk connection to the bus stop.
- Town officials noted that spectators attending sports games at the University of St. Joseph often park on street in the residential neighborhoods north of Route 44 such as Sequin Road and Brainard Road.

- 4) Install sidewalk in missing locations on south side of Route 44 (Albany Avenue), particularly in the area between Mohegan Road and Bainton Road.
  - **Next Step:** Town may apply to install additional pedestrian facilities via [Encroachment Permit](#)

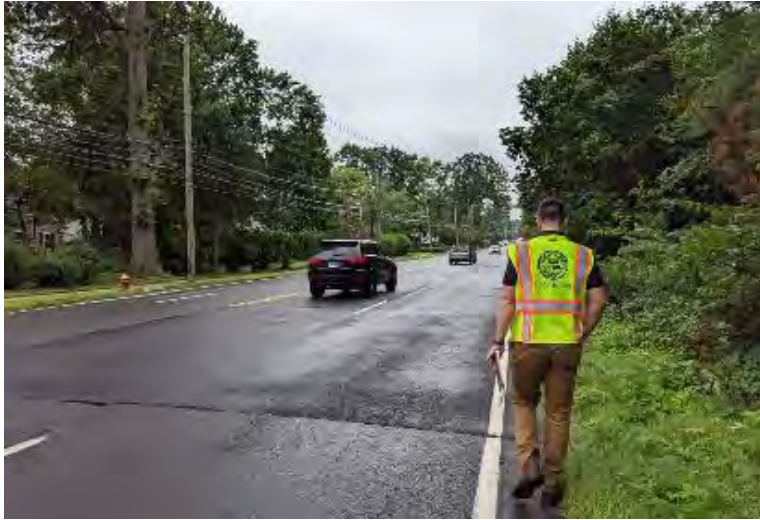
*Exhibit 28: Steele Road is a Common Bicyclist Route*

- There is a large setback on the frontage of the University of St. Joseph campus, as shown in Exhibit 28.
- Many bicyclists utilize Steele Road as a north-south route in town. Exhibit 29 displays a picture of a bicyclist in the corridor.
- Participants stated that many motorists turn left from Route 44 (Albany Avenue) westbound to Steele Road southbound. This causes frequent lane weaving from through vehicles.
- Participants stated that the vertical curve east of Steele Road presents sight distance concerns, especially for westbound motorists approaching Steele Road.

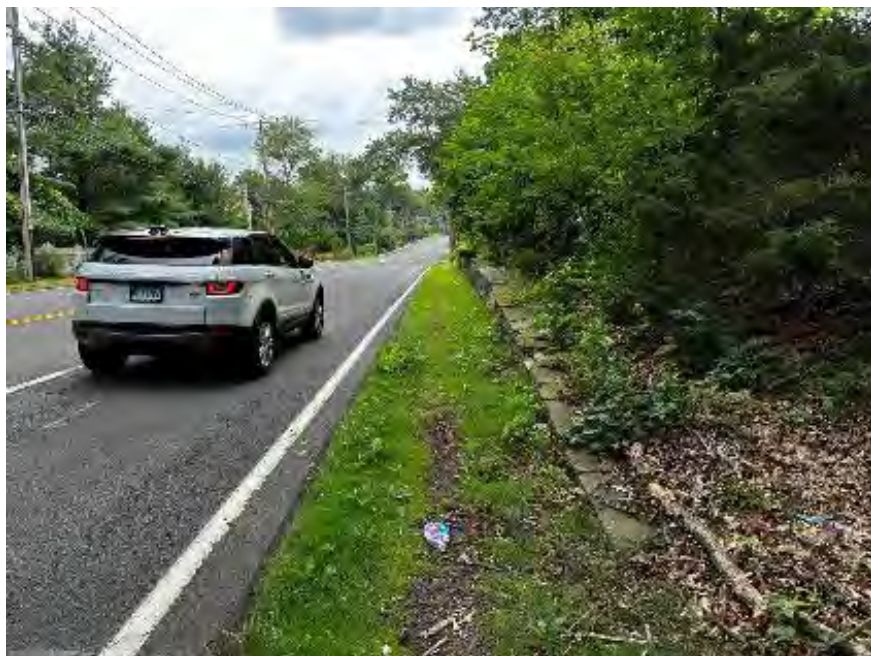
*Exhibit 30: Lack of Sidewalk and Downhill Grade*

- High vehicular speeds were noted in this location, particularly in the eastbound direction which has a downhill grade.
- There is a lack of sidewalk on the south side of Route 44 in this location, as shown in Exhibit 30.

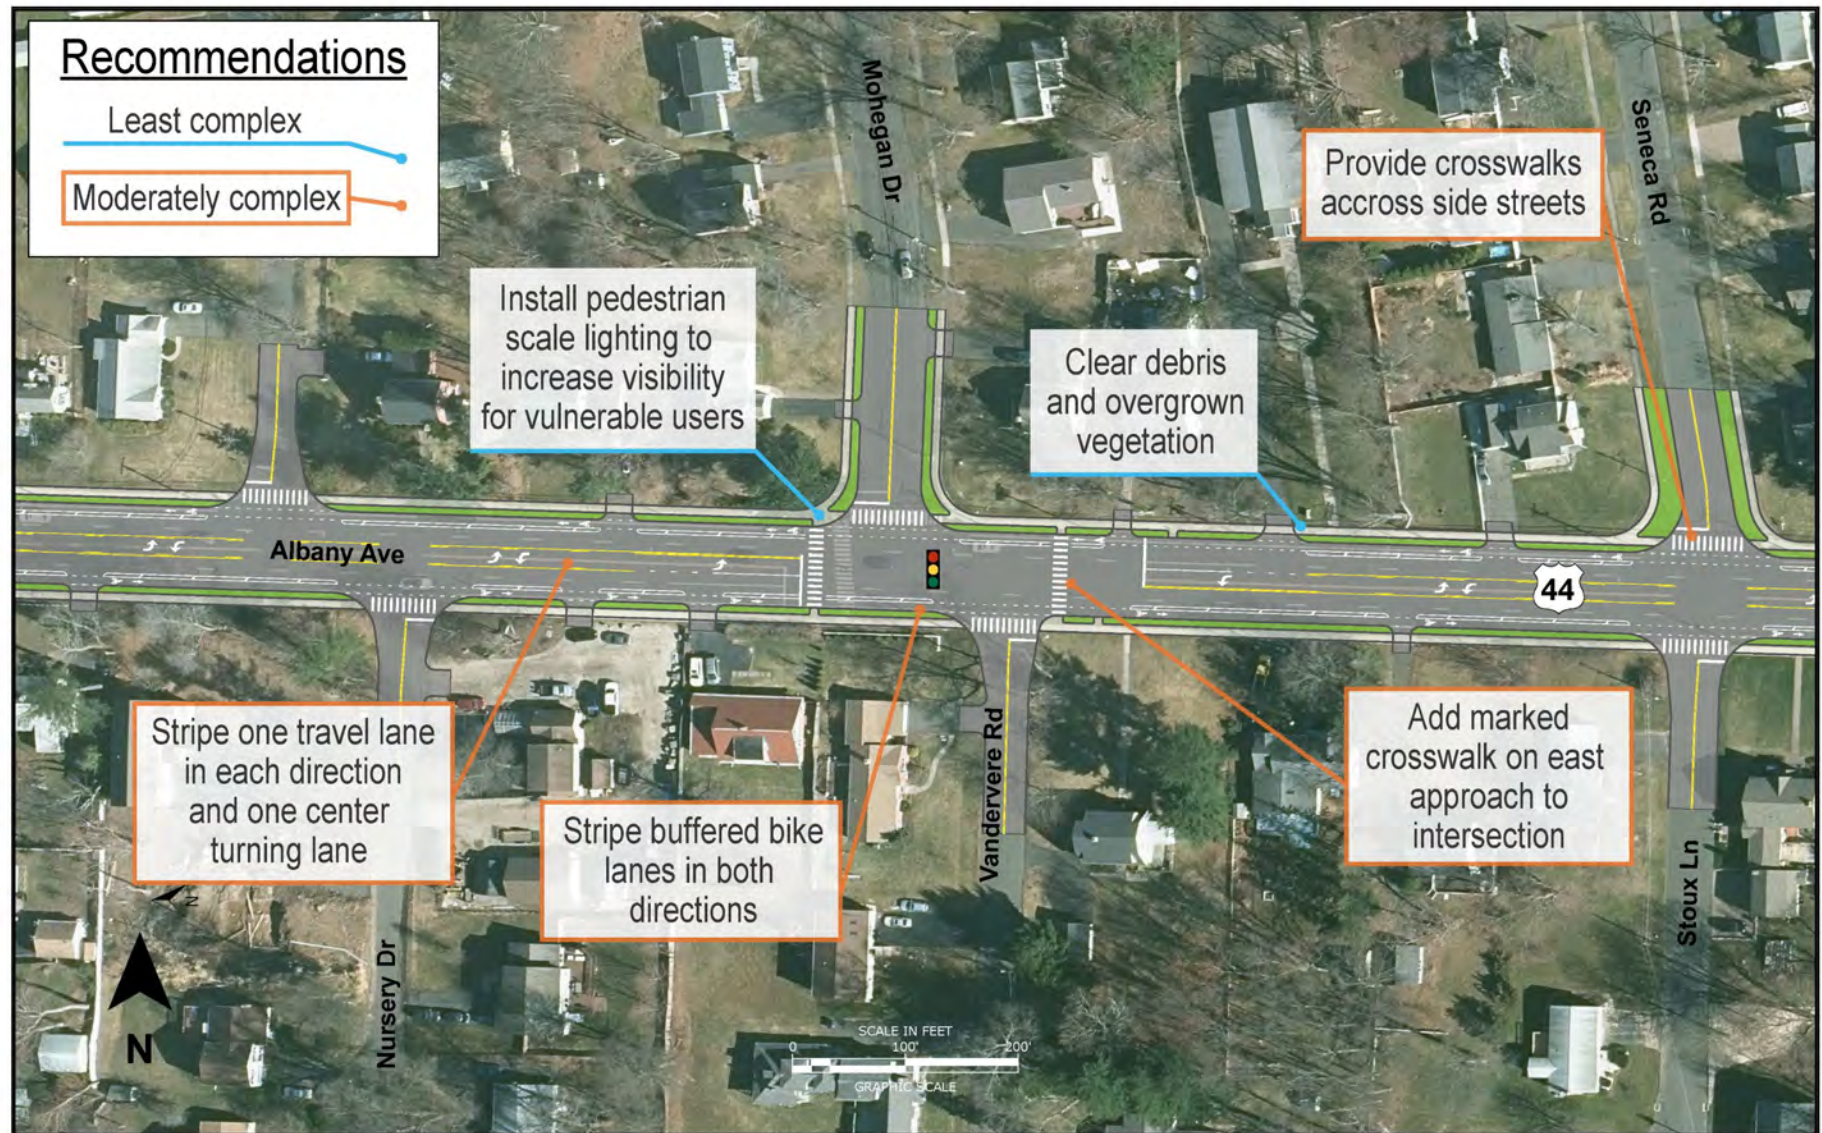
Exhibit 32: Representative Center Concept #1

A table of recommendations organized by location is presented in Exhibit 31. Two concept drawings of the center segment of the roadway are presented in Exhibit 32 and Exhibit 33.

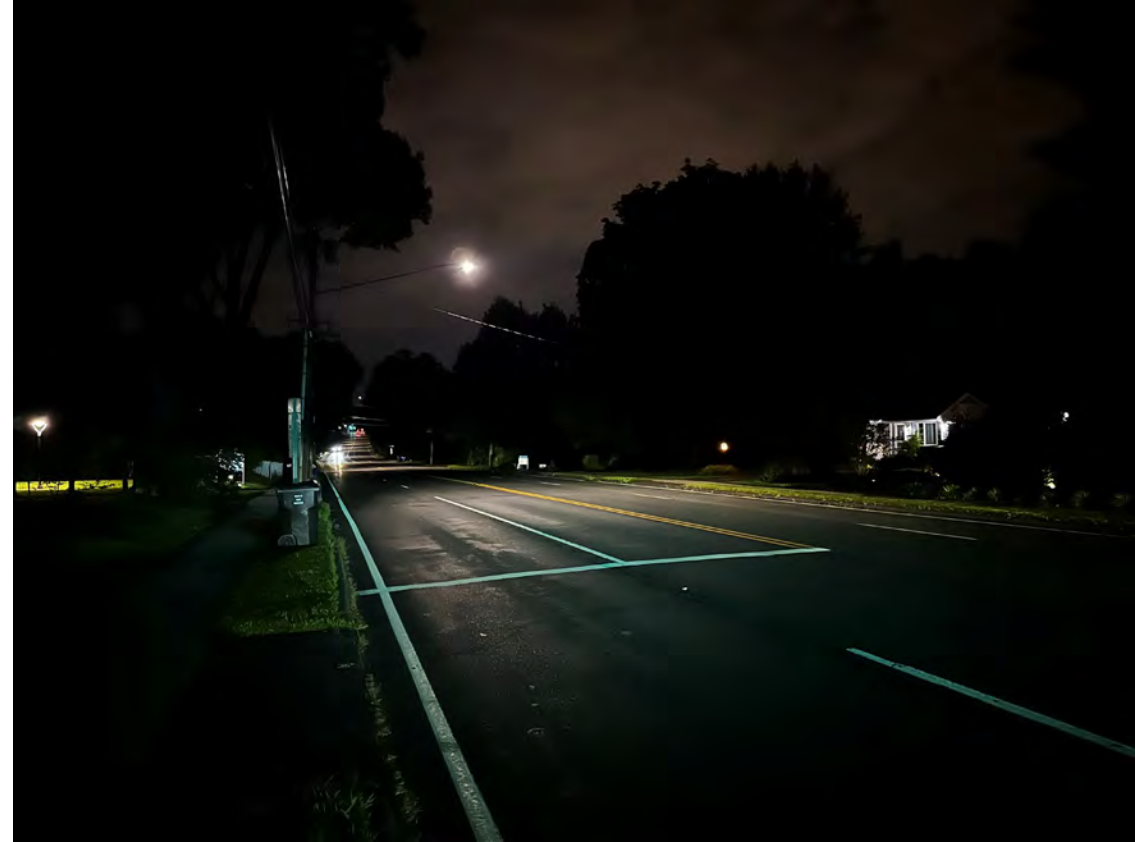
*Route 44: View east from Mohegan Dr  
Source: Town of West Hartford*

- Route 44 at Seneca Rd, NW Corner: 1.03 lux (horizontal)
- Route 44 between street lights: 0.01 lux (horizontal), 0.2 lux (vertical)
- 2240 Albany Ave, north curb: 1.8 lux (horizontal)
- Route 44 at Mohegan Dr, NE corner: 0.1 lux (horizontal), 0.25 lux (vertical)
