# West Haven Road Safety Audit

Route 705 (Ocean Avenue): Route 162 (Jones Hill Road)  
to South Street

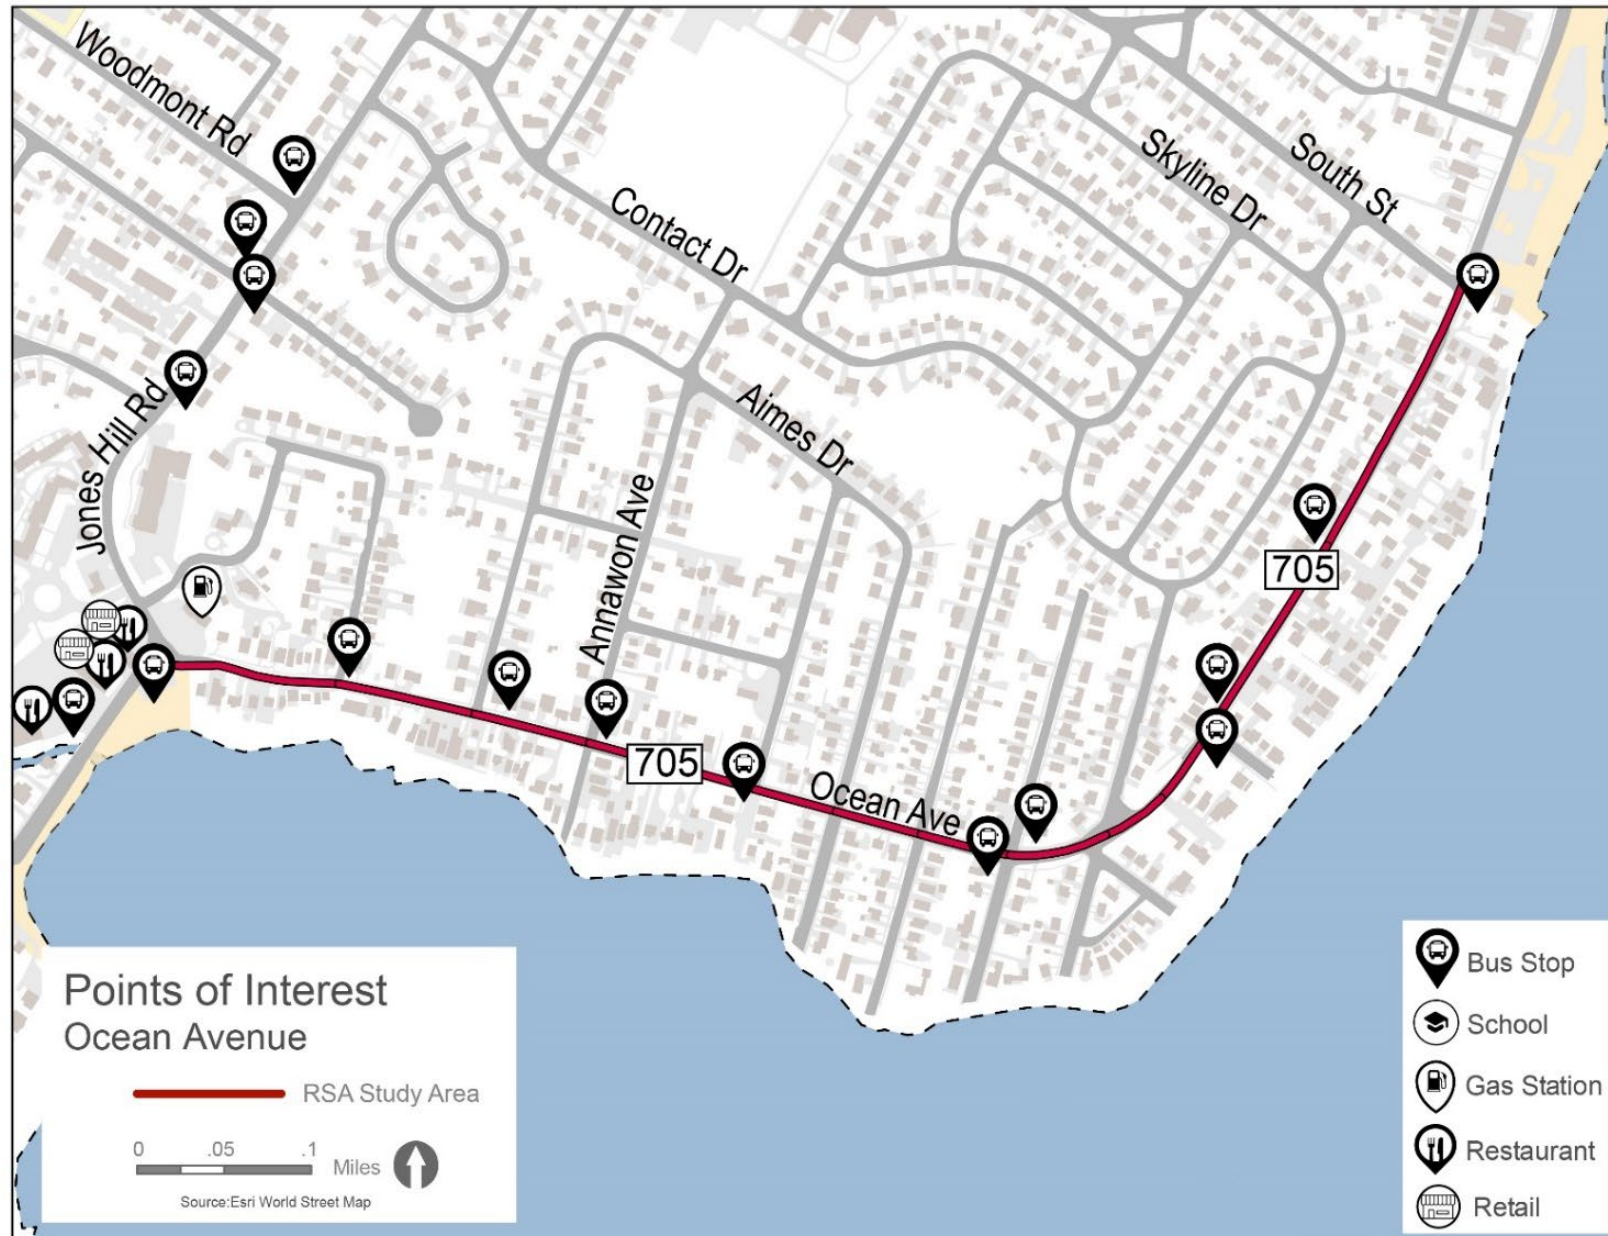
Exhibit 3: Study Area Points of Interest

Route 705 (Ocean Avenue) is a dynamic corridor with many points of interest on the west side of the study area, has several bus stops for bus Route 271 Kimberly Avenue, and is used heavily by bicyclists. The Route 705 study area contains access to businesses, restaurants, residential areas, Seth Haley School, and beaches. Pedestrians and bicyclists use the Route 705 corridor to access the beaches, homes, and businesses in the area. Exhibit 3 displays points of interest located along the corridor.

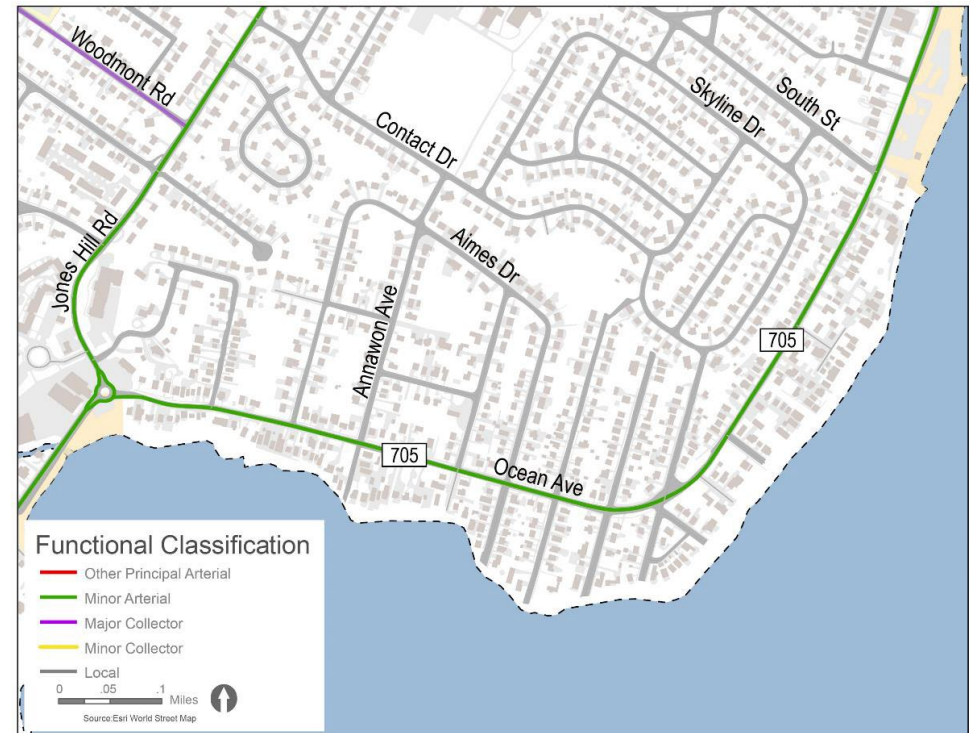
Exhibit 4: Functional Classification

Route 705 is classified as a minor arterial roadway, as displayed in Exhibit 4, which is typically used for vehicle trips of moderate distance and slower speeds. The study area intersects with many minor arterial roads. The study area serves a wide variety of network users including pedestrians / bicyclists, bus transit riders, vehicle commuters, business employees and patrons, and delivery drivers. Exhibit 5 displays the roadway geometry.

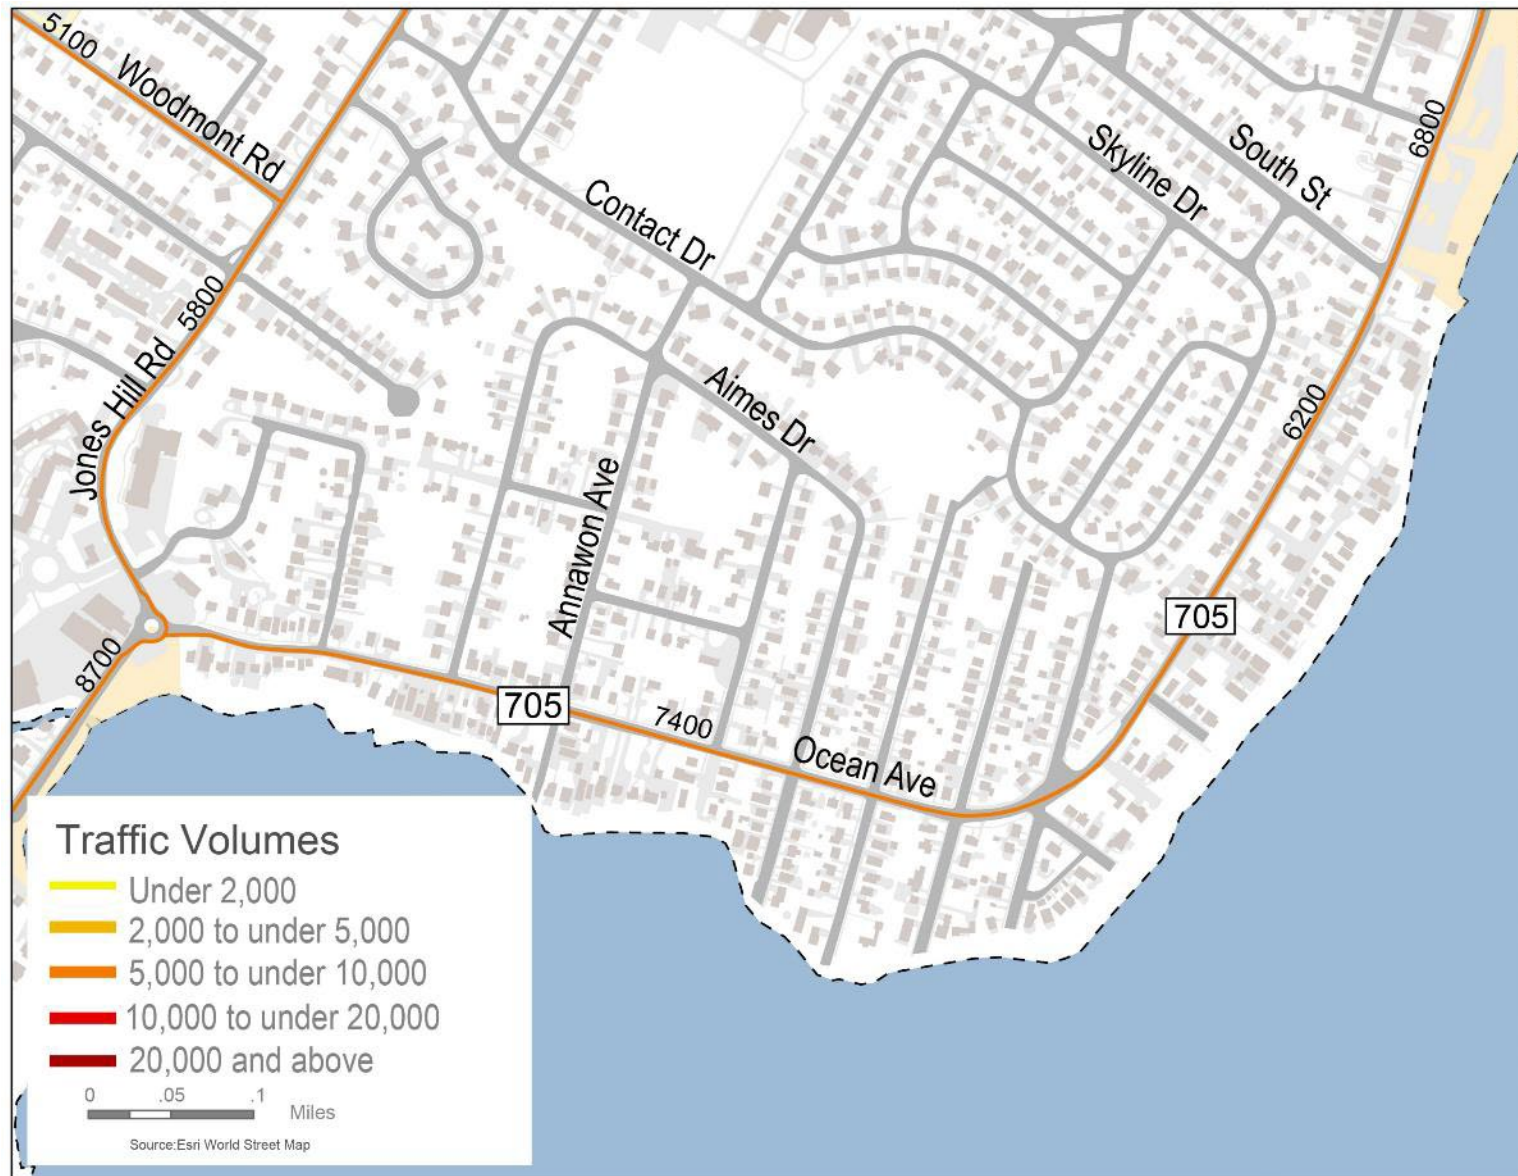
Exhibit 6: Average Daily Traffic Volumes

Average Annual Daily Traffic (AADT) collected in the study area ranges between 6,200 and 8,700 vehicles per day, with the highest volumes seen at the center of the study area between Nichols Street and Berkshire Avenue. Exhibit 6 displays daily traffic in the study area.

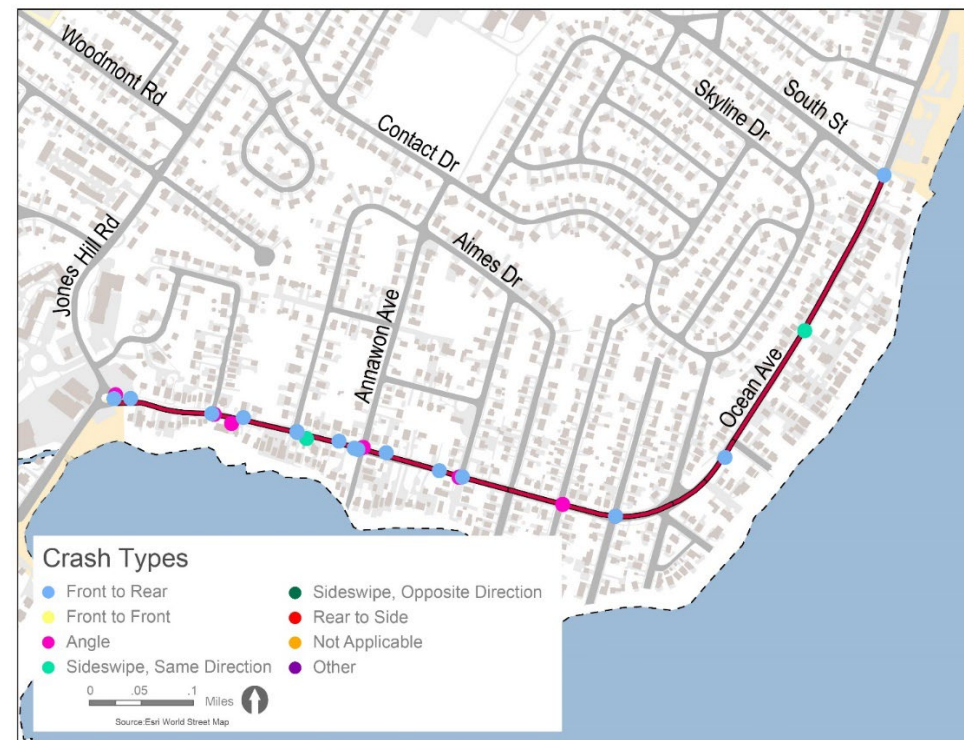
Exhibit 11: Crashes by Type

**Crashes by Type:** Most crashes were angle and front-to-rear types. Angle crashes are typical in areas with ingress / egress movements at property entrances. Front-to-rear crashes occur most commonly at intersections where cars are queued to make turning movements. Exhibit 10 displays crashes by type and severity. Exhibit 11 displays a map of crashes by location and type in the corridor.

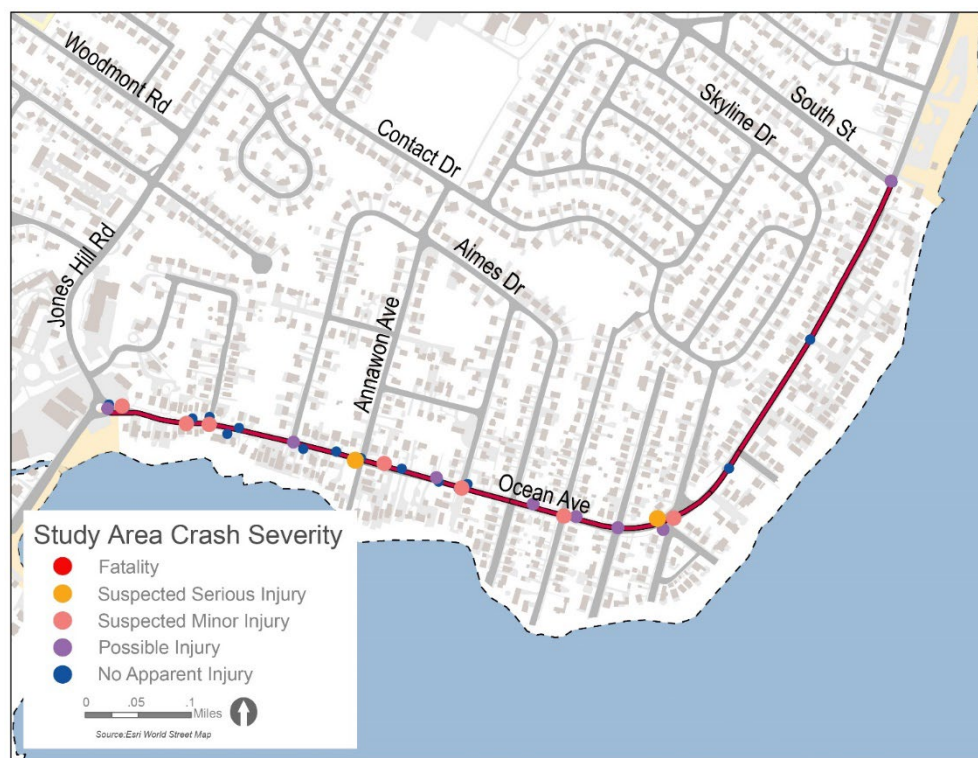
Exhibit 12: Crash Severity by Location

**Crash Severity:** Most reported crashes (28) were classified as no apparent injury crashes. Of these reported crashes, there were two (2) suspected serious injury crashes. Exhibit 12 displays the severity of crashes and their locations.

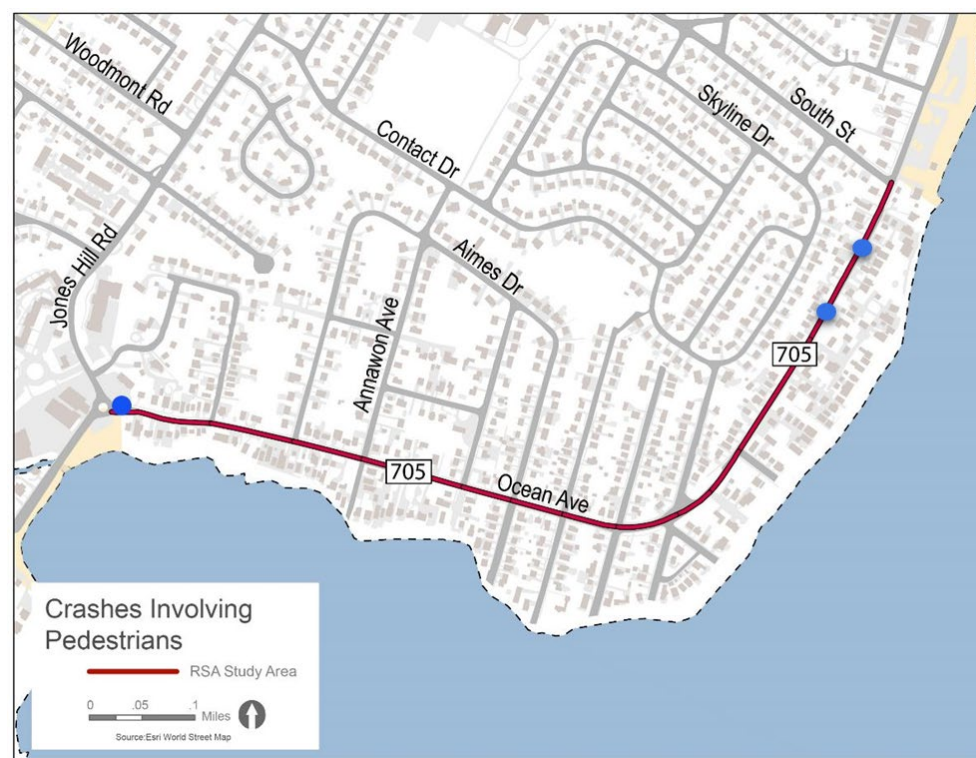
Exhibit 13: Crashes Involving Pedestrians (2017 - 2024)

**Crashes by Involved Person:** There was one (1) reported crash involving pedestrians in the six-year period of 2017-2022. In 2024, there were two (2) additional suspected serious injury pedestrian-involved crashes in the eastern portion of the corridor. Exhibit 13 displays the locations of crashes involving pedestrians, including those that occurred in 2024.

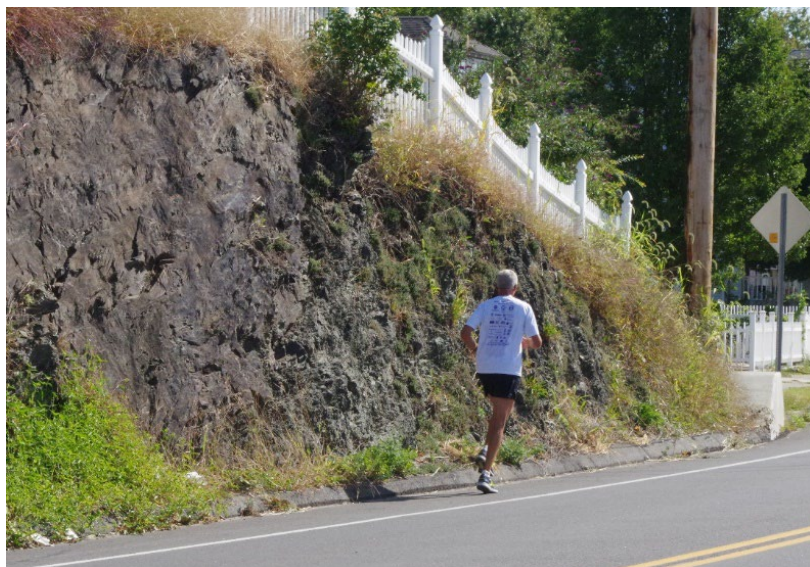
*Exhibit 16: Elevated Sidewalk (View East) on South Side of Route 705*

- The roundabout at Route 162 (Jones Hill Road) was constructed in 2009. The roundabout is not built to the current design standards and could benefit with additional curb on the approaches.
- West Haven Police Department representatives stated that the luminaires at the roundabout do not work.
- Participants stated that pedestrians avoid the elevated sidewalk on the north side of Route 705 (Ocean Avenue) and use the narrow roadway shoulder instead. The team observed this during the site visit. The sidewalk is narrow, not ADA-compliant, and overgrown with vegetation. Exhibit 16 and Exhibit 17 display the elevated sidewalk on the north side of Route 705 (Ocean Avenue).

- 1) Repair / replace sidewalk in areas of disrepair.
  - **Next Step:** Municipality to coordinate with adjacent property owners for access management
  - **Next Step:** Municipality to consider applying for an [Encroachment Permit](#) through the District permit office

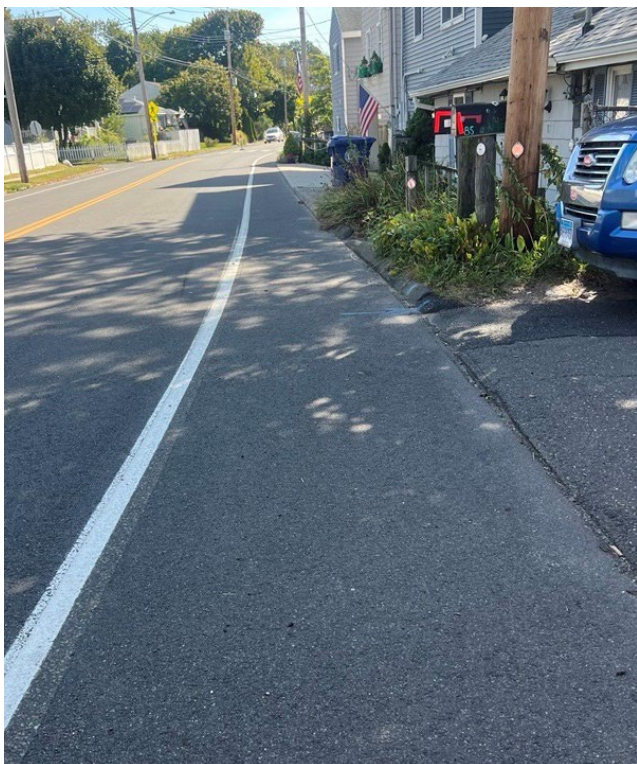
*Exhibit 18: Southern Shoulder (View East)*

- The southern shoulder of Route 705 (Ocean Avenue) narrows when traveling to the east and creates a constraint. Exhibit 18 displays this shoulder.
- There is a sidewalk gap at the gas station driveway near the Route 162 (Jones Hill Road) roundabout. A pedestrian was struck here. Exhibit 19 shows the sidewalk gap walking from the elevated sidewalk on the north side of Route 705 (Ocean Avenue) towards the roundabout.

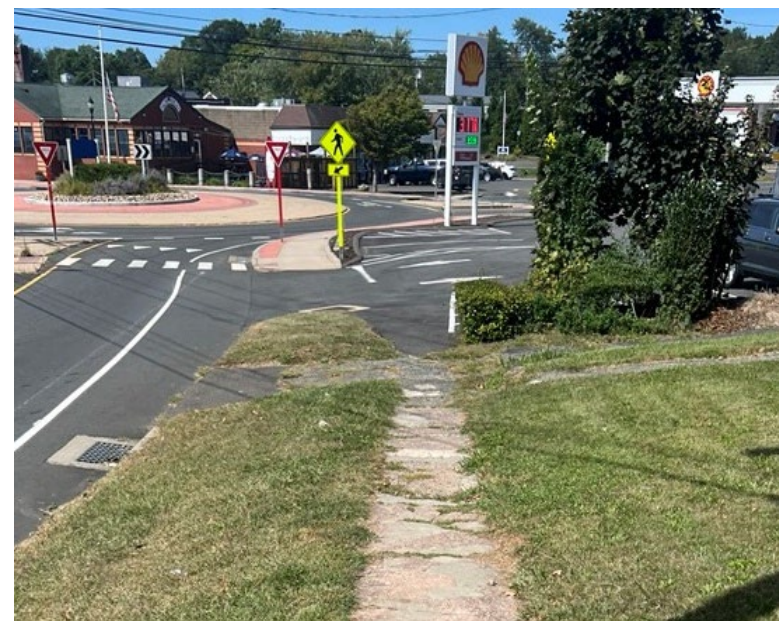
*Exhibit 19: Pedestrian walking East on Route 705 Shoulder*

- The vegetation is overgrown, and trimming is needed in several areas, particularly near the Nashawena Avenue intersection.
- The sidewalk on the southern side is discontinuous east of Oyster River Beach. Exhibit 20 shows a pedestrian walking on the shoulder of the road.
- In the westernmost portion of the corridor, the grade of properties and driveways on both sides of Route 705 (Ocean Avenue) will likely be a constraint to constructing a sidewalk. The

roadway elevation is lower than several properties, driveways, and garages.

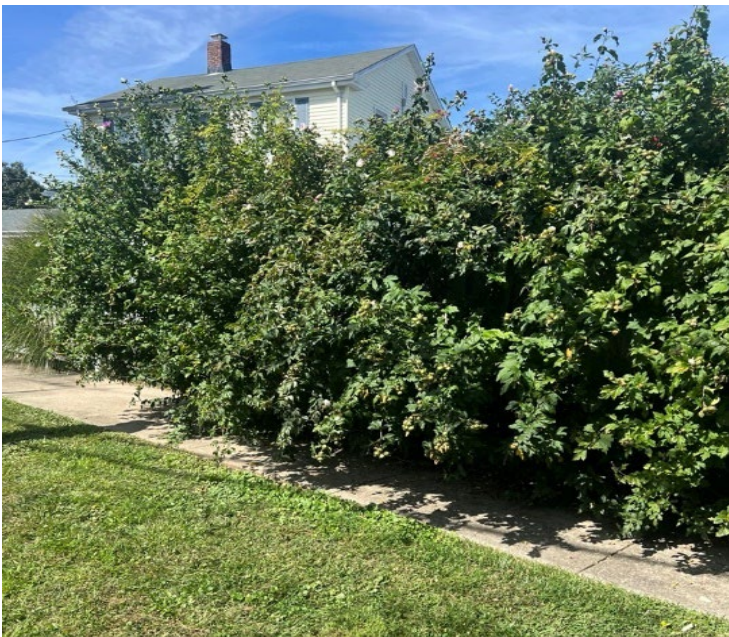
*Exhibit 22: Vegetation on Morris Street Sidewalk*

- Participants suggested constructing a raised crosswalk at Annawon Avenue. Many cross here and it isn't safe because of driver speeds.
- There is poor visibility at the Holcomb Street crosswalk.
- The vegetation is overgrown and trimming is needed on Route 705 (Ocean Avenue), particularly on the west side of Morris Street. Exhibit 22 displays shrub overgrowth on the sidewalk.
- The left curve sign at Baldwin Street is visibility blocked by a tree. Exhibit 23 displays RSA participants near the tree obstructing the curve sign.

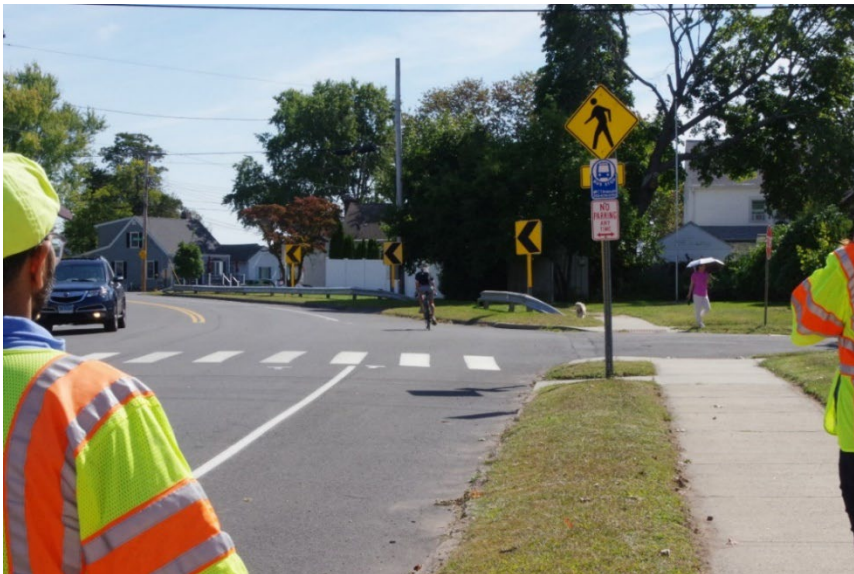
*Exhibit 24: Missing Chevron Sign at Morris Street Curve*

- There are missing chevron markings at the curve near Morris Street. The height for the chevron signs is low and not installed to the current design standard. Exhibit 24 shows three left curve signs approaching the curve.
- The south side guiderail is also low, and not installed to the current design standard. Exhibit 25 shows a guiderail that is lower than standard at the curve.
- The dynamic speed limit sign located on the north side of Route 705 (Ocean Avenue) near Trumbull Street is on the shoulder and can be hazardous to bicyclists. Exhibit 26 shows the current placement of the sign.

- 3) Install missing chevron signs at curve near Morris Street.
    - **Next Step:** LTA to send request to [DOT.TrafficEngineering@ct.gov](mailto:DOT.TrafficEngineering@ct.gov) for review of signing.

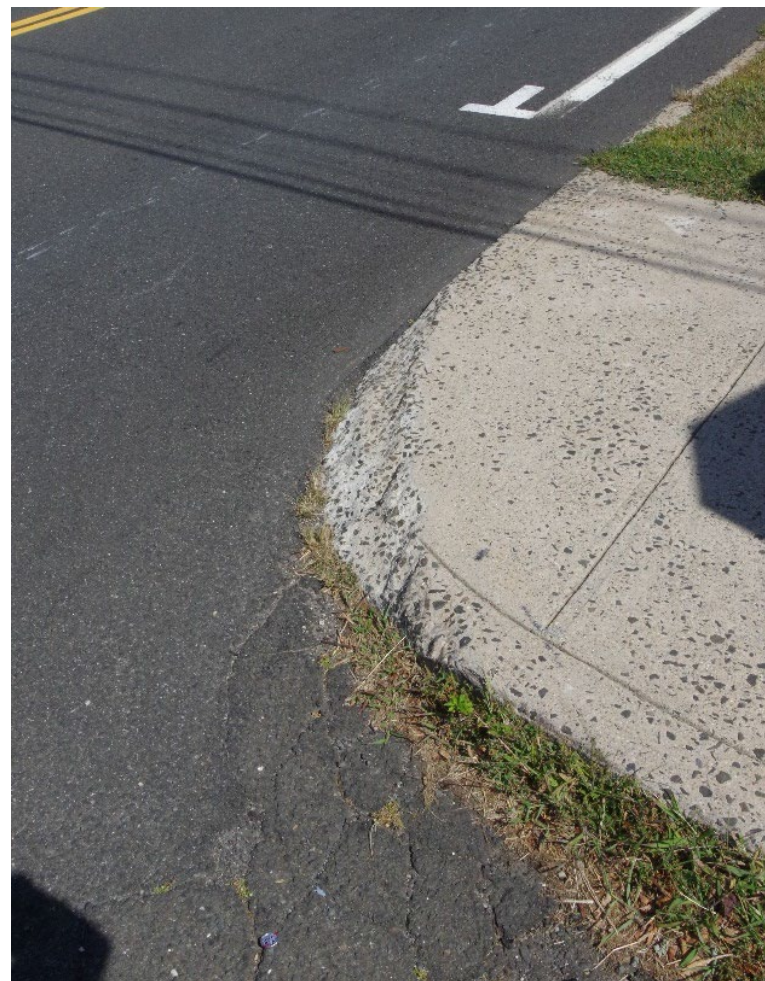
Exhibit 27: Curb at Roberts Street

- The Roberts Street intersection pedestrian ramps are deteriorated. Exhibit 27 shows the poor conditions of the curb and landing.
- There are no sidewalks on several areas of the corridor in this section including the north side between Woodruff Street and Woody Crest, the south side between Annawon Avenue and Trumbull Street, and the south side between Morris Street and Woodruff Street.
- The crosswalk at Woodruff Street is not ADA-compliant. It needs a curb on the southeast corner and repairs on the southwest corner.

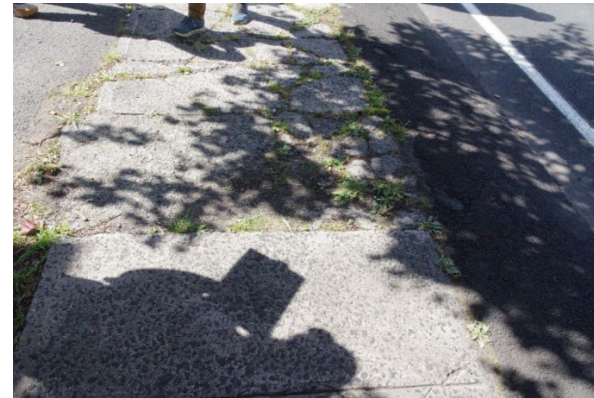
*Exhibit 28: Sidewalk near Woody Crest Avenue*

- The sidewalk at Woody Crest is in poor condition, with an uneven surface and multiple cracks with vegetation in the cracks. This is displayed in Exhibit 28.

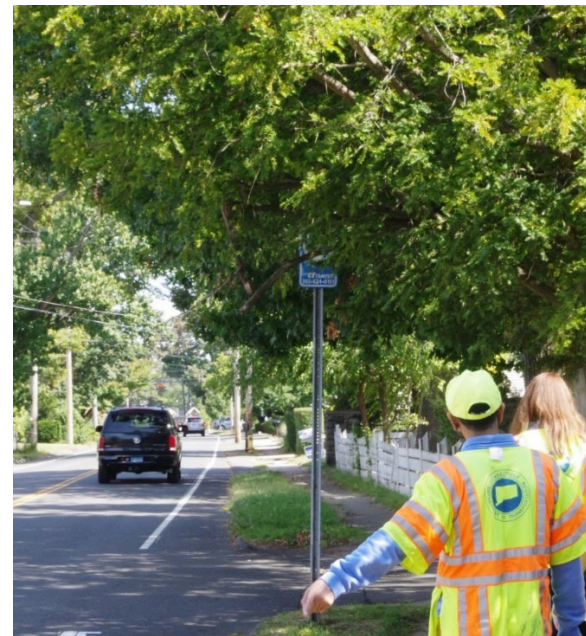
*Exhibit 29: Bus Stop Sign Obstructed by Tree Vegetation*

- Vegetation trimming and a bus pad are needed at the Scott Street bus stop. Exhibit 29 shows the current condition of the bus stop with the signage being covered by tree overhang.

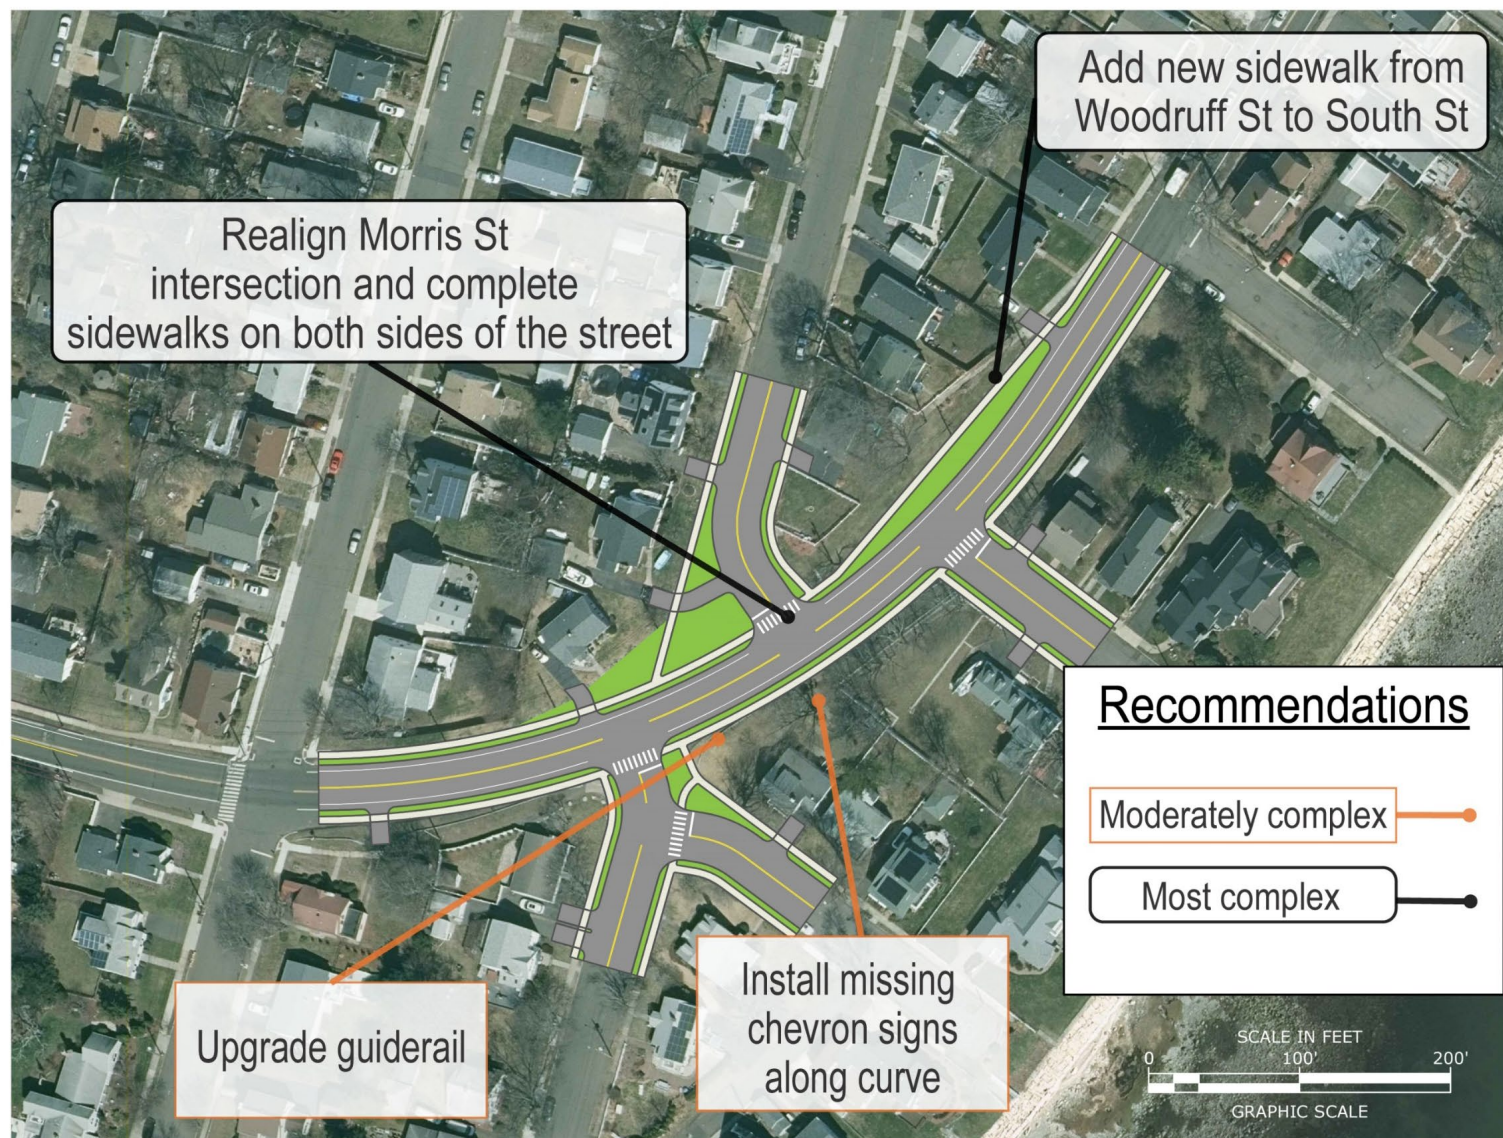
Exhibit 31: Concept for the Morris Street intersection and Curve on Route 705 (Ocean Avenue)

Additional recommendations in this section of the corridor focus on sidewalk and crossing improvements. A conceptual drawing of the roadway segment of Route 705 (Ocean Avenue) at Morris Street is presented in Exhibit 3.

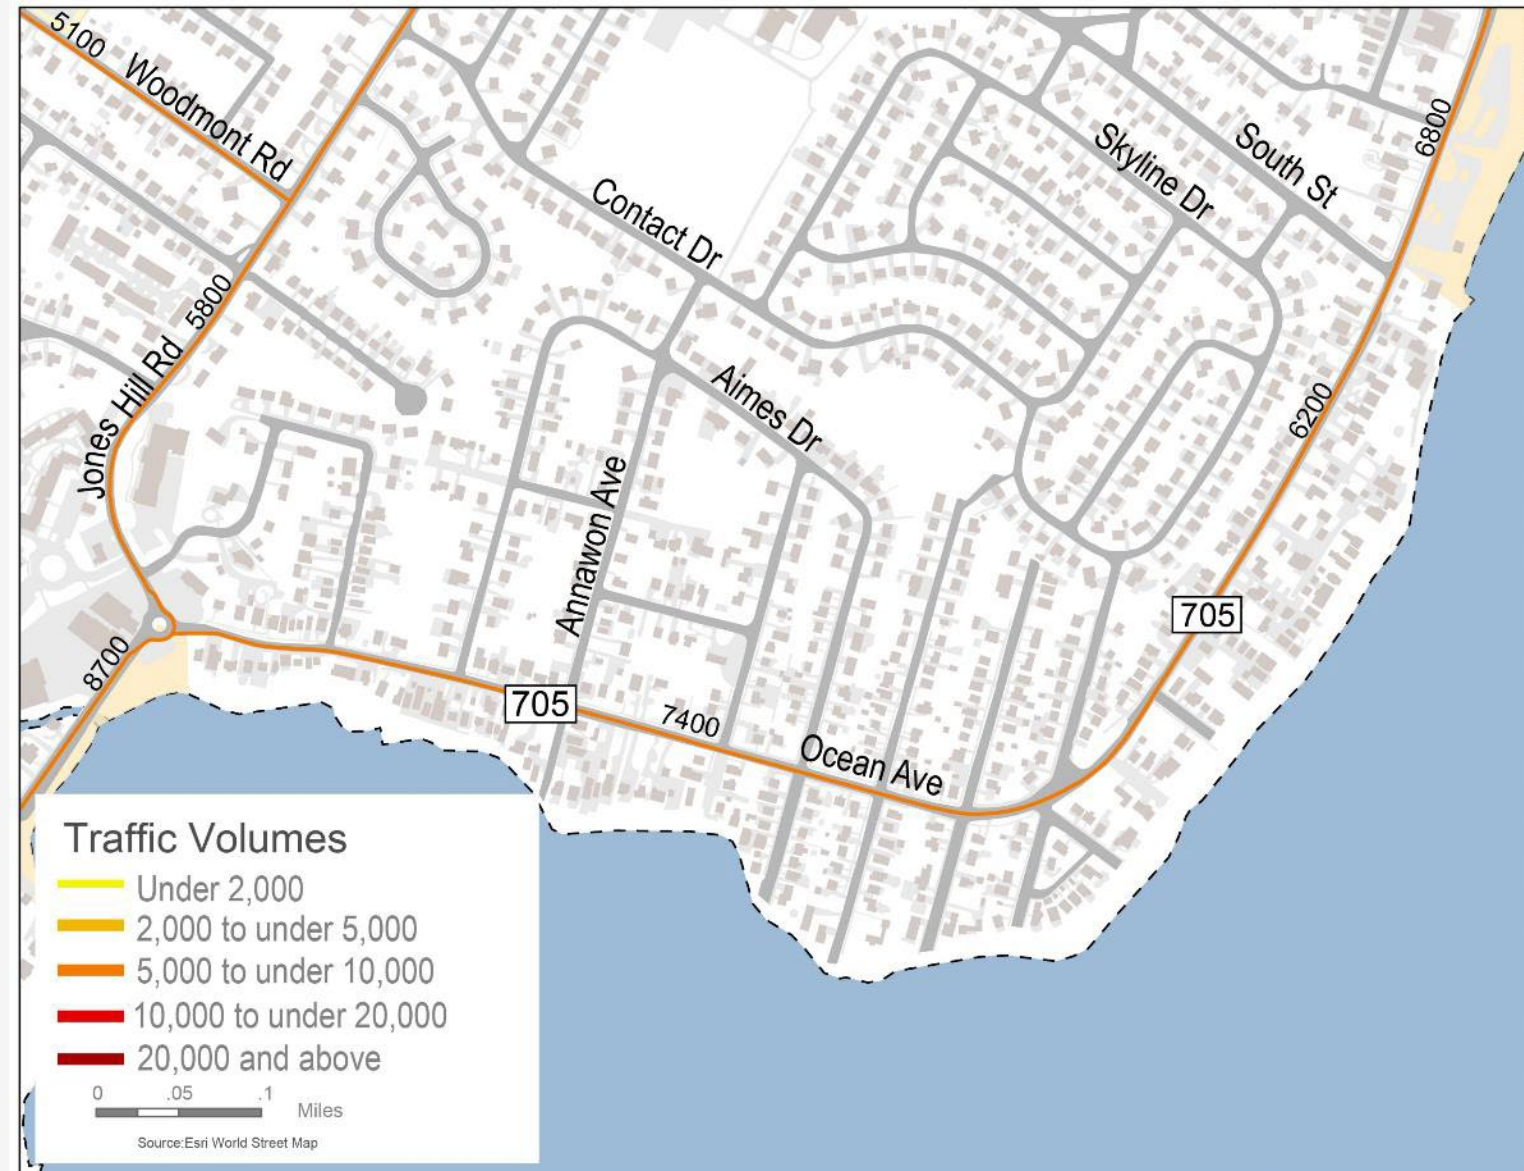
# Traffic Volumes

- Highest volume on New Haven Av approaching roundabout
- Next highest volume is on Ocean Av between Jones Hill Rd and Scott St

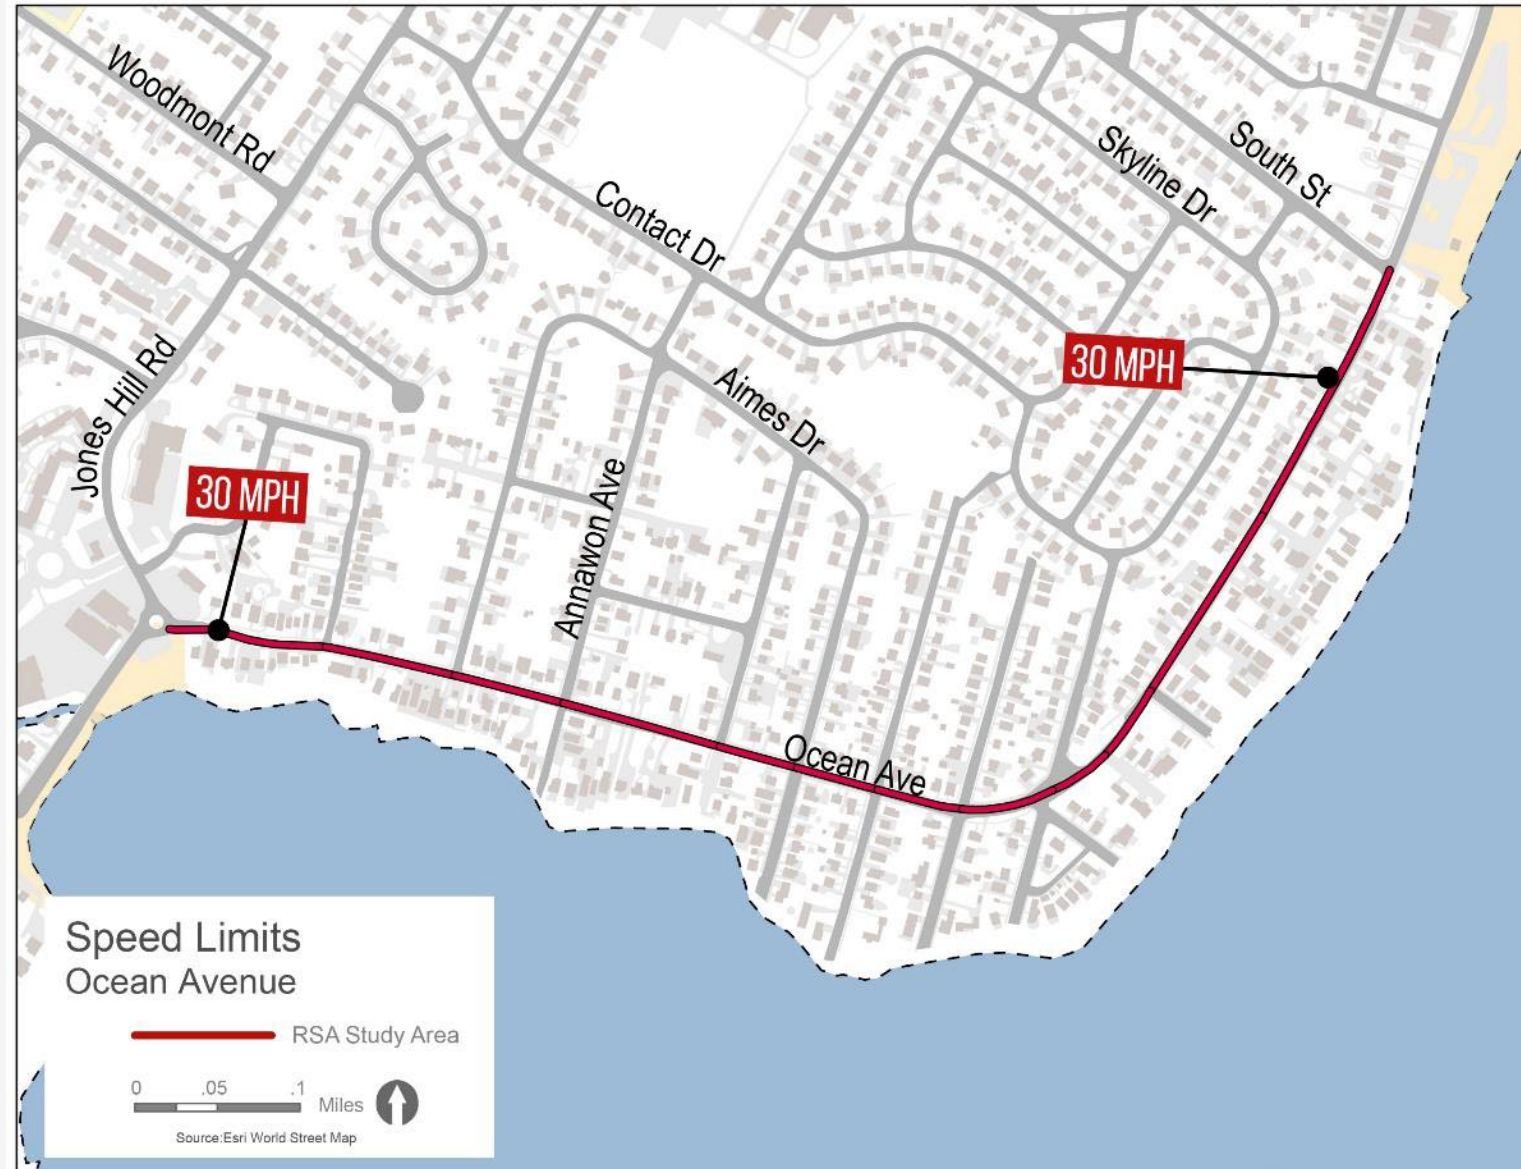
# Traffic Speed Limits

- Route 705 (Ocean Av) is 30 miles per hour (MPH) through study area
- 85<sup>th</sup> percentile speeds at Route 705 South of South St are 41.0 MPH
- 85<sup>th</sup> percentile speeds at Route 705 east of Route 162 are 35.8 MPH

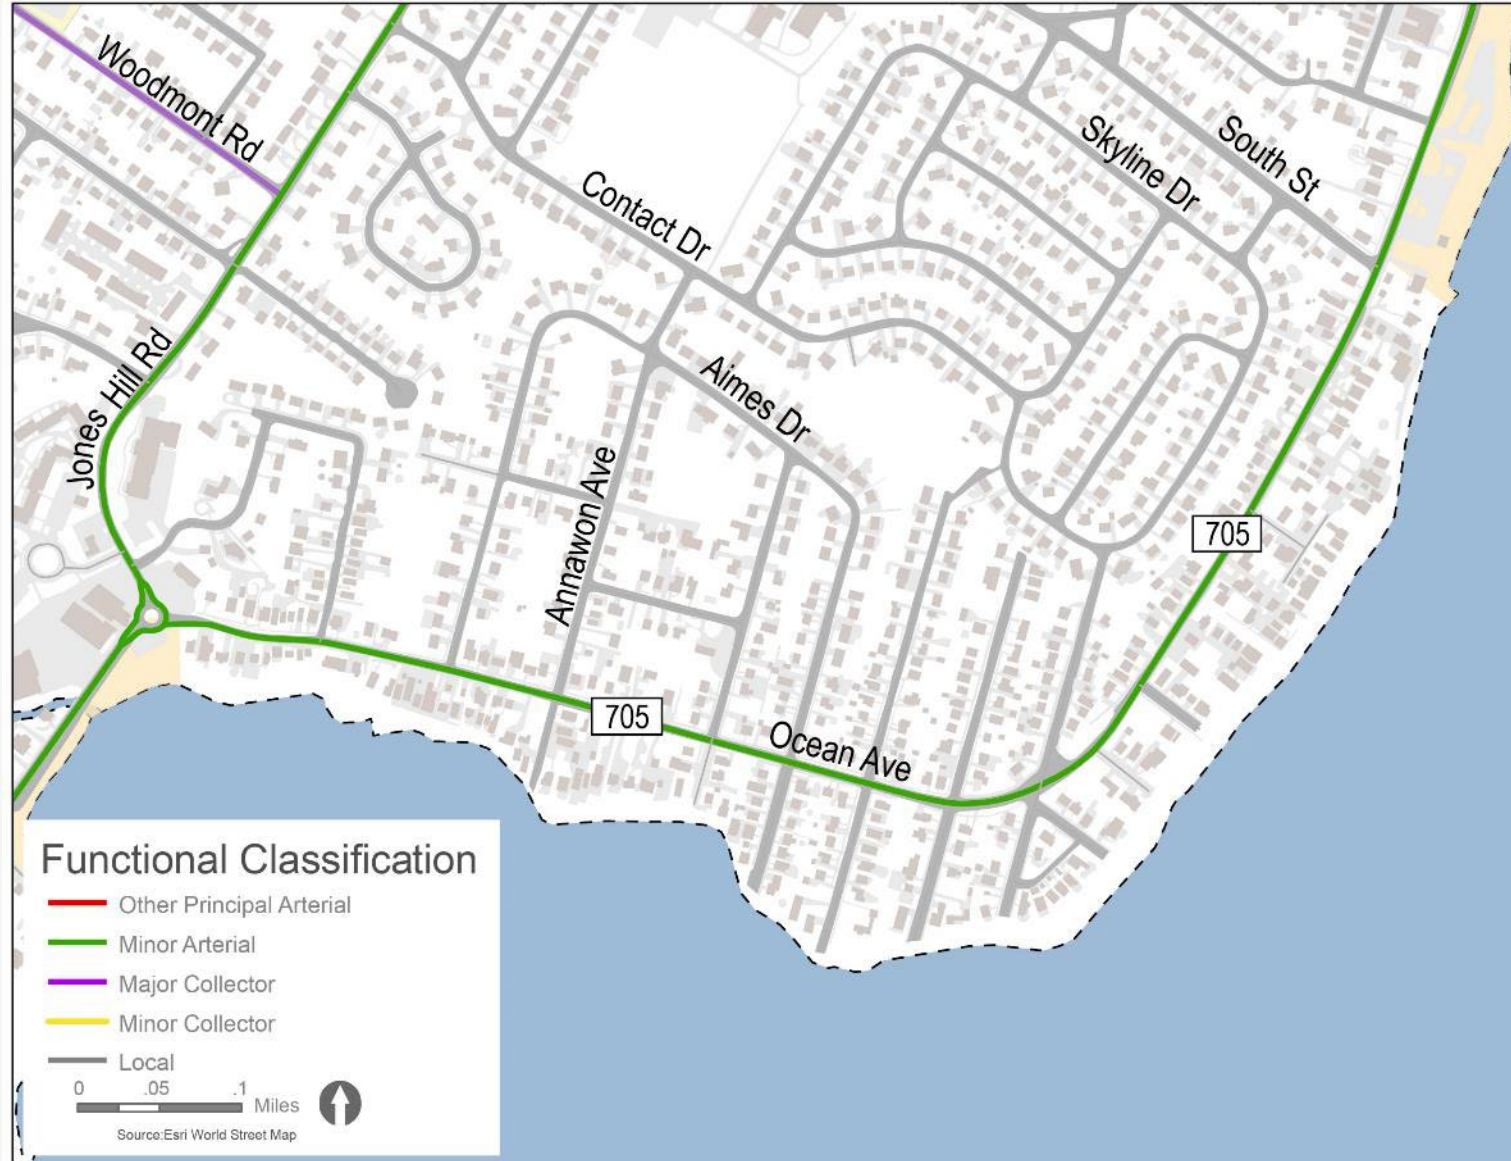
# Functional Classification

- Minor arterial
- Mainly local roads intersect with Route 705
- Major collector at Woodmont Rd

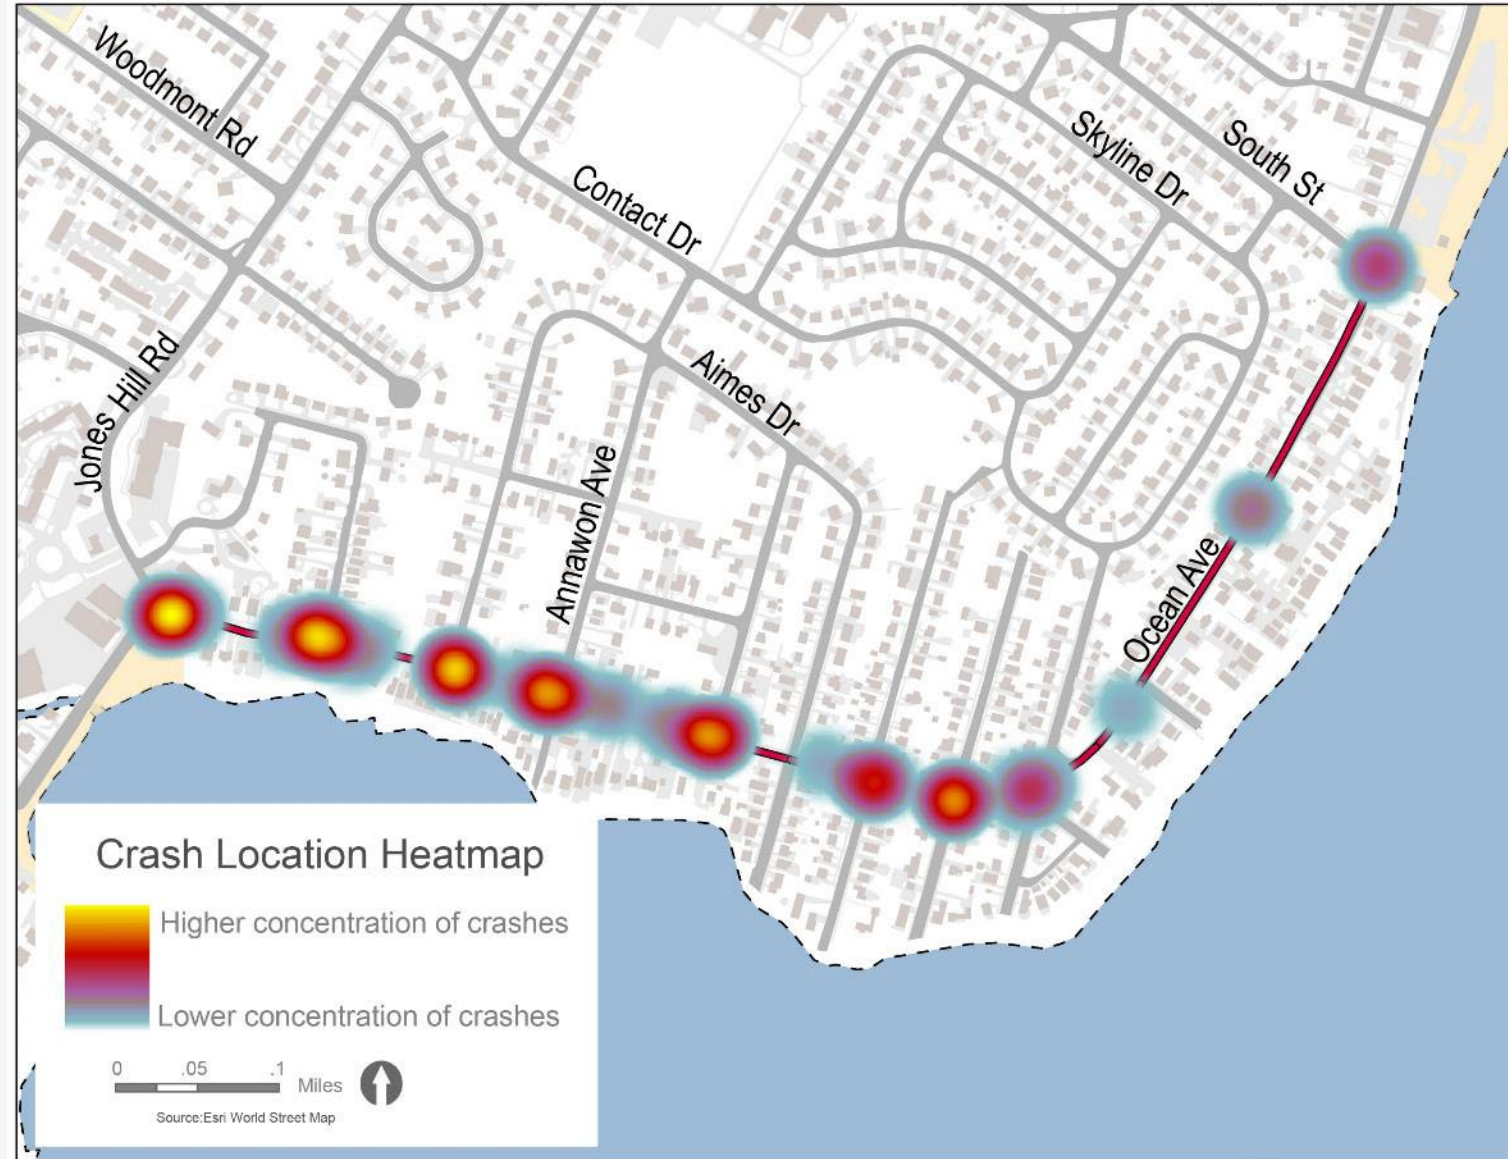
# Crash Hotspots (2017 – 2022)

- Route 705 and Jones Hill Rd
  - 4 crashes
- Route 705 and Nashawena Av
  - 3 crashes
- Route 705 and Anawon Av
  - 3 crashes
- Route 705 and Trumbull St
  - 3 crashes
- Route 705 and Harding St
  - 3 crashes

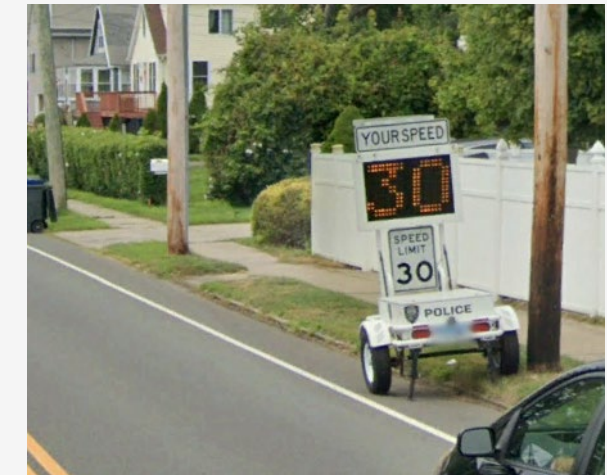
Dynamic speed signs

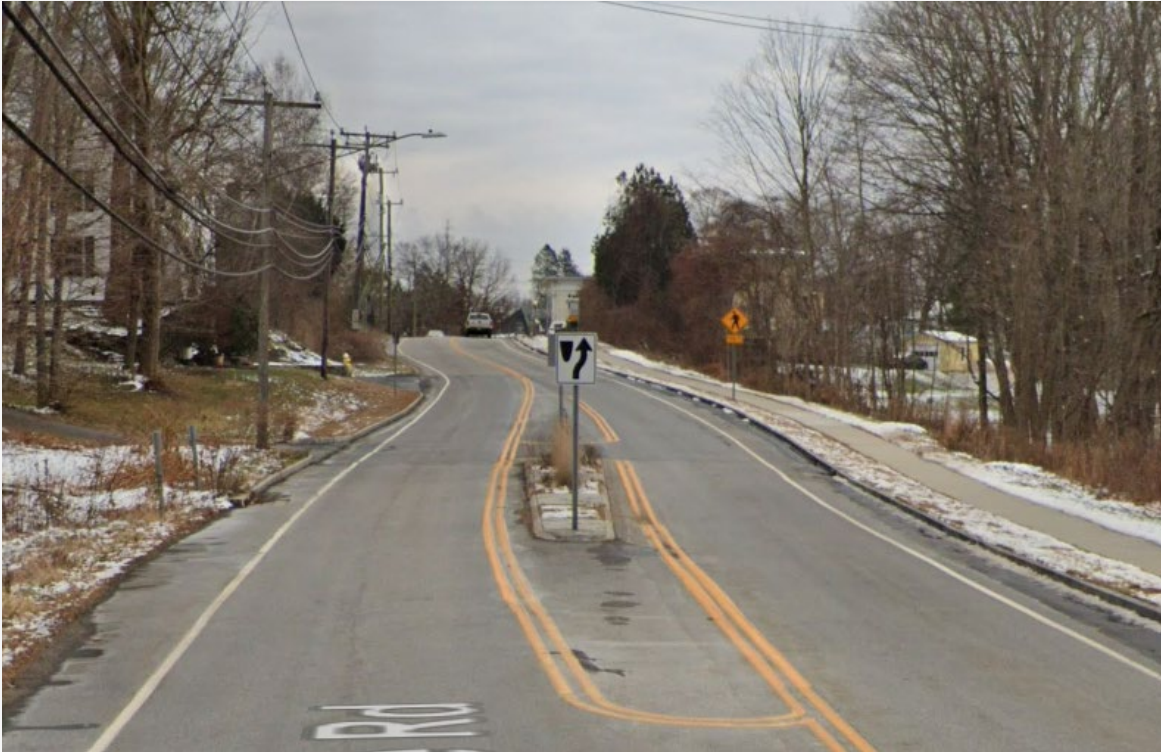
Short medians / lateral shift
