# West Haven Road Safety Audit

Route 705 (Ocean Avenue): Route 162 (Jones Hill Road)  
to South Street

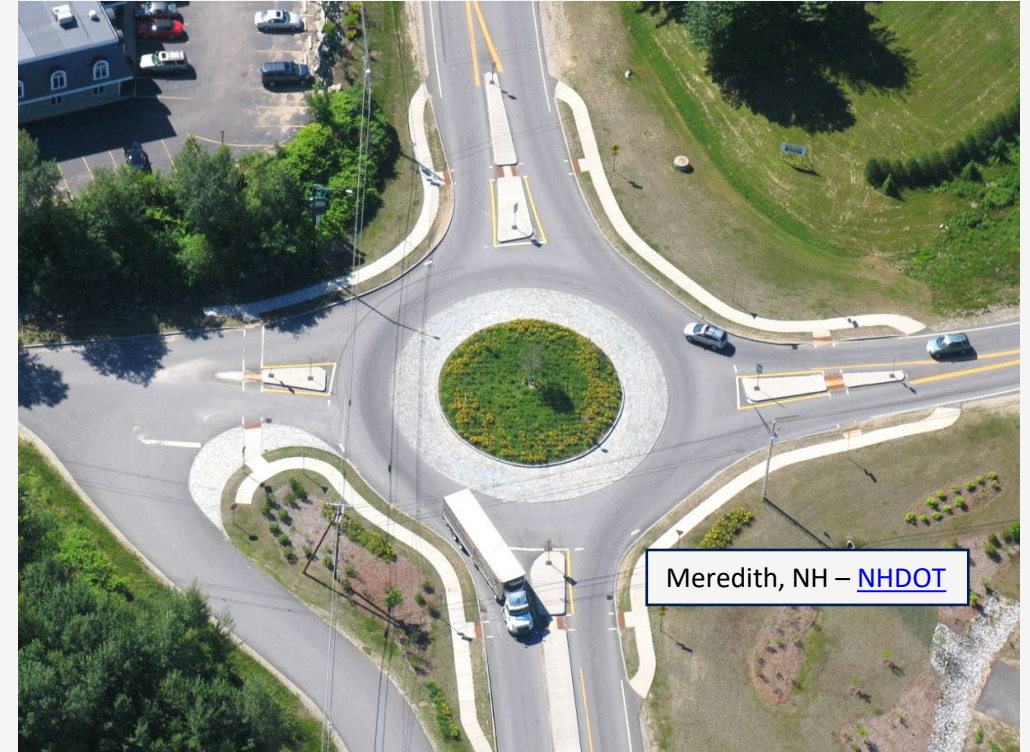
Roundabout

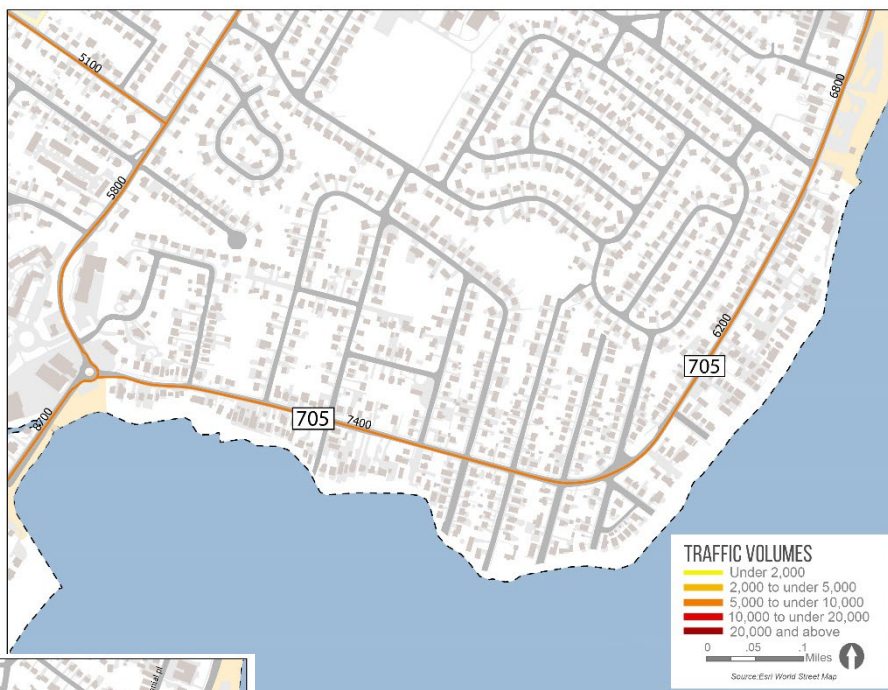
### Average Daily Traffic Volumes in 2019

- Average Daily Traffic (ADT) in the study area is highest on New Haven Av approaching the roundabout
- Next highest volumes are on Ocean Av between Jones Hill Road and Scott St

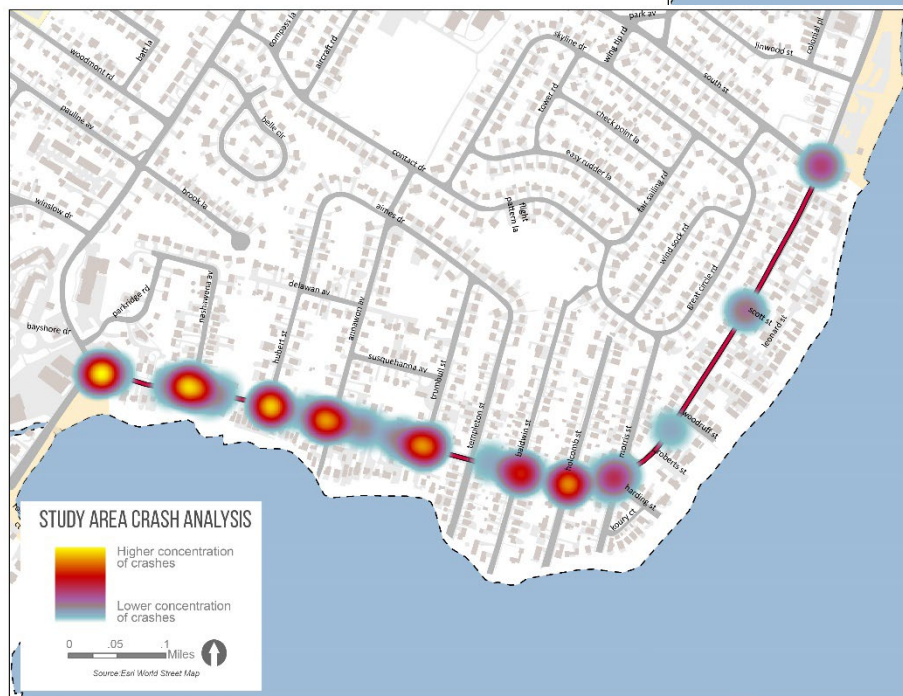
### Crash Summary Heat Map

- Route 705 (Ocean Ave) and Jones Hill Rd– **4 crashes**
- Route 705 (Ocean Ave) and Nashawena Av – **3 crashes**
- Route 705 (Ocean Ave) and Anawon Av – **3 crashes**
- Route 705 (Ocean Ave) and Trumbull St – **3 crashes**
- Route 705 (Ocean Ave) and Harding St – **3 crashes**
