# SEYMOUR ROAD SAFETY AUDIT

Route 67 (Bank Street) & Klarides Village Drive

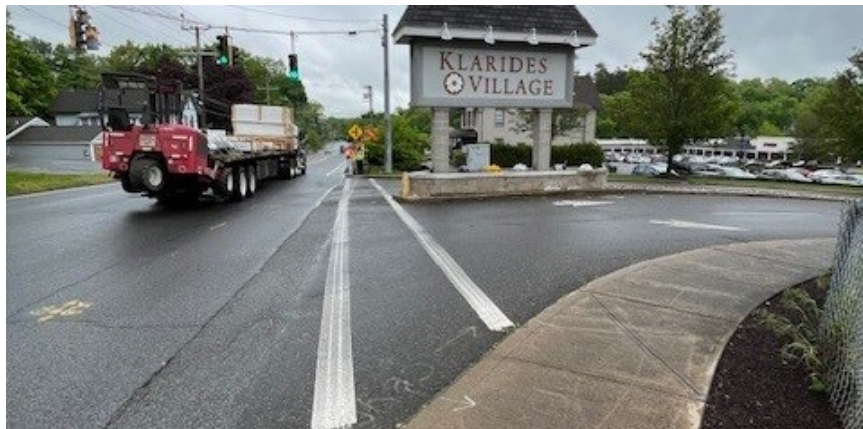
*Exhibit 14: Klarides Village Drive Intersection and Entrance*

The following summary describes observations and discussion of issues and concerns throughout the Seymour RSA study area. Exhibit 14 shows the start of our walk at the Klarides Village Drive intersection on Route 67. Discussions were held at each of the noted locations below.

- Pedestrian fatalities in 2021 at this signalized intersection
- Sidewalks currently only exist on the south side of Route 67
- Town participants expressed the need for a safer pedestrian experience crossing from the funeral home to the plaza driveway
- NVCOG discusses this intersection in their 2023 Spot Improvement Study and plans to improve the condition of the
